TOWN OF PLYMOUTH COMMUNITY PRESERVATION COMMITTEE

TO: Town Meeting, Board of Selectmen, and the Advisory & Finance Committee
From: The Community Preservation Committee
Date: Friday August 30, 2019
Re: FALL ATM 2019: CPA Article 9F

The Community Preservation Committee is recommending to Town Meeting the restoration of the Town of Plymouth Bell. Town Meeting utilized CPA funding in 2005 for the Bell to be retrofitted with an electronic ringing system. The Bell origins dates back to the original Town Bell of 1697. The Bell has not rung by hand since 1976. The Bell is unable to rung by pulling the it's rope because the rocker had deteriorated over the years. This most recent request will cover the total refurbish of the Bell, including a new rocker, electronic ringing system and returning the ability to ring the bell by pulling the rope.

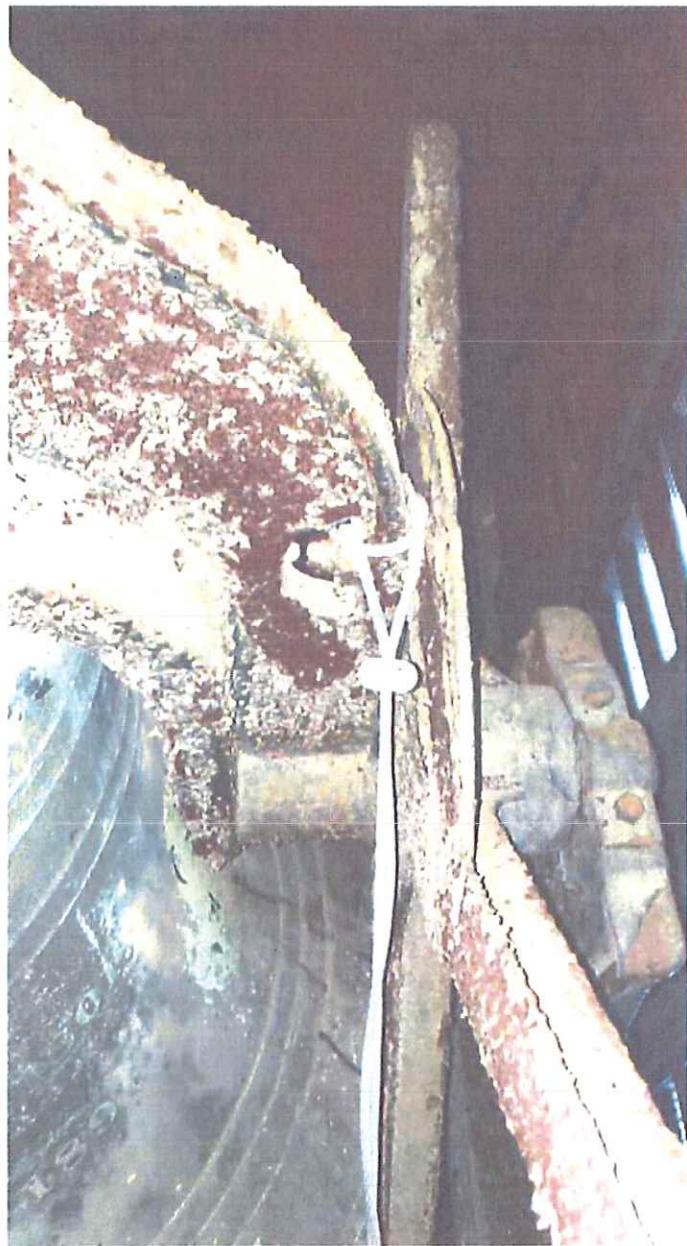
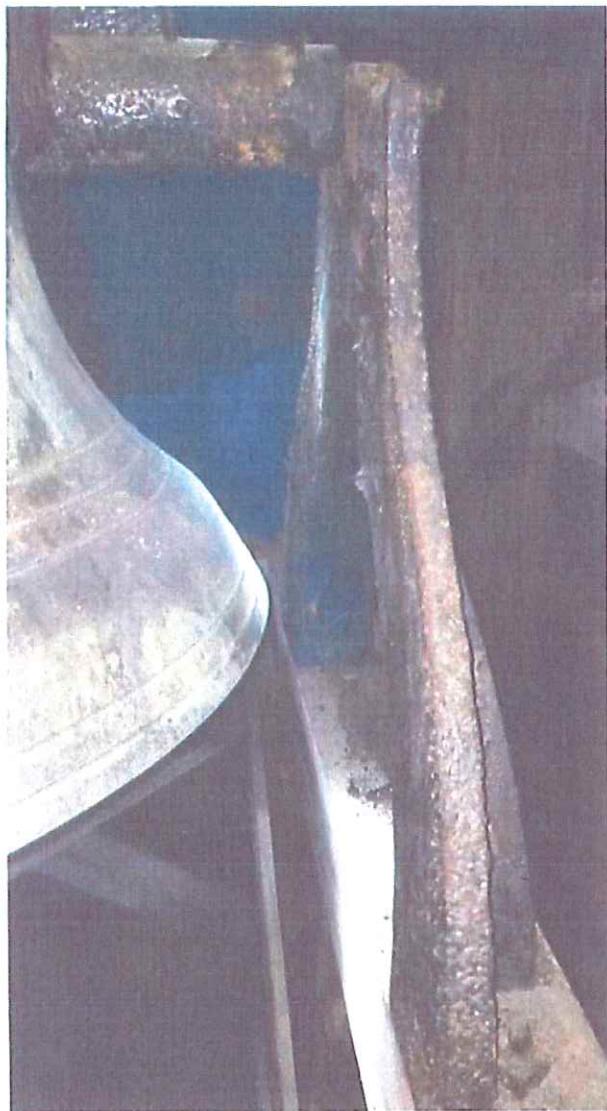
As shown below, the yoke, A stands and wheel are showing surface rust. We will sandblast, clean, prime & paint with rust inhibiting paint to prolong its life.

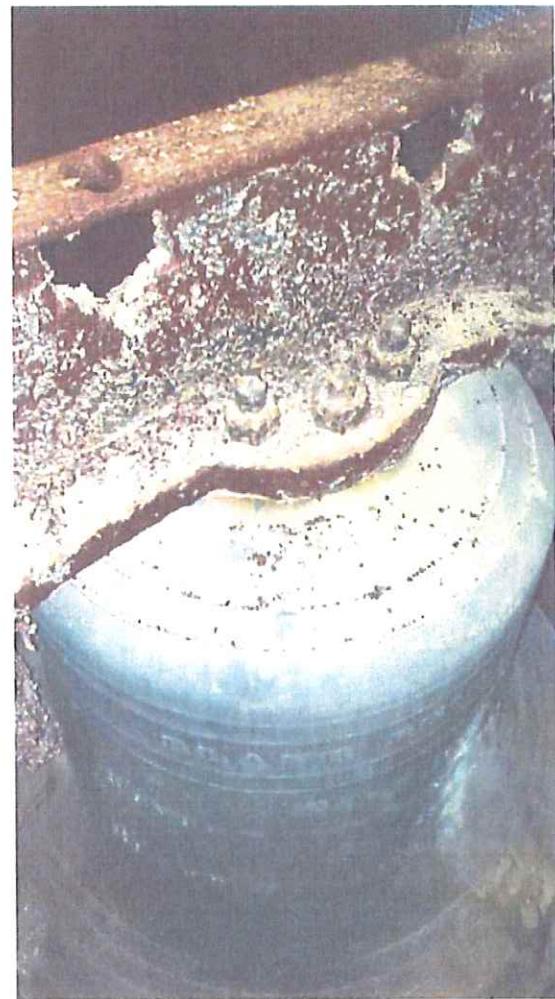
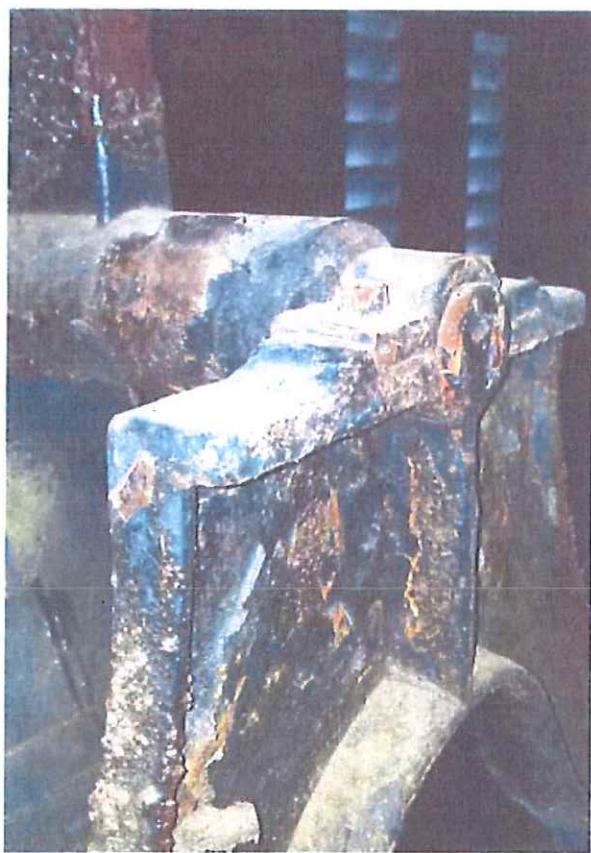
Surface Rust continued....

The head bolts on the single bell are showing signs of rust & corrosion. These bolts support the weight of the single bell and shall be replaced with new stainless steel bolts as part of the restoration.

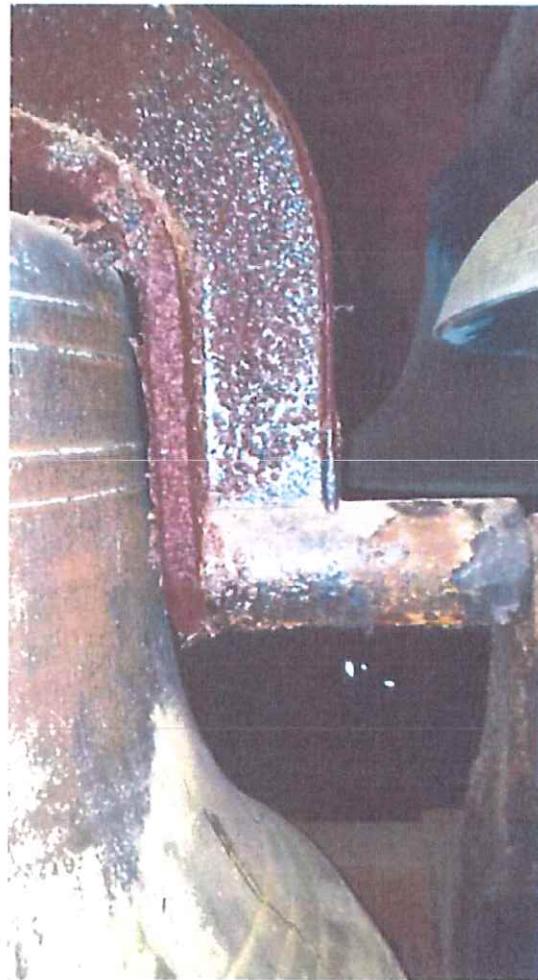
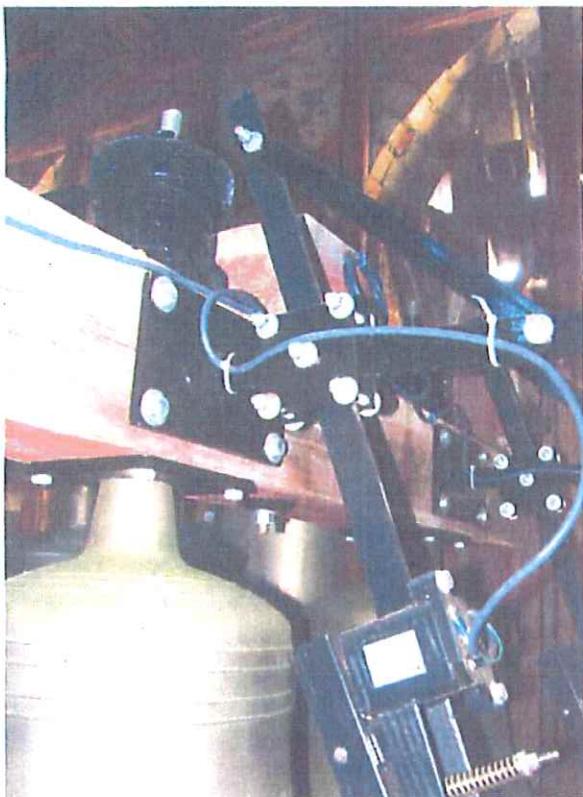
Surface Rust continued....

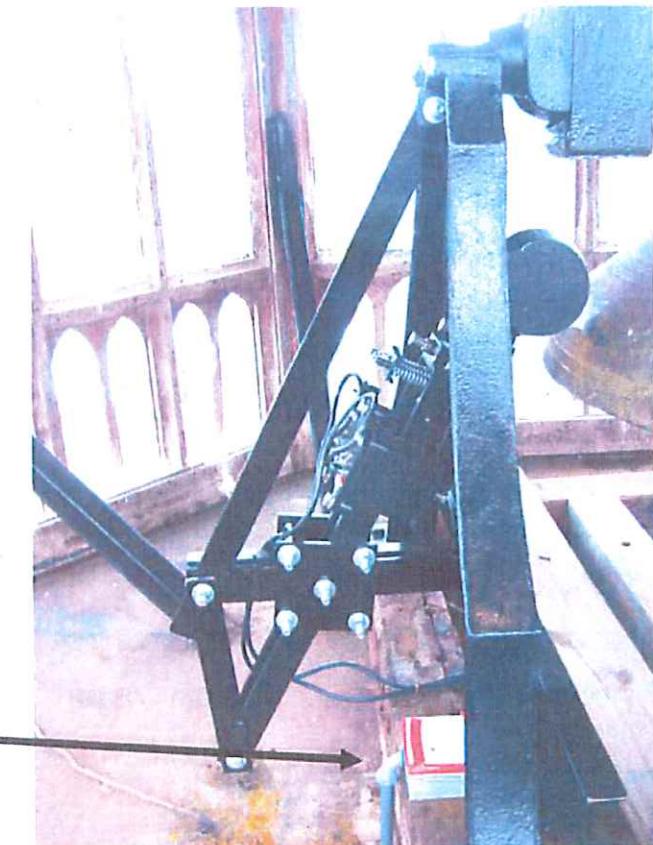
Junction Box shown here where the wiring goes from striker to the box, then downstairs where the relay panel is located. They may all travel within one conduit to the panel area. Please refer to wiring diagram provided by Verdin prior to installing wiring

Each Bell striker comes from the factory pre-wired (about 6-8 ft.) That wire goes into an electrical junction box either single or multiple. Our short cable is exterior grade. The electrician would typically decide on wiring from the relay panel below to each junction box based on local code requirements. It can be a Seal Tight conduit. Each cable has 2 conductor wires. The wiring drawing will indicate bringing spare wires as well.
