**ARTICLE 16B: To see if the Town will vote to transfer from the Community Preservation Historical Fund, estimated annual revenues, fund balance, or reserves, or otherwise fund, a sum of money for the preservation rehabilitation and restoration work of the identified forty stain glass windows, which are identified as #1 thought #40 in the Community Preservation Application submitted to the Community Preservation Committee on January 11, 2012 by the First Parish Meetinghouse Church for the stain glass windows in the First Parish Meetinghouse Church located at the Town Square as Lot 21, plat 19; in exchange for a Historic Preservation Restriction to be placed on the windows and also greater public access thought mutually agreed upon easement in the amount of \$300,000.00, and authorize the Board of Selectmen to accept said easement, or take any other action relative thereto.**

Project Name: First Parish Meetinghouse Restoration - Stained

Re: Repair and restoration of the stained glass windows at the First Parish Church

## STAINED GLASS WINDOW RESTORATION REPORT FIRST PARISH IN PLYMOUTH

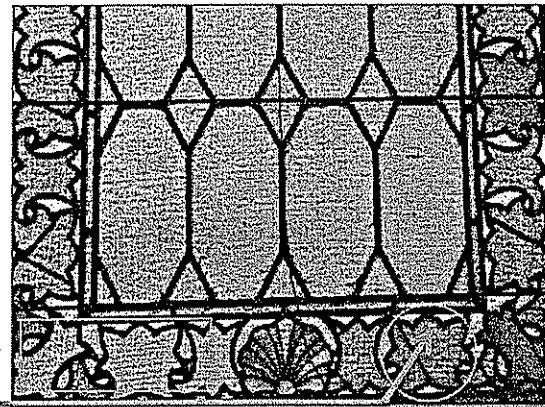
As mentioned to you during my visit, some of the leaded glass windows in the nave aisle were previously repaired. Unfortunately, most of them have suffered from ill-advised and poorly-executed workmanship, such as numerous pieces of mismatched glass replacement, shoddy soldering joints, wrong size and profile leads and poorly attached support bars.

*Mismatched replacement glass*

*Dutchman repairs*

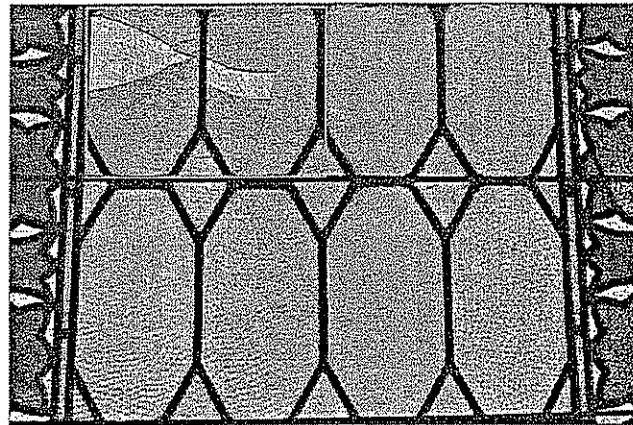
Many of the decorative windows located on the right nave aisle of the Sanctuary, are in much worse condition than the windows on the left side. There are numerous pieces of broken and missing glass throughout some of these windows (see photo above). Many of the Sanctuary windows will need to be removed and re-leaded. An itemized list of windows to be restored in order of priority will follow.

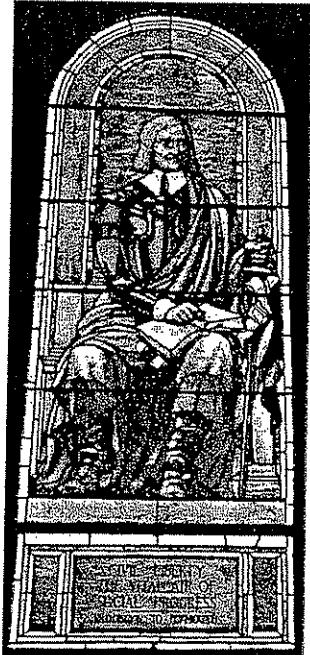
*"Civil Liberty"*

The three plated opalescent glass windows located in the Chancel, "Civil Liberty", "Signing the Compact" and "Religious Liberty", are a wonderful example of the American school of opalescent glass. Although the windows display the "Tiffany Glass & Decorating Co." signature plate they were, no doubt, designed by Edward Peck Sperry. For the most part, these windows are in good condition. The ventilator panels, which were at one point operable, have been sealed shut with silicone and also covered from the exterior with plastic.

The "Civil Liberty" window displays some lead deterioration, cracked glass as well as slight deflection, more pronounced in the bottom right of the window, just above the ventilator frame. The deflection is due to the weak leading design, where a long perpendicular lead line was used, coupled with the weight of the multiple-layered section above this area, causing this already weak area to hinge. There is a long streak on the right side of the figure's face. My guess is that there is a crack in this area and it used to be covered by a lead flange. At some point the lead flange was removed and the area cleaned with a harsh chemical, leaving a bright, streak. It also appears that someone started to clean the area under the man's right eye, which also left a bright spot. These areas should be closely examined over a light table and under a microscope to determine extent of damage in order to determine the possible restoration solutions.

**Window #20 "Civil Liberty"** This is a plated opalescent window, most likely designed by Edward Peck Sperry and fabricated by the Tiffany Studios. This window exhibits some deflection on the right side of the bottom section, caused by a weak leading concept, where one continuous long perpendicular lead came was used, eventually causing this particular area to "hinge" and deflect. The lead matrix throughout the window is in generally good condition, so the window does not need to be completely re-ledged. There are several pieces of cracked glass throughout the window. Of most concern is the missing paint under the right eye and the long white streak across the right side of the figure's face. It is very difficult to determine exactly what could have caused this, but we can speculate that it was a well-intended person who tried to clean the dirt off the face. In order to understand better what has happened to these areas, and a proper conservation approach, the window must be removed and the painted face inspected under a microscope on a light table. My recommendation is to remove this entire window and flatten the deflection at the bottom panel. After flattening, the structural system in the problem area will be augmented in order to prevent deflection from occurring again. The window will be partially and selectively dismantled and re-ledged only where necessary. All cracked glass will be repaired and retained. The face of the male figure will be closely inspected, and once we determine the cause of the paint loss, the Church will be notified and a plan of conservation will be recommended. The silicone sealing the ventilator panel shut will be cut and removed and the ventilator will be rendered operable again. After restoration and conservation, the window will be reinstalled in its opening. The existing obscured plastic covering the exterior of the window will be removed and discarded and new, vented clear laminated glass will be installed.

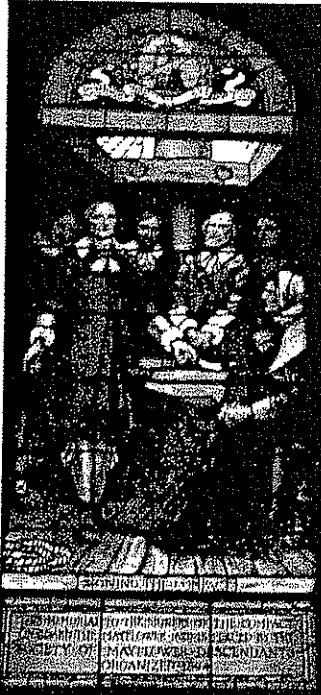
*"Signing the Compact"*

**Window #21 "Signing the Compact"** This window is in good condition and requires little work at this time. My only recommendation would be to remove the obscured plastic covering the exterior of the window, and install new, vented, clear laminated glass. The once operable ventilator panel was previously removed and re-ledged and it is in good condition structurally, however it was sealed shut with silicone sealant. We will cut and remove the silicone and the ventilator will be rendered operable again.

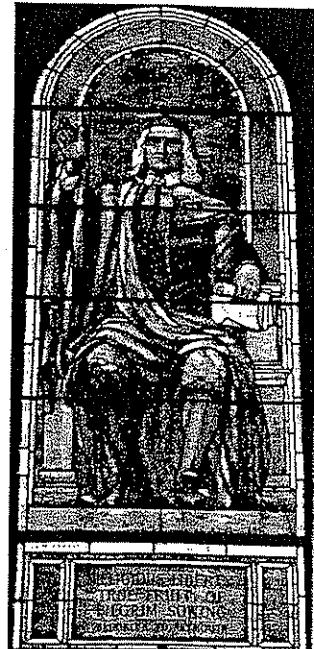
*"Religious Liberty"*

**Window #22 "Religious Liberty"** This window is in good condition and requires little work at this time. As with the "Signing the Compact" window, I recommend removing the obscured plastic covering the exterior of the window, and installing new, vented, clear laminated glass. The silicone sealing the ventilator panel shut will be cut and removed and the ventilator will be rendered operable again.

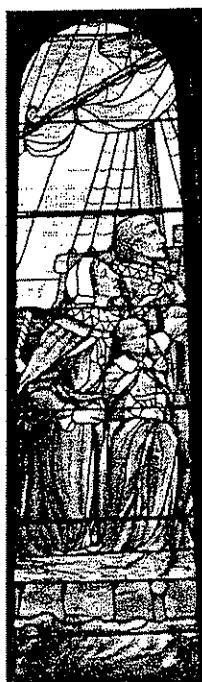
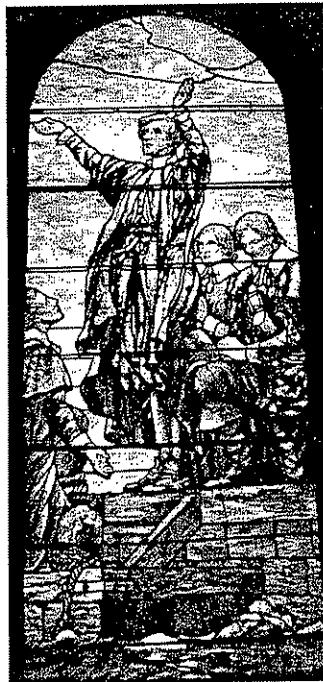
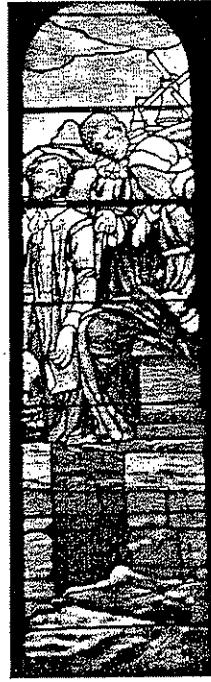
*"JOHN ROBINSON BLESSING THE PILGRIMS ON THEIR DEPARTURE FROM DELFT HAVEN"*

These three plated opalescent glass windows are in need of attention as they all exhibit lead deterioration, deflection and glass breakage. Most of the copper tie-wires that were soldered to the panels and twisted around the support bars, have pulled away and broken off, leaving the windows with no means of support. The deterioration of these windows has been accelerated by water infiltration in, and around, the walls. These three windows should be removed and restored as soon as possible.

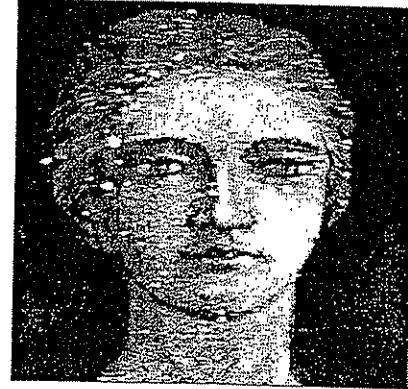
All of the windows in the Narthex are in very good condition and require no major work at this time. Some of the Narthex windows, most prominently Window #6, exhibit some pitting of the fired paint. This is clearly visible on the figure's face (see photo on the right). There could be several reasons why this has occurred. There could have been some remnants of oil on the glass, which later caused the fired paint in those areas to lift and disappear. Or, there could have been an issue with that particular batch of vitreous paint. I do believe that it will not deteriorate further. If the Church wishes to, we can infill the "spots" using artists' oil paint. This technique is safe and completely reversible.

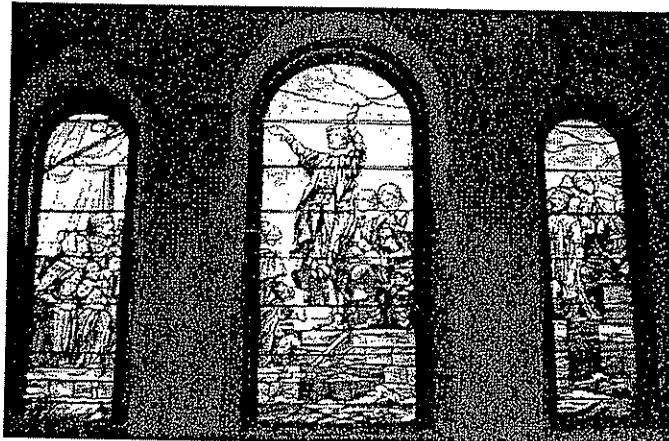
*JOHN ROBINSON BLESSING THE PILGRIMS ON THEIR DEPARTURE FROM DELFT HAVEN*

These three plated opalescent windows (#'s 38, 39, 40) display serious structural problems as well as some lead deterioration. Most of the copper tie wires have pulled away from the leads and support bars, leaving the individual panels very weak and in danger. Most of the perimeter glazing-compound (putty), sealing the windows in their frames has come off. There are numerous pieces of cracked glass throughout the windows. These three windows should be removed restored and properly re-installed. After re-installation, the exterior plastic, covering the stained glass windows, will be removed and new, vented, clear laminated glass will be installed. If not removed soon, this window will continue to deteriorate, more historic glass will crack and it will eventually collapse.
