Town of Plymouth

Part A – Executive Summary

October 2019

Prepared by the
**Institute for
Human
Centered
Design**

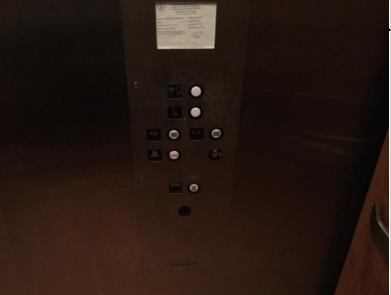
Illumination levels are lower than 54 lux (5 ft. candles)	-	Increase illumination level to 5 foot candles min.	1	Labor	\$0
Signage												
16	Lecture Room	UL		Signage	Designation

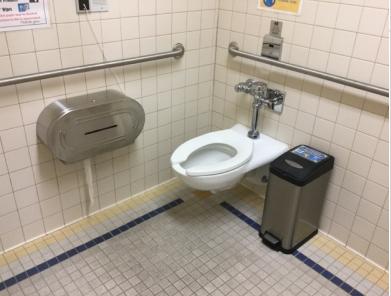
Clearance at toilet < 60" clear width	-	Relocate trash can to maintain the 60" min. clear floor space at the toilet.	1	Labor	\$0
Dispensers												
25	Women's Toilet Room	LL	003	Dispensers	Hand Dryer

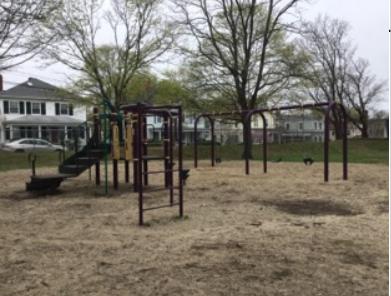
Surface not stable, firm, and slip-resistant	450'	Repair surface. (Cost based on 450 square feet of poured in place rubber.)	1	6300	\$6300

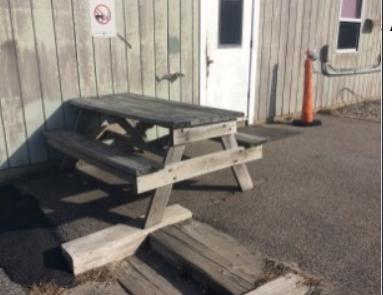
At least 5% accessible spaces not provided	-	Ensure that at least 5% (minimum one) of dining surfaces are accessible. (Provide one accessible picnic table.)	1	700	\$700
Toilet & Bathing Rooms												
Lavatory												
10	Toilet Room	1		Lavatory	N/A

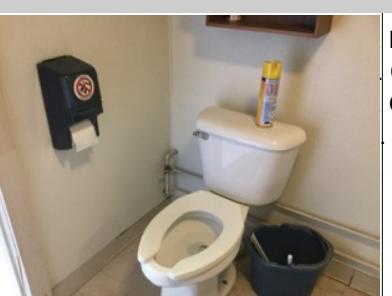
Flush control not on open side Centerline < or > 18" (MAAB) Grab bar not provided Toilet paper dispenser is not compliant	20.25 - -	Relocate the flush control to the open side. Relocate toilet so that the centerline is 18" from the side wall. Provide side and rear grab bars. Relocate toilet paper so that it is 15" min. high, located under the grab bar, and between 7" and 9" from the front of the toilet. Replace dispenser if it does not allow continuous paper flow.	1	2852	\$2852

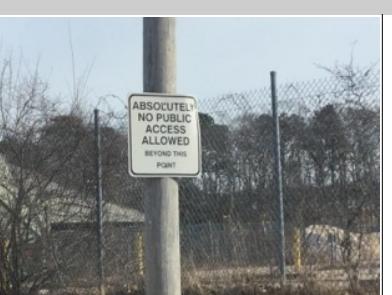
Sign at entrance says "Absolutely No Public Access Allowed Beyond This Point." If this building is used for Town programming, ensure this sign is removed to avoid confusion.	1	0	\$0

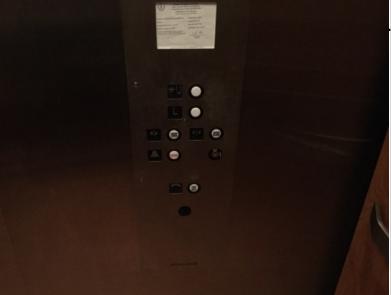
Illumination levels are lower than 54 lux (5 ft. candles)	-	Increase illumination level to 5 foot candles min.	1	Labor	\$0
Signage												
16	Lecture Room	UL		Signage	Designation

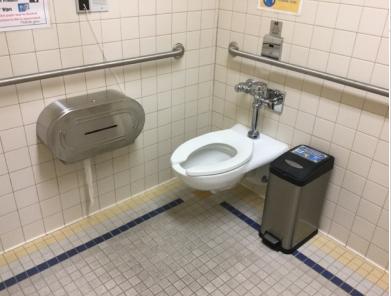
Clearance at toilet < 60" clear width	-	Relocate trash can to maintain the 60" min. clear floor space at the toilet.	1	Labor	\$0
Dispensers												
25	Women's Toilet Room	LL	003	Dispensers	Hand Dryer

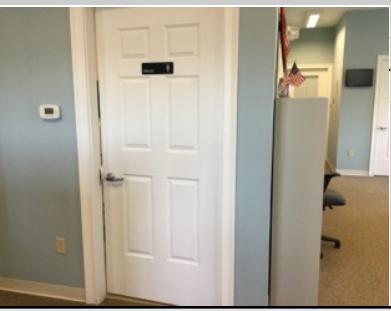
Raised characters not provided Braille not provided International Symbol of Acc. not compliant	- - -	Provide text with raised characters duplicated in braille. Replace signs with signs containing the International Symbol of Accessibility.	2	116	\$232

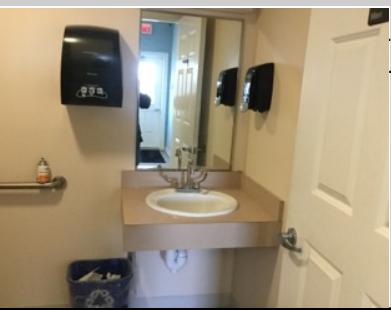
Lavatory rim or counter > 34" high Dispensers not within reach range	37" -	Provide one lavatory in each toilet room with the rim no higher than 34". Relocate paper towel and soap dispensers to 42" max. above the floor. (Cost based on providing two (2) lavatories at a compliant height - one (1) in each toilet room - and relocating four (4) dispensers - two (2) in each toilet room.)	2	2253	\$4506
Best Practice

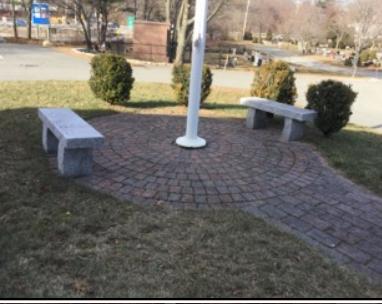
50 percent of benches lack back support		Recommend providing at least one (1) bench with back support	1	0	\$0
10	Main Entrance	Ext.		N/A	N/A

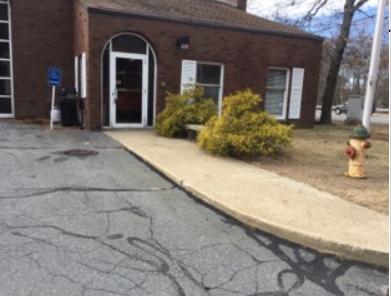
Accessible route not provided	-	Ensure an accessible route is provided to the main entrance by relocating the accessible parking space. This will allow for a van accessible parking space with a compliant access aisle and sign. (At present, if a car were to park at this location, it would block the accessible route to the main entrance.) See ID #3 for cost.	1	Labor	\$0
Off-Street Parking Lot or Garage												
2	Rear Entrance Parking, West Side	1		Off-Street Parking Lot or Garage	N/A

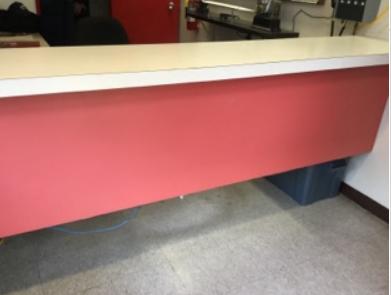
Counter > 36" high	40.25"	Provide a counter that is 36" max. above the ground or finished floor.	1	440	\$440
Toilet & Bathing Rooms												
Overall Access												
11	Toilet Room	1		Overall Access	Toilet Room

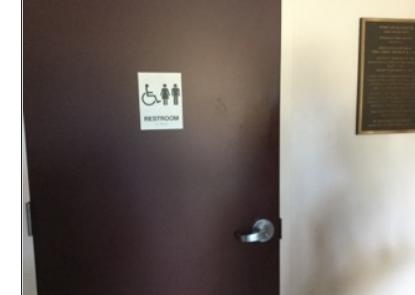
Door requires > 5 lbs. of force to open Sign not located on the latch side of the door	17 lbs -	Adjust closers so doors do not require more than 5 pounds of force to open. Locate sign at permanent rooms alongside the door on the latch side.	1	Labor	\$0

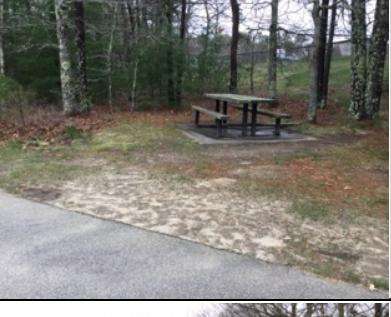
Toe or knee clearance at table not provided Picnic table not on an accessible route		Provide at least one picnic table with toe and knee clearance. Locate picnic table on an accessible route. (Cost based on one accessible picnic table and a new 36" wide min. 12' long concrete path.)	1	976	\$976
17	Baseball Park Pathway	Ext.		Picnic Tables	N/A

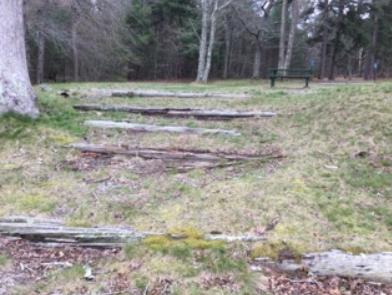
Route from parking area to beach is not accessible.		Consider adding a sign directing visitors to the accessible route.	1	0	\$0

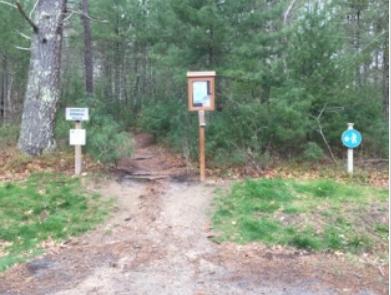
Outdoor rec access route not provided	10'	Provide an outdoor recreation access route. (Cost based on 36" wide min. 10' long stone dust path with running slope of 5.00% (1:20) max. and cross slope of 2.00% (1:50) max.)	1	114	\$114
Beach Access Routes												
12	Pond	Ext		Beach Access Routes	Permanent

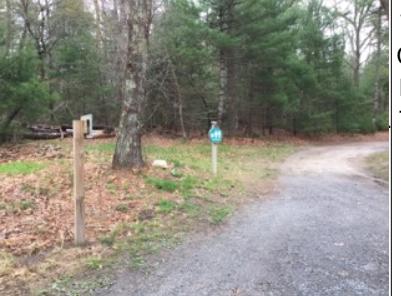
Visual characters < 40" above ground Contrast not compliant Directional sign to acc. toilet room not provided Text size not compliant	- - - -	Mount visual sign so that the baseline of the lowest character is 40" min. above finish floor. Provide signs with a non-glare finish with characters that have a high contrast to the background. Provide a sign indicating the location of the nearest accessible toilet room. Ensure that character size complies with the Character Height Table 703.5.5 in the ADA 2010 Standards.	1	116	\$116
Picnic Tables												
27	Pond	Ext		Picnic Tables	N/A

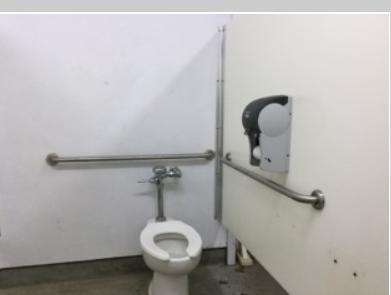
Door with malfunctioning self-closing hinge Side grab bar < 42" long Rear grab bar < 42" long Non-compliant toilet paper dispenser Clearance at toilet < 60" clear width Item mounted over grab bar (MAAB)	- 40.25" 40.75" - 58" -	Repair hinge. Provide a side wall grab bar that is 42" long min. located 12" max. from the rear wall and a rear wall grab bar that is 42" long min. and extends from the toilet 12" min. on one side and 24" min. on the other side (open side). Relocate toilet paper dispenser below grab bar. Width is not entirely compliant but is usable.	1	Labor 1251	\$1251
35	Men's Toilet Room	1	1	Toilet Compartment	Accessible Compartment

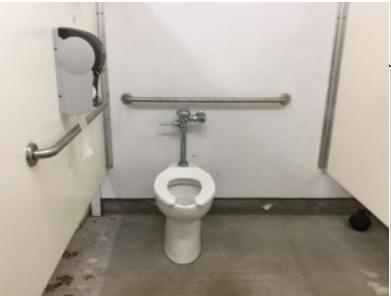
Door with malfunctioning self-closing hinge Flush control not on open side Item mounted over grab bar (MAAB)	- - -	Repair hinge. Provide the flush control on the open side of the toilet (transfer side). Relocate toilet paper so that it is not mounted over the grab bar.	1	Labor 540	\$540

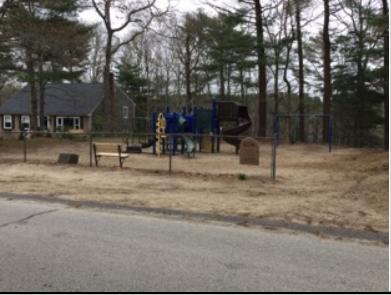
Accessible route not provided	45'	Ensure an accessible route is provided. (Cost based on 36" wide min. 45' long stone dust path with running slope of 5.00% (1:20) max. and cross slope of 2.00% (1:50) max.)	1	513	\$513
Curb Ramp												
2	Curb to Park	Ext		Curb Ramp

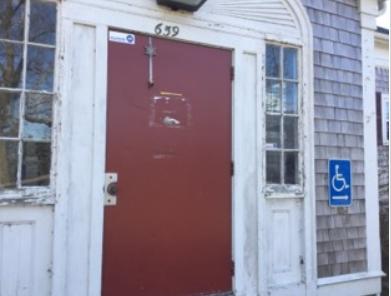
Hardware not operable with a closed fist	-	Provide hardware that can be operable with one hand and not require tight grasping, pinching, or twisting of the wrist.	1	242	\$242
Stairways												
16	Egress Near Main Entrance	Ext.		Stairways	139

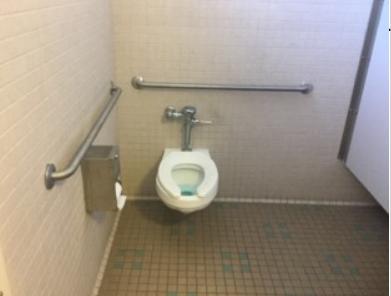
Door has malfunctioning self-closing hinge	-	Repair hinge.	1	Labor	\$0

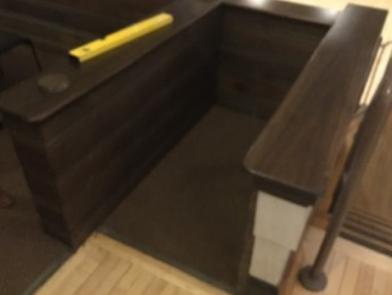
Narrower than required for accessible seating.		Recommend not reserving four similar boxes for accessible seating as they are narrower than the minimum width required for accessible seating, and lack a companion seat.	4	0	\$0

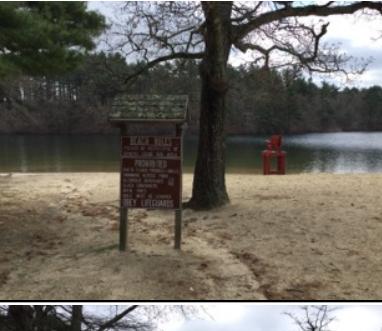
Beach route not provided	75'	Provide a beach access mat to ensure an accessible route is provided. Ensure the accessible route extends to the recreation water level. (Cost for 60" wide 75' long beach access mat.)	1	1925	\$1925

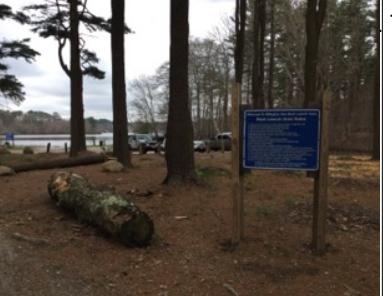
Text size non-compliant	-	Ensure that character size complies with the Character Height Table 703.5.5 in the ADA 2010 Standards.	1	400	\$400
Picnic Tables												
22	Parking at Red Springs Beach	Ext.		Picnic Tables	N/A

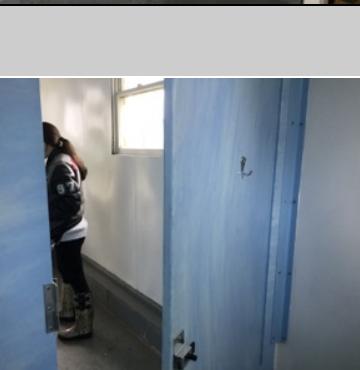
Door with malfunctioning self-closing hinge Coat hook > 48"	- 52.5"	Repair hinge. Lower coat hook so that it is no higher than 48".	1	Labor 75	\$75

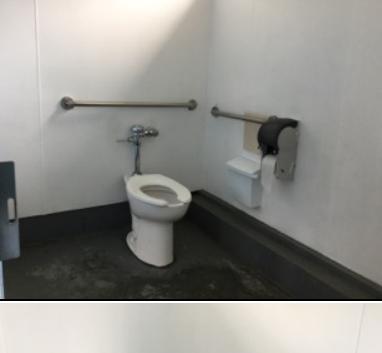
Side grab bar < 42" long Rear grab bar < 42" long Non-compliant toilet paper dispenser Coat hook > 48"	24" 35.5" - 52.75"	Provide a side wall grab bar that is 42" long min. located 12" max. from the rear wall. Provide a rear wall grab bar that is 42" long min. and extends from the toilet 12" min. on one side and 24" min. on the other side (open side). Relocate toilet paper to between 15" and 48" above the finish floor and between 7" and 9" from the front of the toilet. Lower coat hook so that it is no higher than 48".	1	1326	\$1326
21	Men's Toilet Room	1		Toilet Compartment	Accessible Compartment

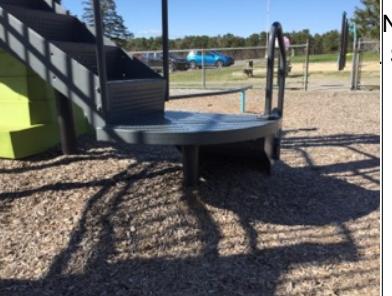
No compliant transfer system Surface not stable, firm, and slip-resistant	21" -	Alter height of transfer system to 18" max. aff. Provide an accessible impact-attenuating surface around and under play components. (Cost based on 1,030 square feet of poured in place rubber.)	1	14420	\$14420
Field												
21	Baseball Field	Ext		Field	Baseball

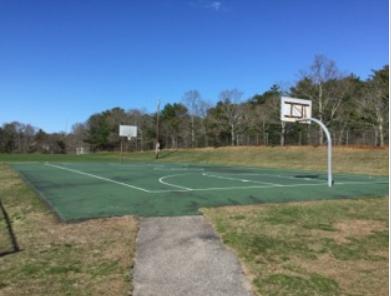
Running slope > 1:20 (5.00%)	8.4%	Reduce the running slope to be no steeper than 1:20 (5.00%). (Cost based on 36" wide min. 32' long of concrete to correct path running slope to 5.00% (1:20) max.)	1	480	\$480
Bleachers												
26	Baseball Field	Ext		Bleachers	N/A

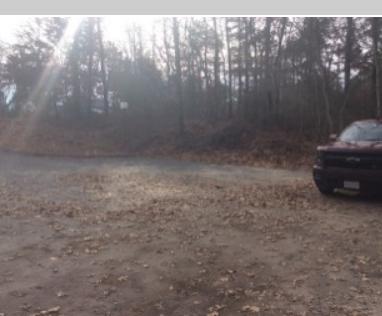
Total # of parking Total # of designated accessible parking spaces Access aisle not provided Sign not provided	10 0 - -	Provide one van accessible space with access aisle that is at least 96" wide. Provide a sign with the bottom of the sign 60" min. above the ground and the top 96" max. above the ground. Add the designation "Van Accessible."	1	925	\$925

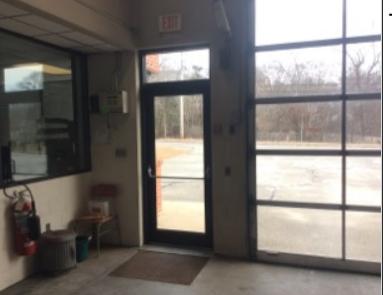
Tactile exit sign not provided	-	Ensure tactile exit signs with raised characters and braille are provided at exit doors. Mount signs between 48"- 60" above finish floor located on the latch side of the door.	2	116	\$232
Operable Parts												
6	Main Entrance	1	-	Operable Parts	Switch

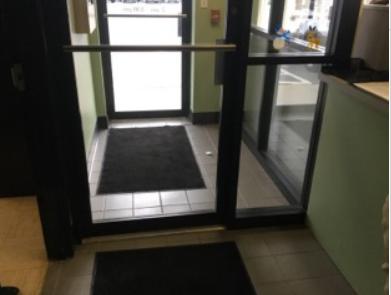
Tactile exit sign not provided	-	Ensure tactile exit signs with raised characters and braille are provided at exit doors. Mount signs between 48"- 60" above finished floor located on the latch side of the door.	2	116	\$232
Interior Access Route												
6	Main Office Area	1		Interior Access Route	N/A

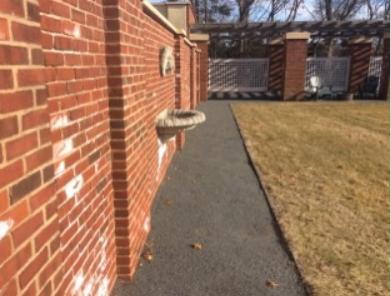
Obstructed by protruding objects	31"	Provide a cane-detectable barrier and ensure an 36" wide accessible route is maintained.	1	100	\$100
2	Route to Community Garden From Parking Lot, South Side of Building	1		Exterior Access Route	Exterior

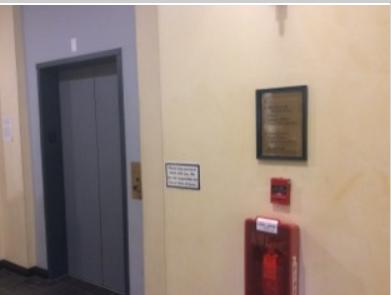
Recommend providing an informational sign with high contrast.	1	0	\$0

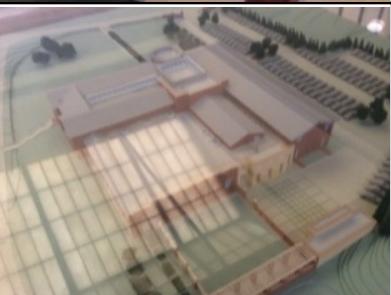
Recommend removing glass or creating a low-glare, matte finish to ensure visibility by all users.	1	0	\$0

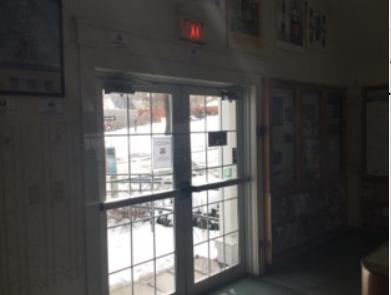
Tactile exit sign not provided Mat not securely attached Illuminated International Symbol of Acc. not provided	- - -	Ensure tactile exit signs with raised characters and braille are provided at exit doors. Mount signs between 48"- 60" above finished floor located on the latch side of the door. Securely attach mat. Provide the International Symbol of Accessibility (ISA) on the illuminated exit sign above the exit door.	1	216	\$216
Signage												
6	Men's and Women's Toilet Rooms	1		Signage	Designation

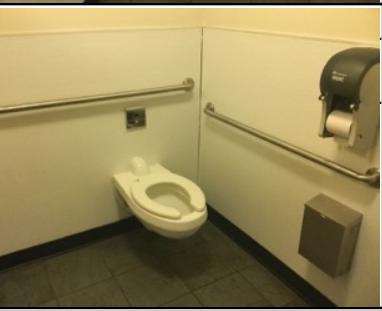
Door has malfunctioning self-closing hinge Side or rear grab bar < 33" or >36" high Non-compliant toilet paper dispenser	- 29.5" -	Repair hinge. Locate rear grab bar between 33"- 36" above the finished floor. Relocate toilet paper dispenser so that it is 15" min. high, located under the grab bar, and between 7" and 9" from the front of the toilet.	1	481	\$481

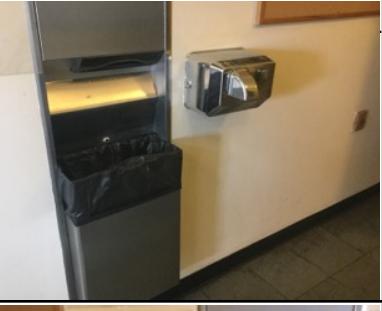
Dispenser acts as a protruding object	10"	Relocate hand dryer out of the circulation path.	1	353	\$353
12	Women's Toilet Room	1		Dispensers	Hand Dryer

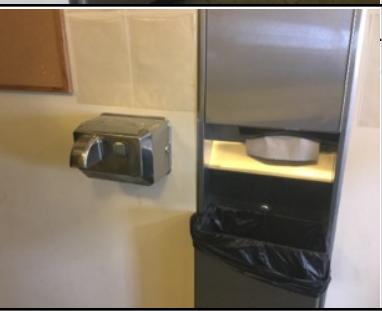
Dispenser acts as a protruding object Not in operable working condition	10" -	Relocate hand dryer out of the circulation path. Ensure hand dryer is kept in operable working condition.	1	353	\$353
Best Practice

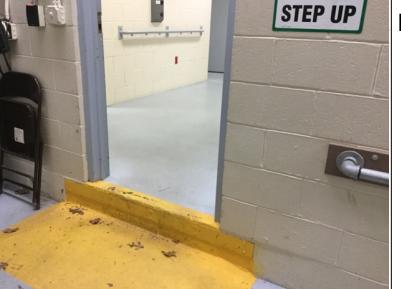
Level changes > 1/4"	-	Changes in level greater than 1/2" must be ramped. Consider providing a transition aluminum threshold ramp.	1	75	\$75
6	Men's Toilet Room	1		Doors, Doorways, & Gates	Toilet Room

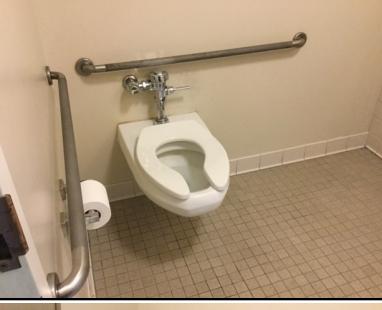
Side or rear grab bar < 33" or > 36" high	31"	Mount grab bars 33"- 36" above the floor.	2	128	\$256
20	Women's Toilet Room	1		Single-User Toilet	N/A

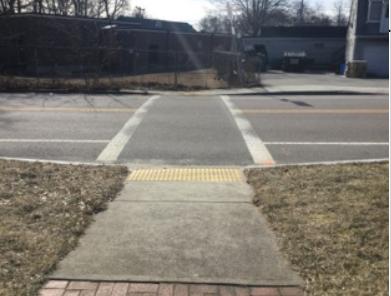
Running slope > 1:20 (5.00%)	6.8%	Reduce running slope to be no steeper than 1:20 (5%). (Cost based on six feet on concrete to correct slope.)	1	90	\$90
Off-Street Parking Lot or Garage												
2	Parking Lot	Ext.		Off-Street Parking Lot or Garage	Visitor

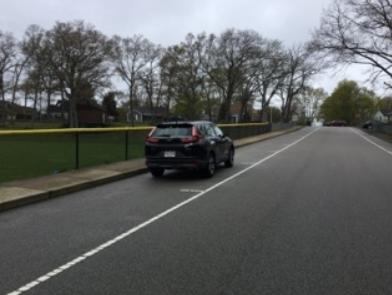
Total # of parking Total # of designated accessible parking spaces	30 0	Consider providing accessible parking spaces for street parking.	1	0	\$0
achers												
25	Baseball Field	Ext.		achers

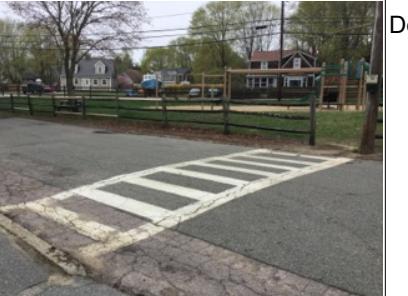
Detectable warning not provided	-	Provide a detectable warning on all curb ramps leading to the park.	12	180	\$2160
Entrance												
7	Entrance by Memorial	Ext		Entrance	Secondary Entrance

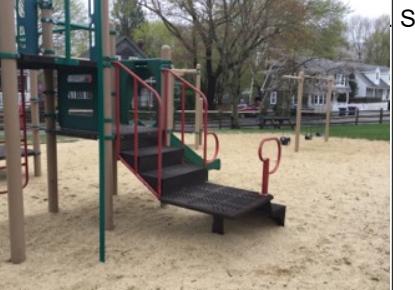
Surface not stable, firm, and slip-resistant	-	Provide a compliant impact-attenuating surface around the play components. (Cost estimate for 1,156 sq. ft. of poured in place rubber surface.)	1	16184	\$16184
11	Route From Entrance to Playground	Ext		Play Areas	N/A

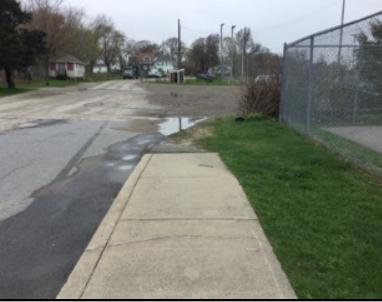
Cross slope > 1:50 (2.00%) (MAAB) Does not prevent accumulation of water Running slope > 1:20 (5.00%)	4.7% - 7.8%	Reduce cross slope to be no steeper than 1:50 (2.00%). Repair surface. Reduce the running slope to be no steeper than 1:20 (5.00%). (Cost based on 36" wide min. 45' long concrete path with running slope of 5.00% (1:20) max. and cross slope of 2.00% (1:50) max.)	1	675	\$675
2	Entrance by Pond	Ext		Exterior Access Route	Exterior

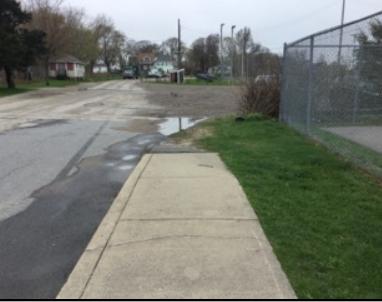
Cross slope > 1:50 (2.00%) (MAAB) Does not prevent accumulation of water Running slope > 1:20 (5.00%)	4.7% - 7.8%	Reduce cross slope to be no steeper than 1:50 (2.00%). Repair surface. Reduce the running slope to be no steeper than 1:20 (5.00%). (Cost based on 36" wide min. 45' long concrete path with running slope of 5.00% (1:20) max. and cross slope of 2.00% (1:50) max.)	1	675	\$675
2	Entrance by Pond	Ext		Exterior Access Route	Exterior

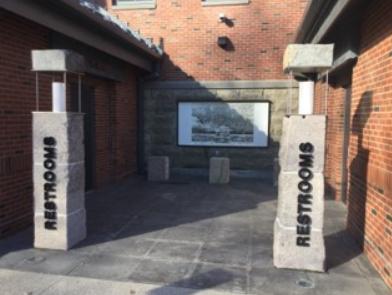
Sign with International Symbol of Accessibility not provided.	-	Recommend providing a sign with the International Symbol of Accessibility (ISA) that can be seen from the street prior to reaching the toilet room entry doors. (A sign with the ISA is properly located outside both the men's and women's multi-user toilet rooms.)	0		\$0

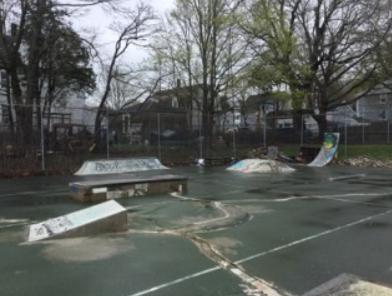
Skateboard park surface has cracks and gaps in surface.		Recommend repairing gaps in surface inside skateboard park.	1	0	\$0
