TO: Town of Plymouth DATE: June 21, 2022  
FROM: Howard Stein Hudson HSH PROJECT NO.: 2021246.00  
SUBJECT: Brook Road over Beaver Dam Brook  
Bridge No. P-13-011 (9KM) – Peer Review & Preliminary Structural Analysis

Plymouth – Brook Road over Beaver Dam Brook Bridge No. P-13-011 (9KM)  
June 2022

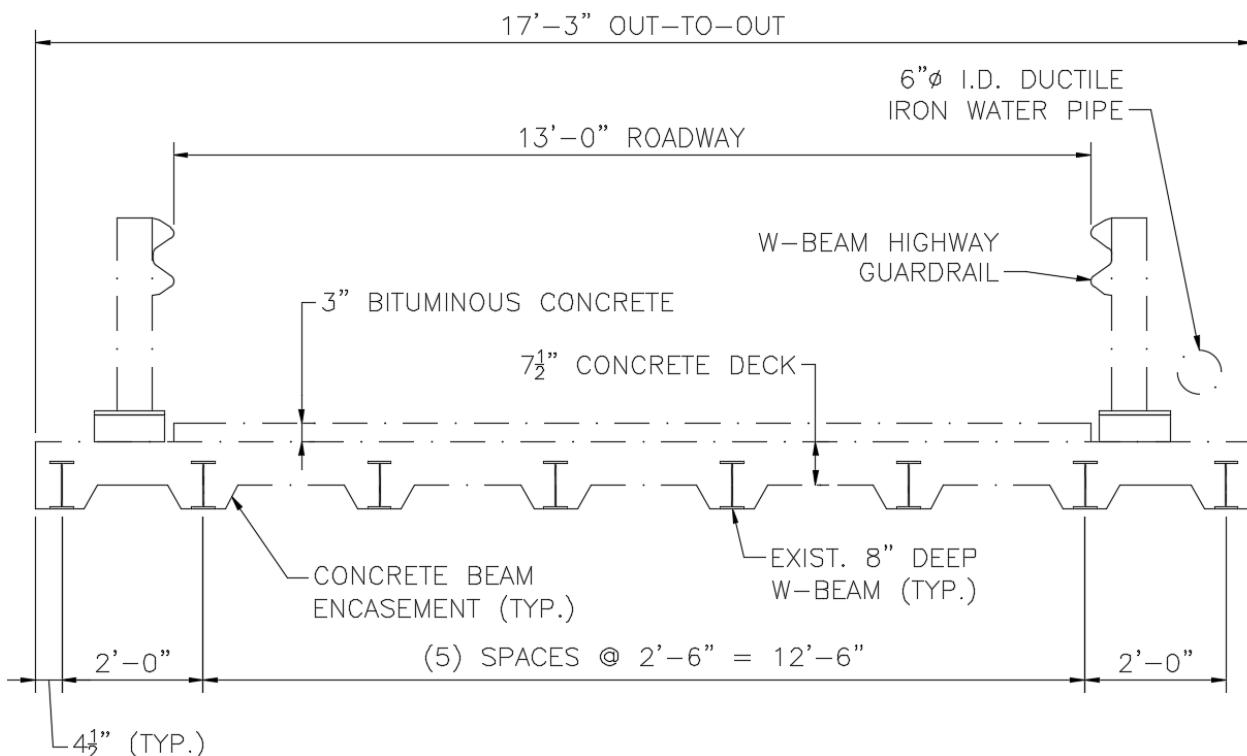
**Figure 1. Existing Cross Section**

The existing bridge structure, originally constructed in the 1800s and reconstructed in 1926, is a single span bridge supported on stone masonry abutments. There are no known plans for the existing structure; however, based on field measurements taken by HSH personnel, the bridge span length is 13'-10" from centerline of bearing to centerline of bearing and is normal to the roadway (i.e. no skew). The superstructure consists of eight (8) concrete encased steel girders with a 7½" concrete deck and a 3" bituminous concrete wearing surface.

The interior beams are spaced at 2'-6" with exterior beams spaced at 2'-0" and 0'-4½" wide overhangs, resulting in a total out-to-out width of 17'-3". The existing roadway width is 13'-0" from face of guardrail to face of guardrail (see **Figure 1**). There is also a 6" diameter water line along the south side of the bridge which is supported on concrete blocks sitting on the top of the deck.

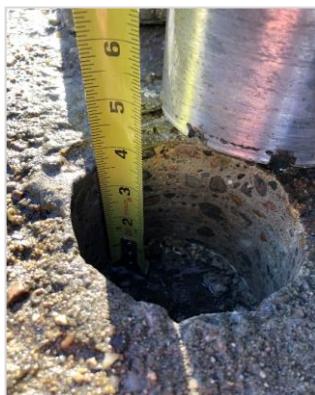
*Photo 1.*

A 4" diameter core was taken approximately 12" from the face of the existing west abutment. The top of beam 8 was encountered at a depth of 3 $\frac{1}{2}$ " from the top of deck (see **Photos 1 and 2**). Based on a depth of 11 $\frac{1}{2}$ " from bottom of beam to top of deck, it was determined that the existing beams have an overall depth of 8". Coring operations also revealed the presence of a bent  $\frac{1}{2}$ " square reinforcing bar in the deck that appears to run transversely through the deck.

*4" Diameter Concrete Core,  
Above Beam 8, 12" From  
Face of West Abutment*

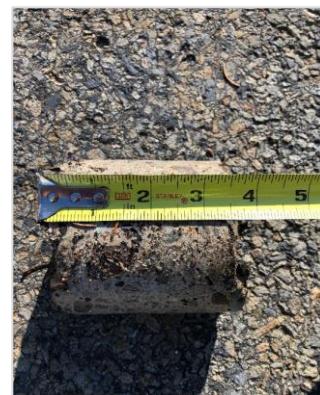
*Photo 2.*

*4" Diameter Concrete Core,  
Above Beam 8, 12" From  
Face of West Abutment*

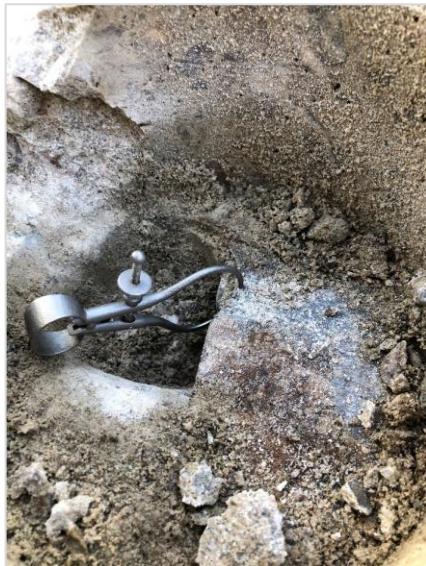
**Photo 3.** *Flange Thickness Measurement*

An additional 6" diameter core was taken approximately 6" from the face of the existing west abutment to facilitate exposing the top flange thickness. Using a micrometer, the top flange thickness was measured at 0.256 inches (see **Photos 3 and 4**). American Institute of Steel Construction (AISC) historic shapes databases were referenced as they will provide more accurate beam section properties for the era in which this bridge was constructed. Based on the measurements obtained, the beam is classified as a CBL8 having an overall depth of 8", and flange width and thickness of 4" and 0.254", respectively.
