## EXECUTIVE SUMMARY

*Churchill Engineering, Inc (CEI) inspected the bridge located on Brook Road spanning the Beaver Dam Brook within the Town of Plymouth, Massachusetts on February 19, 2010. Previous Structures Inspection Field Reports were completed on April, 12 1999 by Beta Group, Inc. and by the Massachusetts Department of Public Works January 17, 1990. Copies of both reports were made available Churchill Engineering, Inc. prior to conducting the inspection and are included within this report.*

The Town of Plymouth Massachusetts has retained Churchill Engineering, Inc. to perform a visual inspection and develop a conditions assessment report for the bridge which carries Brook Road over the Beaver Dam Brook in Plymouth, Massachusetts.

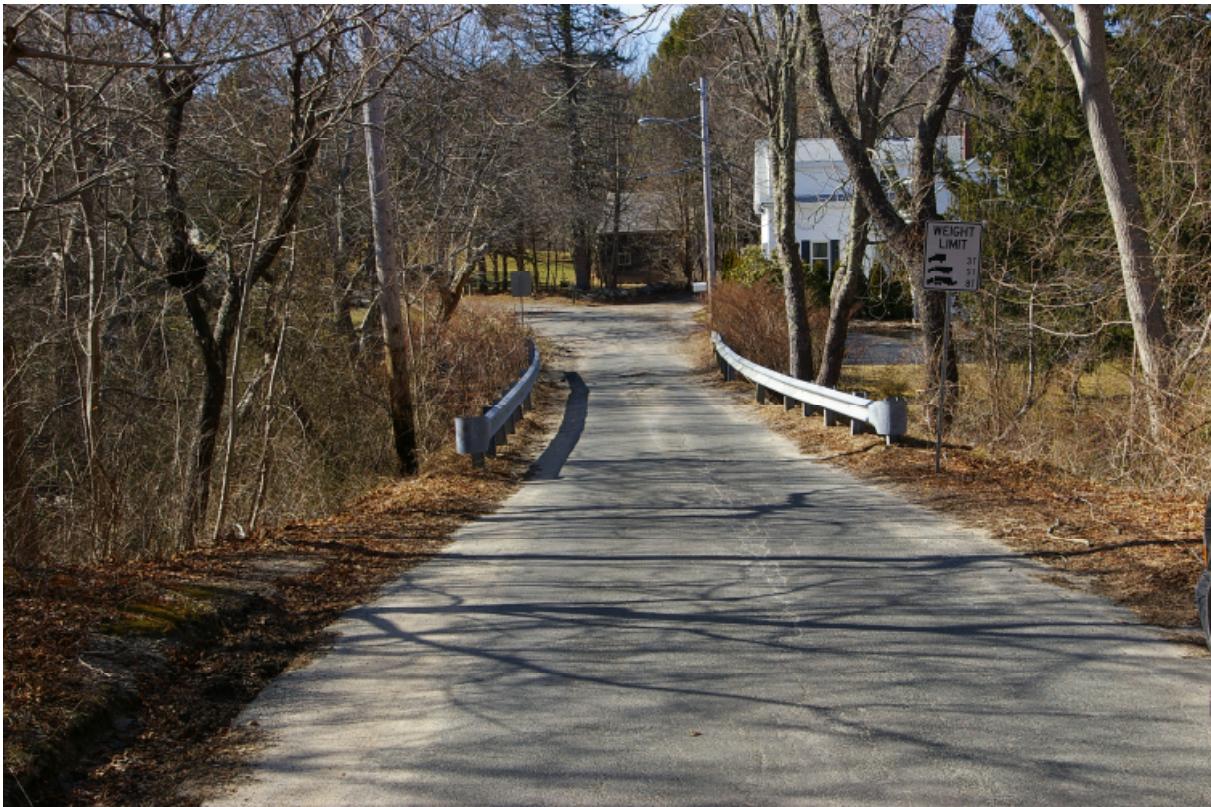
**Figure 3 East Approach**

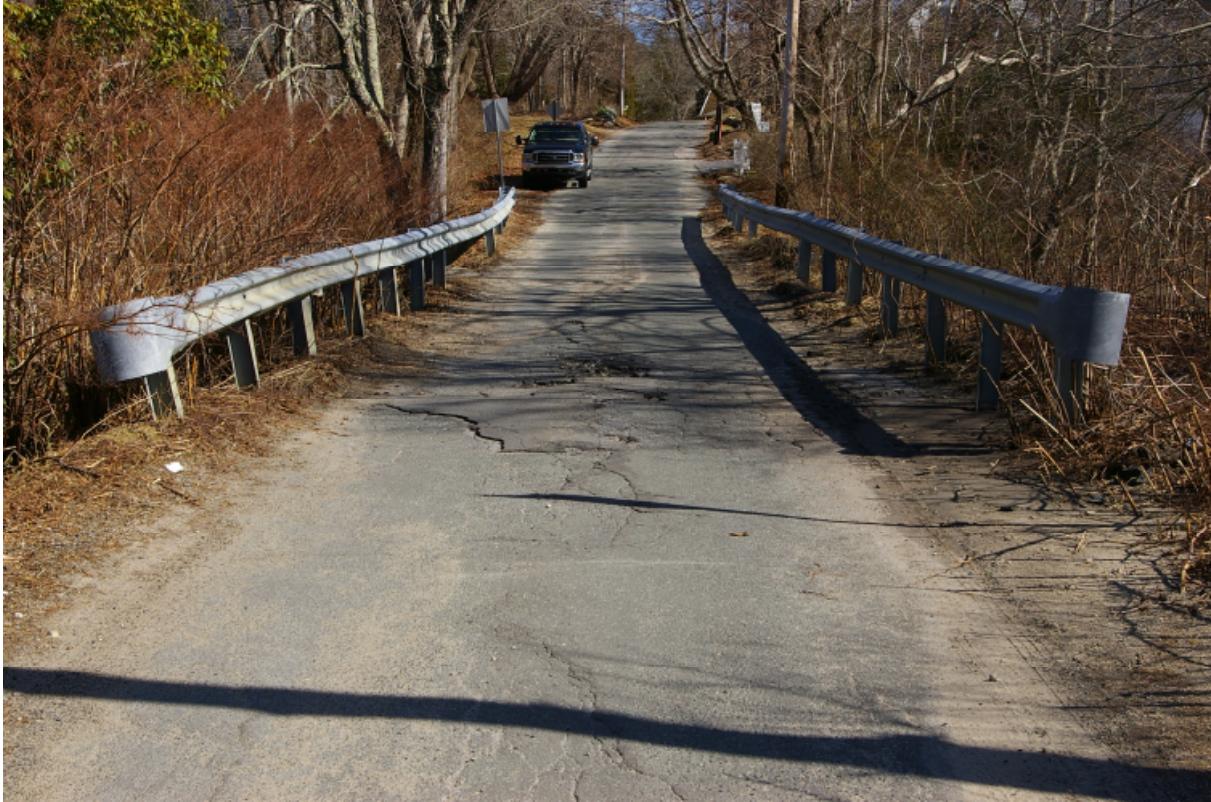
**Figure 4 West Approach**

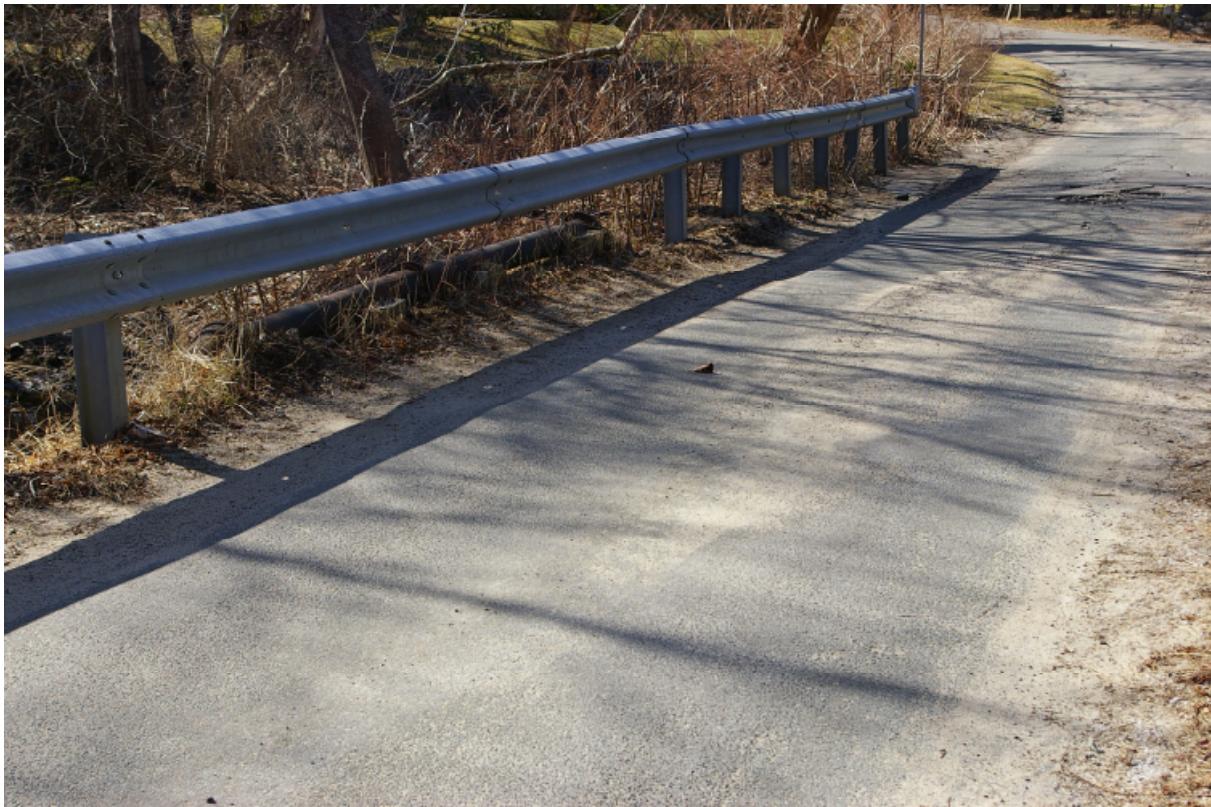
**Figure 5 Bridge Deck**

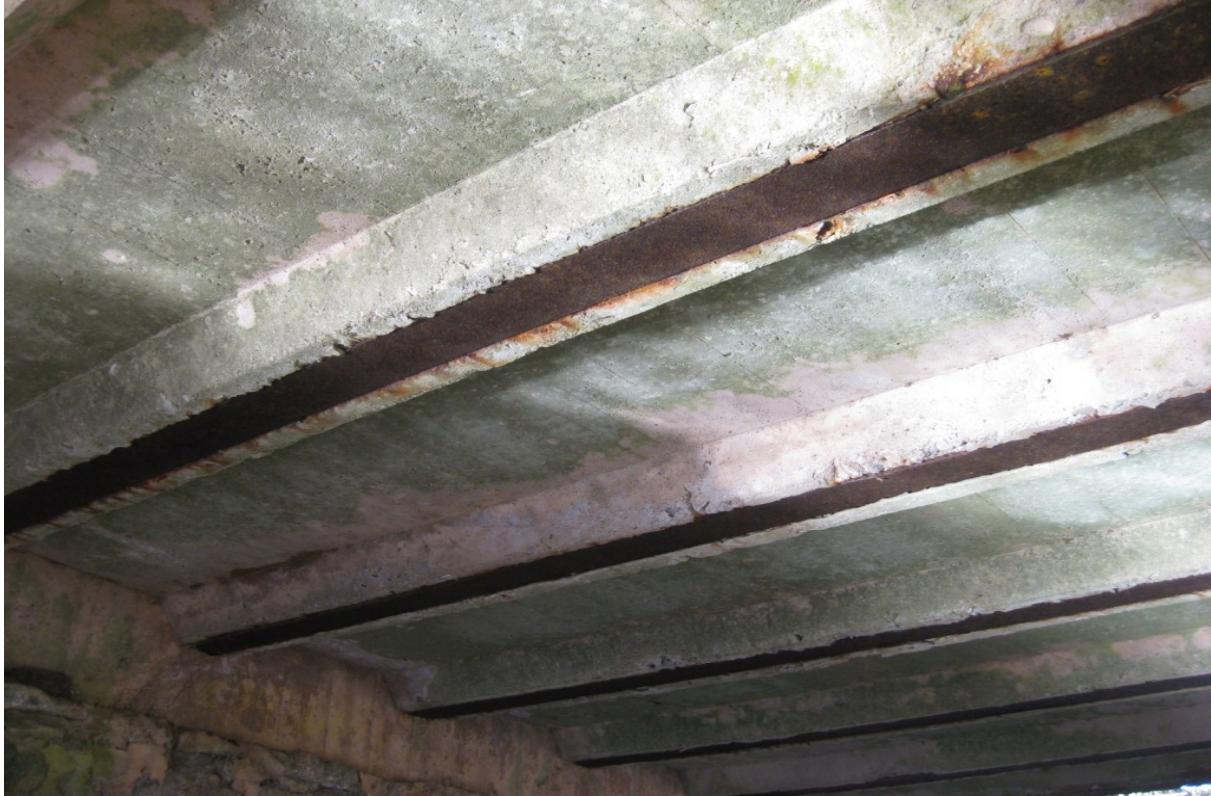
The interior girders / stringers were found to be in satisfactory condition with surface pitting up to 1/8" and approximately 3/16 of flange width remaining. Both North and South facia girders were also found to be in satisfactory condition but suffer from slightly greater section loss and laminar oxidation. This condition appears to have resulted from greater exposure to the elements. The concrete encasement of the girders / stringers has spalled from below the bottom flange typical for all members. The deck appeared in fair condition between the girders/ stringers with no significant defects beyond the spalling noted above. In general, sounding of the underside deck yielded the concrete sound with no voids, delimitations or other deficiencies noted.

**Figure 6 Girders (viewed from underside of bridge deck)**

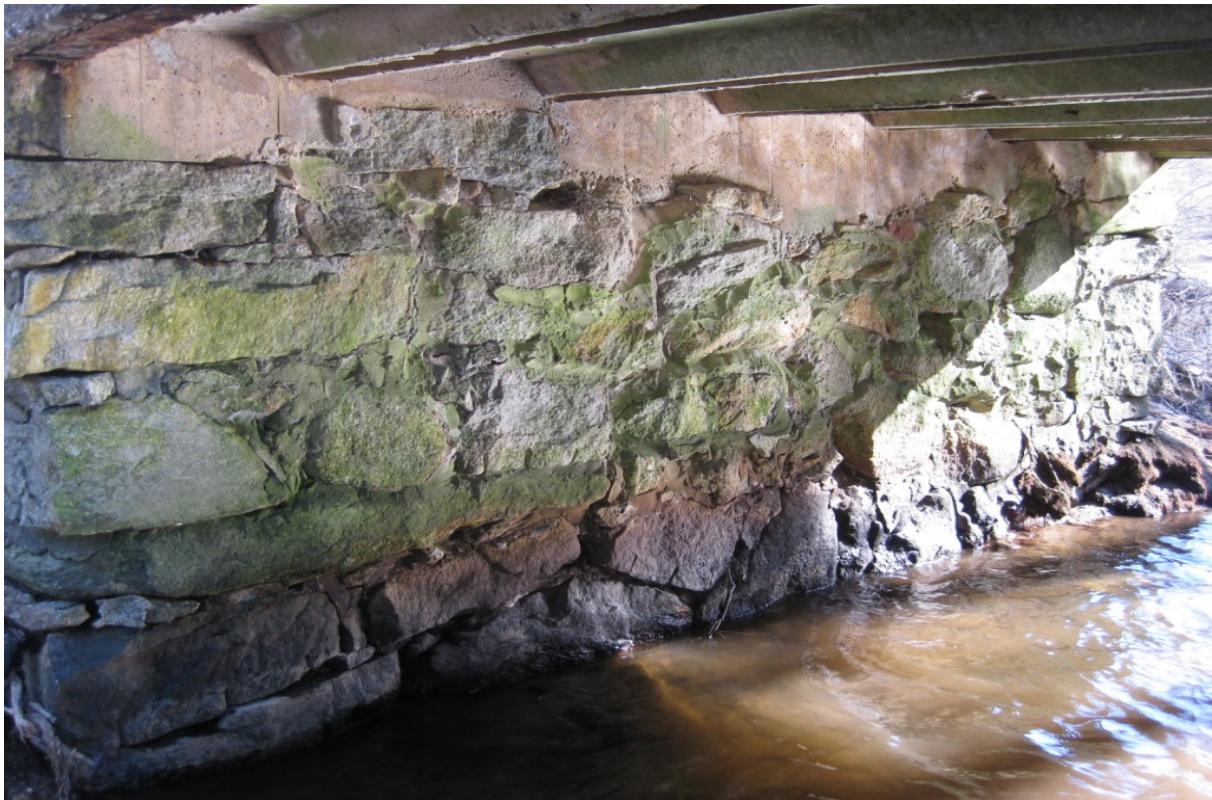
The East abutment was found to be in similar condition to the West abutment. In general deficiencies include cracked stones, missing chinking and mortar. This condition is noted within the lower 3 feet of the breast wall. The bridge seat at the East abutment is also filled with concrete similar to the West, although no cracks were noted. The severity of structural distress due to settlement and displacement of the East breast wall was not noted or considered minor. Both wing walls flanking the East abutment were found to be missing chinking, mortar patches and minor dislodgment of stones. Heavy vegetation growth was noted along the width walls flanking both

**Figure 7 East Abutment**

- Repointing and replacement of missing chinking within masonry elements to prevent further degradation of the substructure.

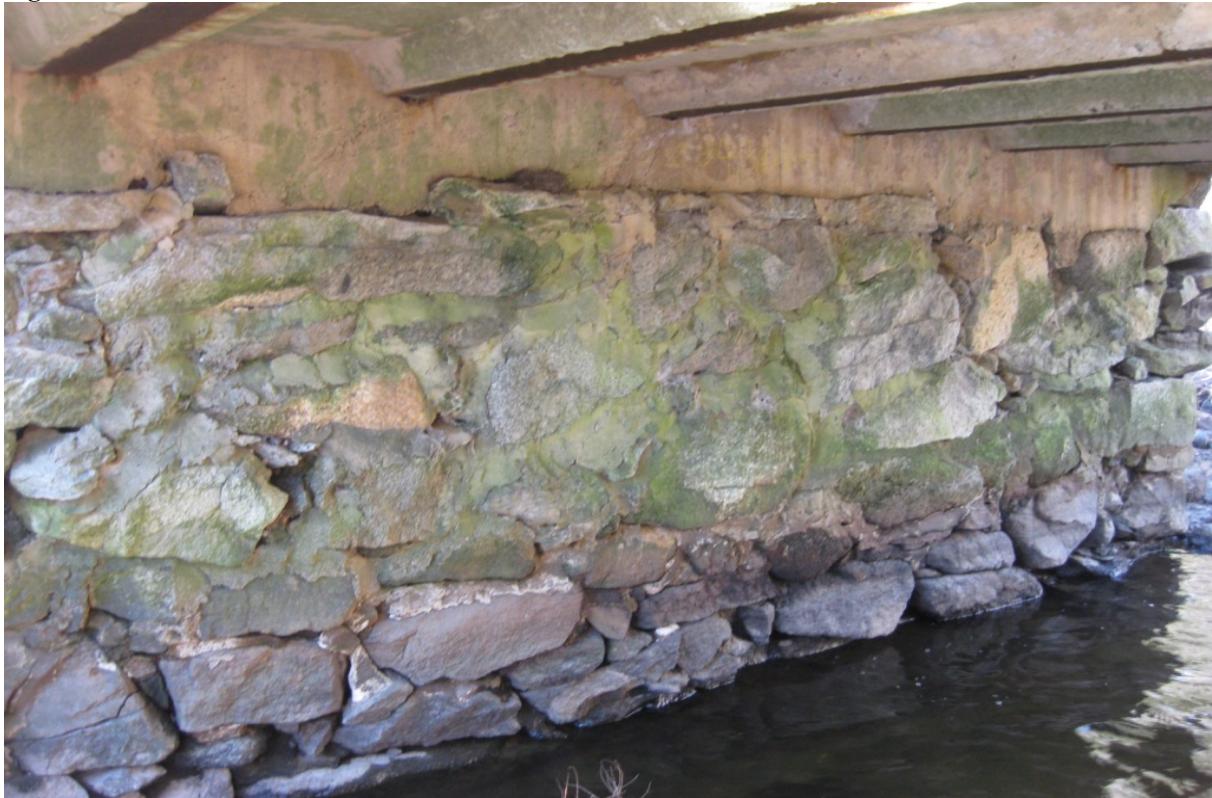
The substructure was found to be in poor condition. The West abutment was found to have numerous chincking stones and mortar within the joints missing typically within the lower 3 feet of the breast wall. Voids with the breast wall measured up to 22 inches in depth.. The bridge seat has filled with concrete below the girders / stringers with a crack observed below the 4<sup>th</sup> girder / stringer from the south edge of the deck. The Northwest corner of the West breast wall appears to have settled and displaced approximately ¾ inch to the North. Within 2 – 3 feet +/- of the Northwest corner of the breast wall is noted to have large voids, cracked stones, missing chinking stones and mortar throughout the full height of the breast wall. It at this corner the largest voids are noted including the void measured to be 22 inches deep. The Northwest wing wall was also found to suffer from the apparent settlement and resulting displacement as with the Northwest corner on the breast wall. The Northwest wing wall was observed to be leaning towards to the North with several large stones displaced approximately 8 – 13 inches northward. The Southwest wing wall was found to be missing chincking stones and mortar similar to the Northwest wall. However, any settlement and displacement of the wall appears to be minor.

**Figure 8 West Abutment**

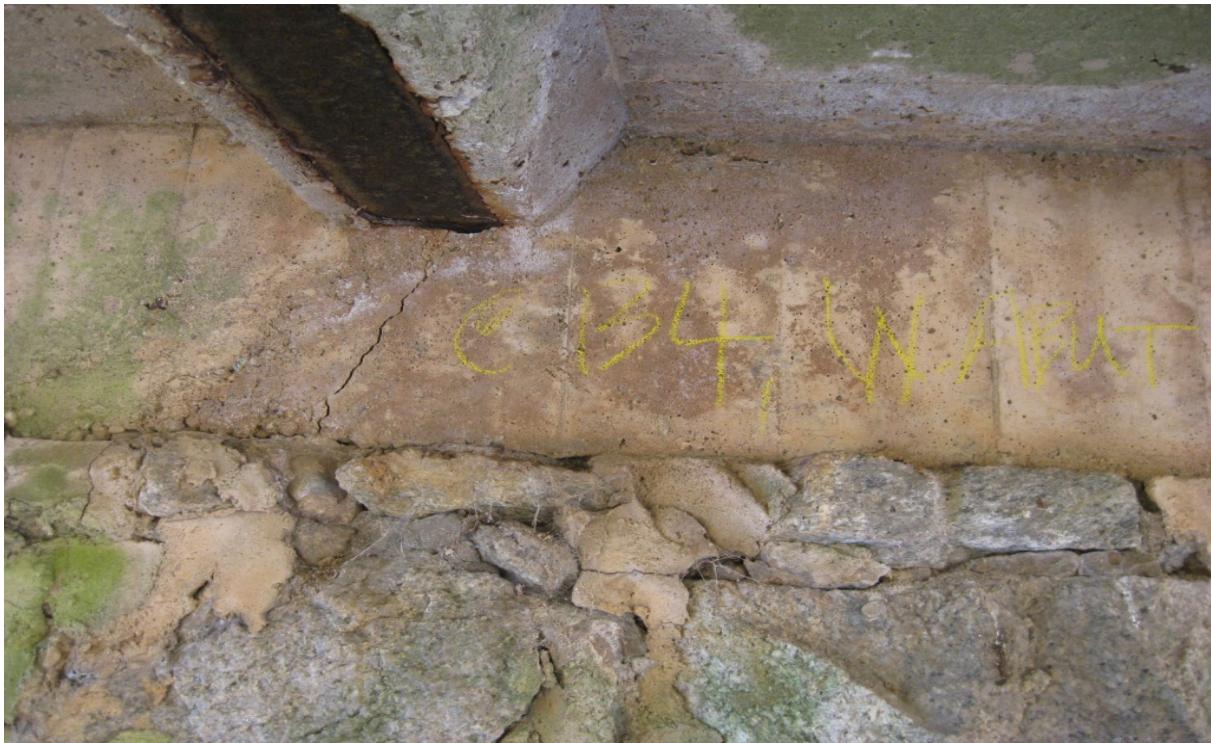
**Figure 9 Crack in West Abutment Bridge Seat (below girder 4)**

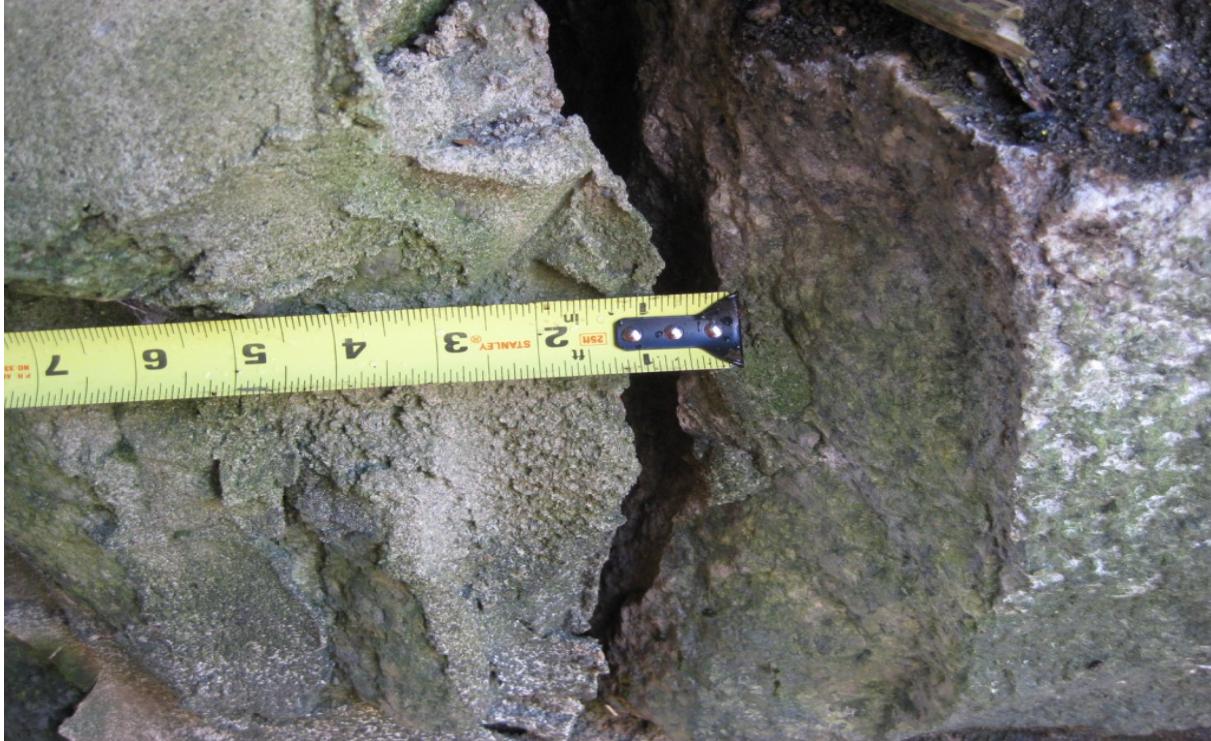
**Figure 10 Lateral Displacement North End West Breast Wall**

- Apparent settlement and displacement of substructure elements should be monitored for continued movement. Misalignment of guard rail elements, particularly along the Northwest wing wall, appears to be a result of this movement. CEI suggests installation of deformation monitoring points and development of a deformation monitoring program to record movements of the structure and to determine the rate at which the movement is occurring. Determination of the rate of movement and any acceleration in the rate of movement may provide advance warning of major structural failure and resulting life safety issues.

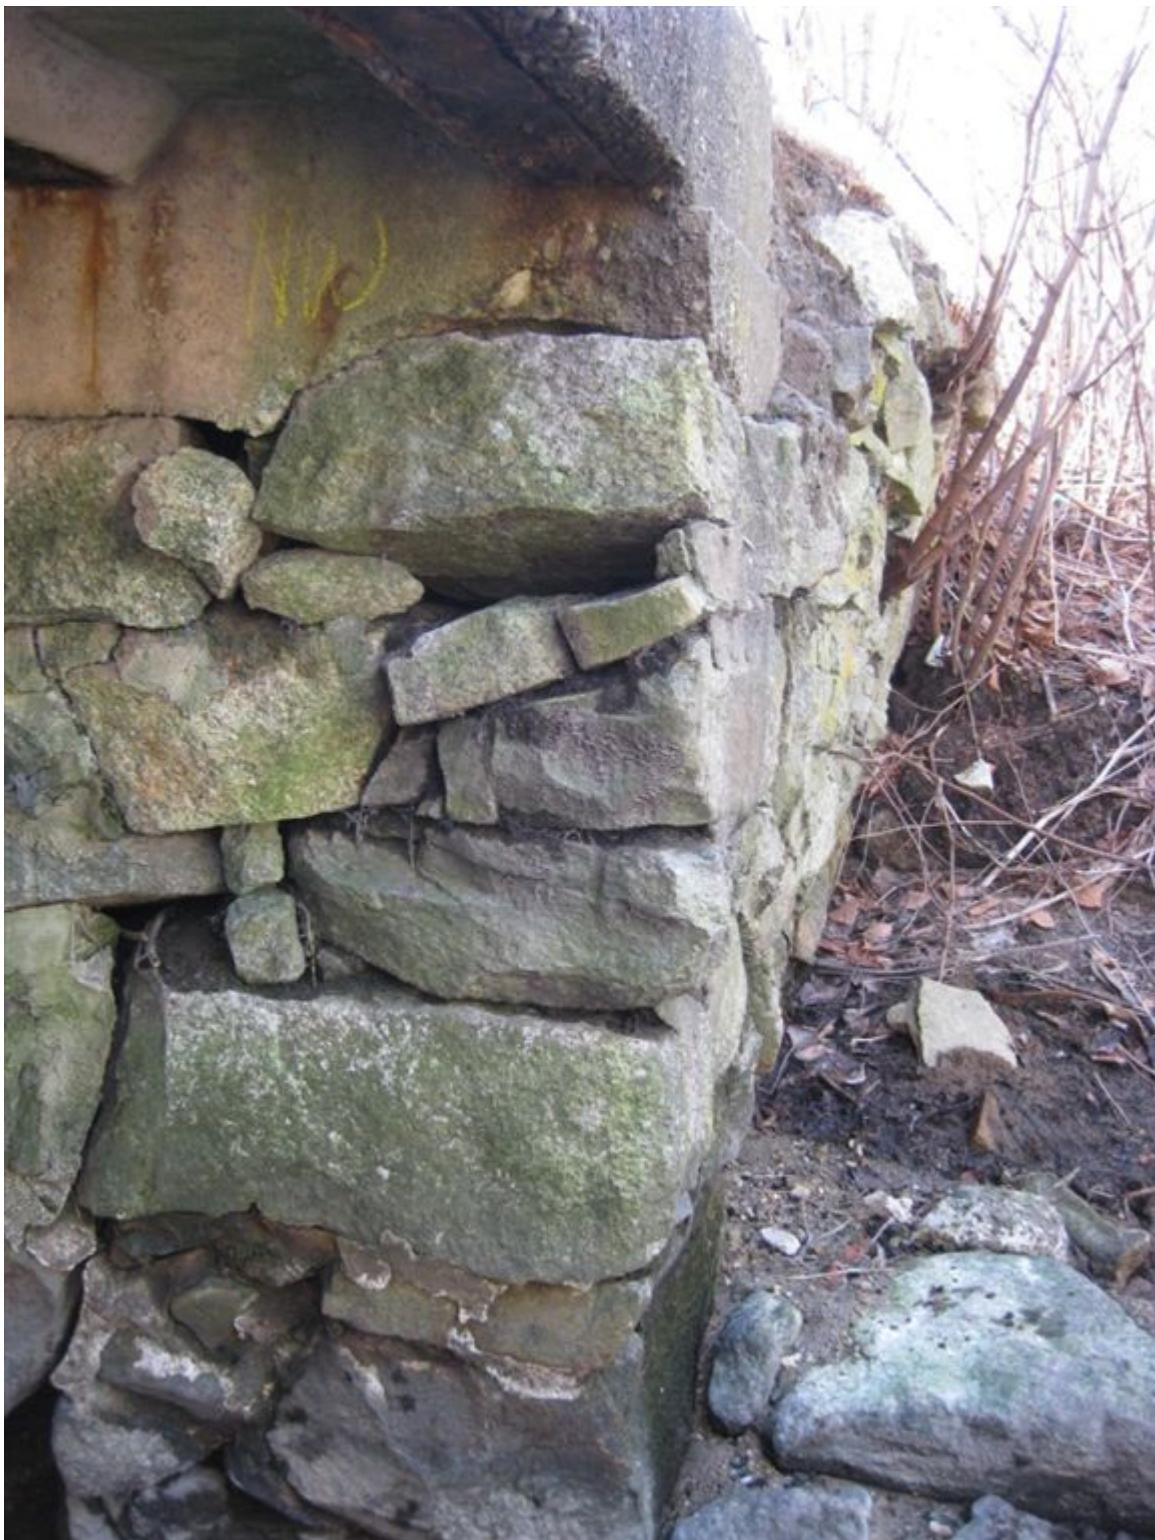
**Figure 11 Settlement and Lateral Movement North West Wing Wall**

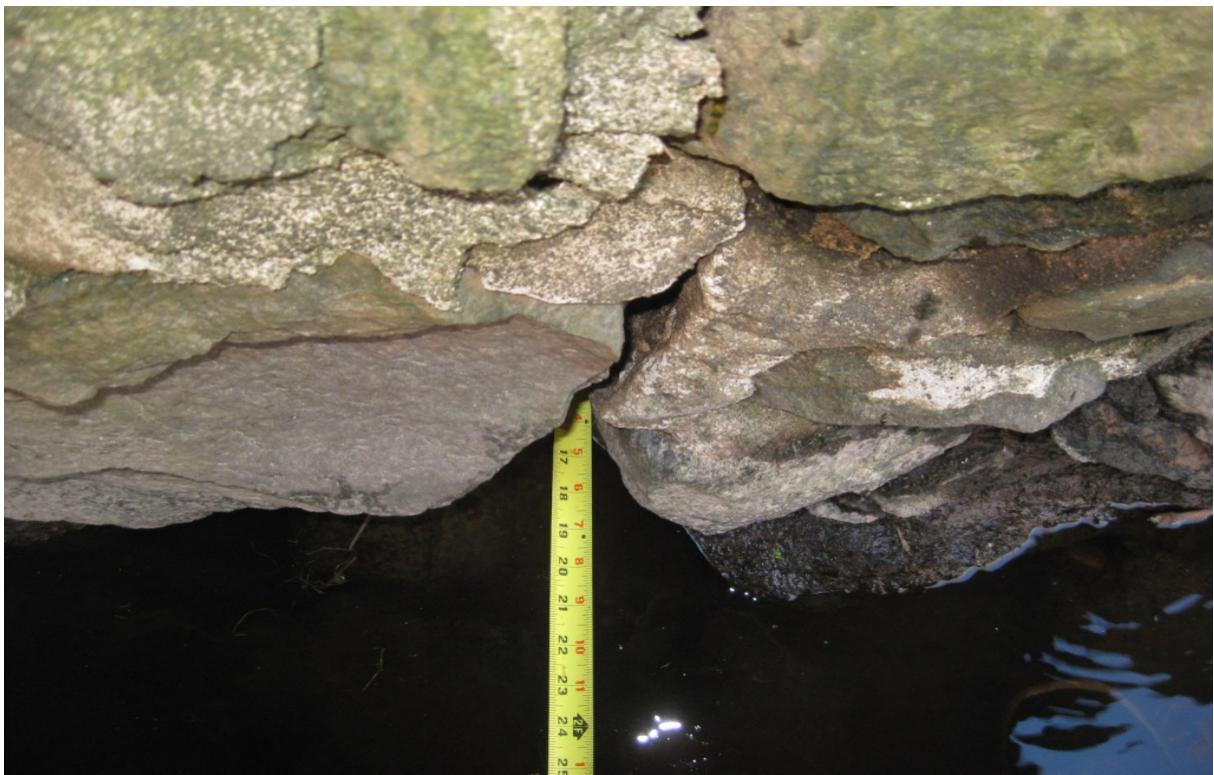
**Figure 12 Void West Breast Wall**

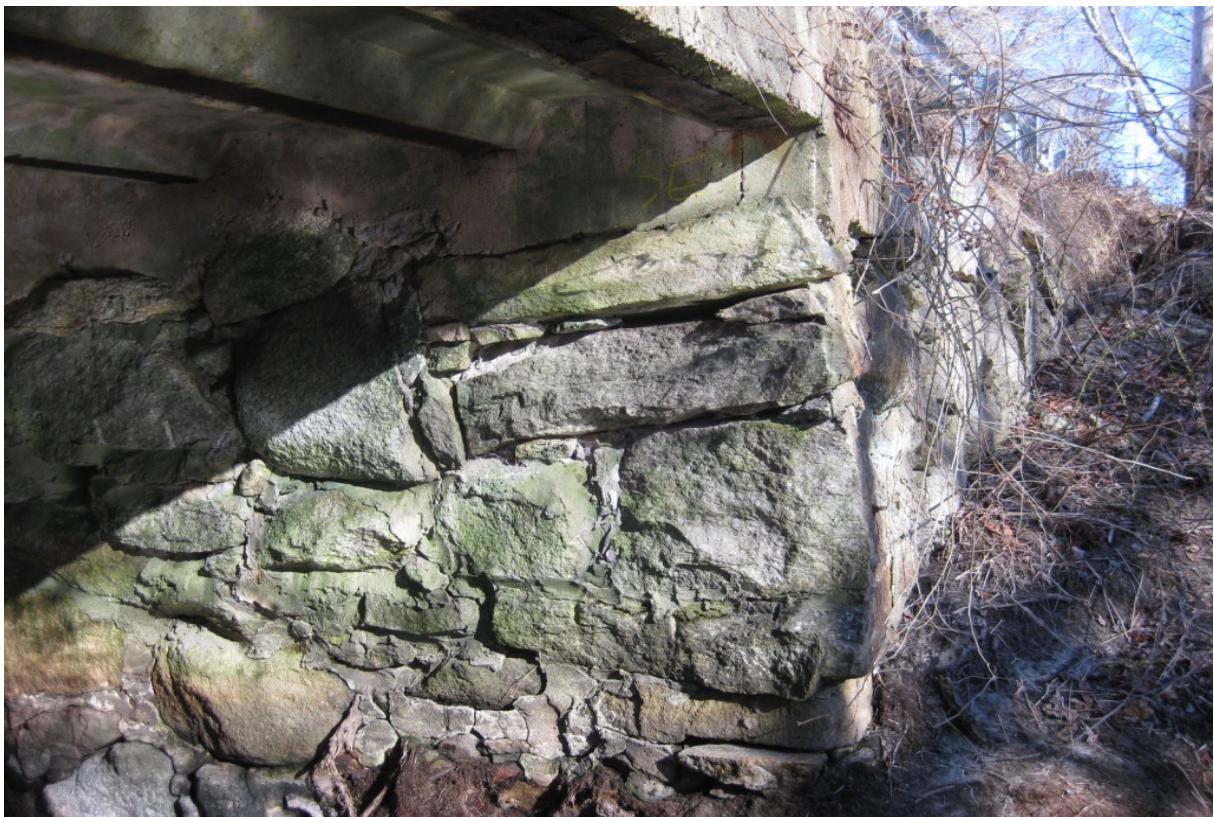
**Figure 13 South East Wing Wall**

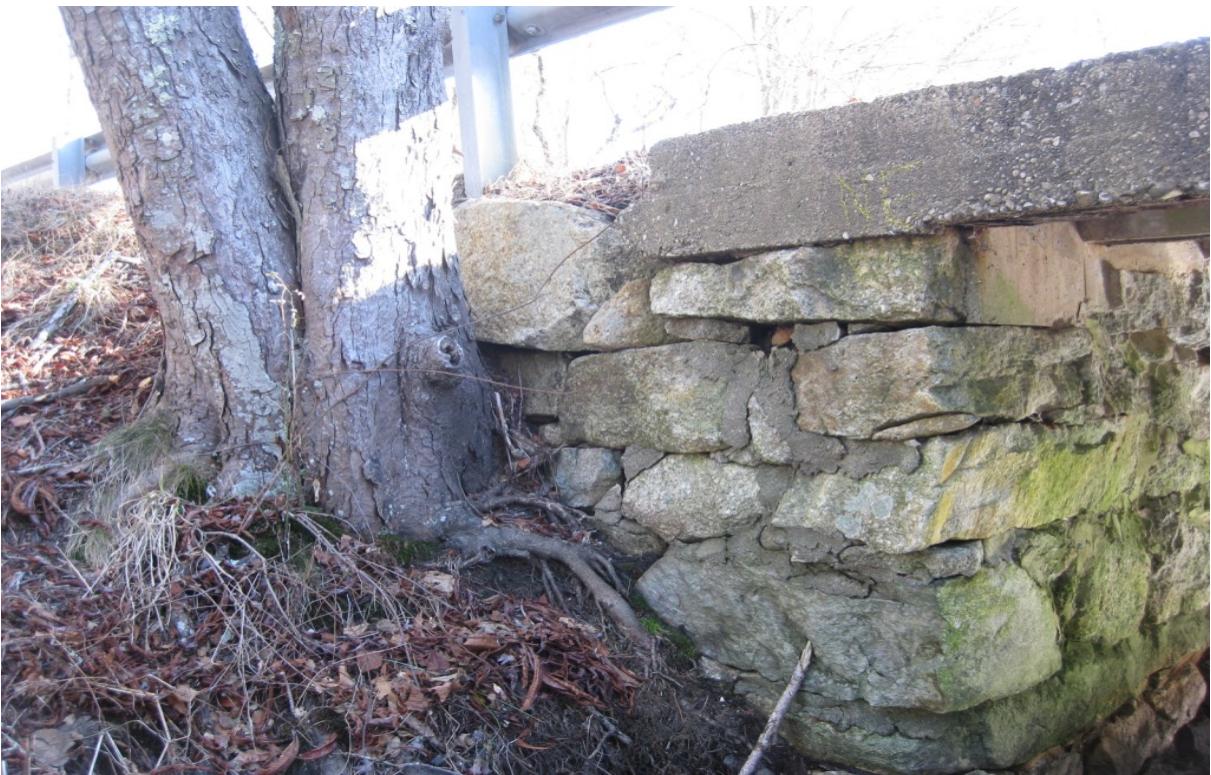
**Figure 14 North East Wing Wall**

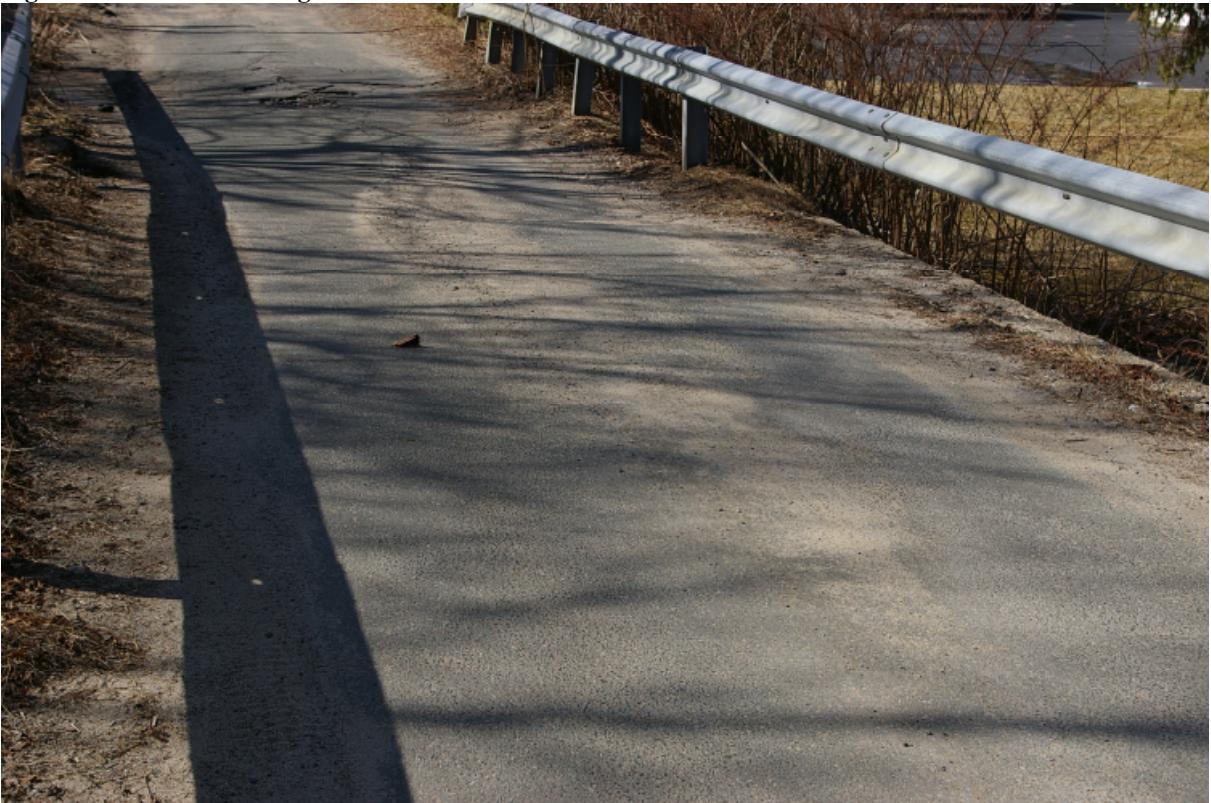
The bridge railing is provided by steel guard rail section unsupported along the approximate 12' length of the structure. The current support condition of the bridge rail is not considered to provide adequate protection for vehicular traffic. Additionally, the utility located along the southern edge of the deck is also not considered to be adequately protected vehicular impact. Approach guardrails and end treatments are present although the guard rail posts appear out of plumb or otherwise misaligned, particularly along the Northwest wing walls. Hence, they not considered to comply with current standards or provide adequate protection to vehicular traffic on the bridge.

**Figure 15 Unsupported North Bridge Rail**

- The bridge rail should be evaluated for conformance with current AASHTO standards. CEI recommends a revised bridge rail design be developed and secured to the superstructure. The approach guard rail should be reviewed for compatibility with the revised bridge rail.
- If the current approach guard rail is determined to be compatible with the revised bridge rail, then the damage to the guard rail on the Northern side of the East Approach should be repaired.

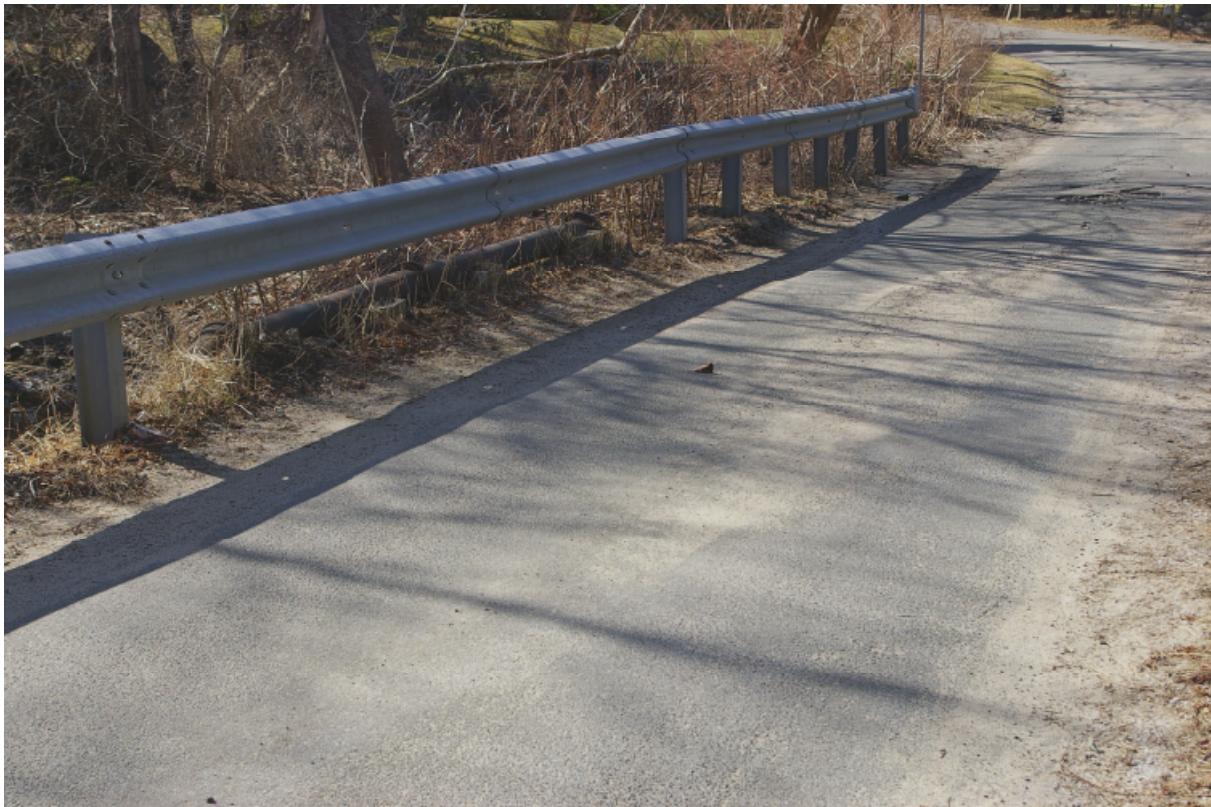
**Figure 16 Unsupported South Bridge Rail**

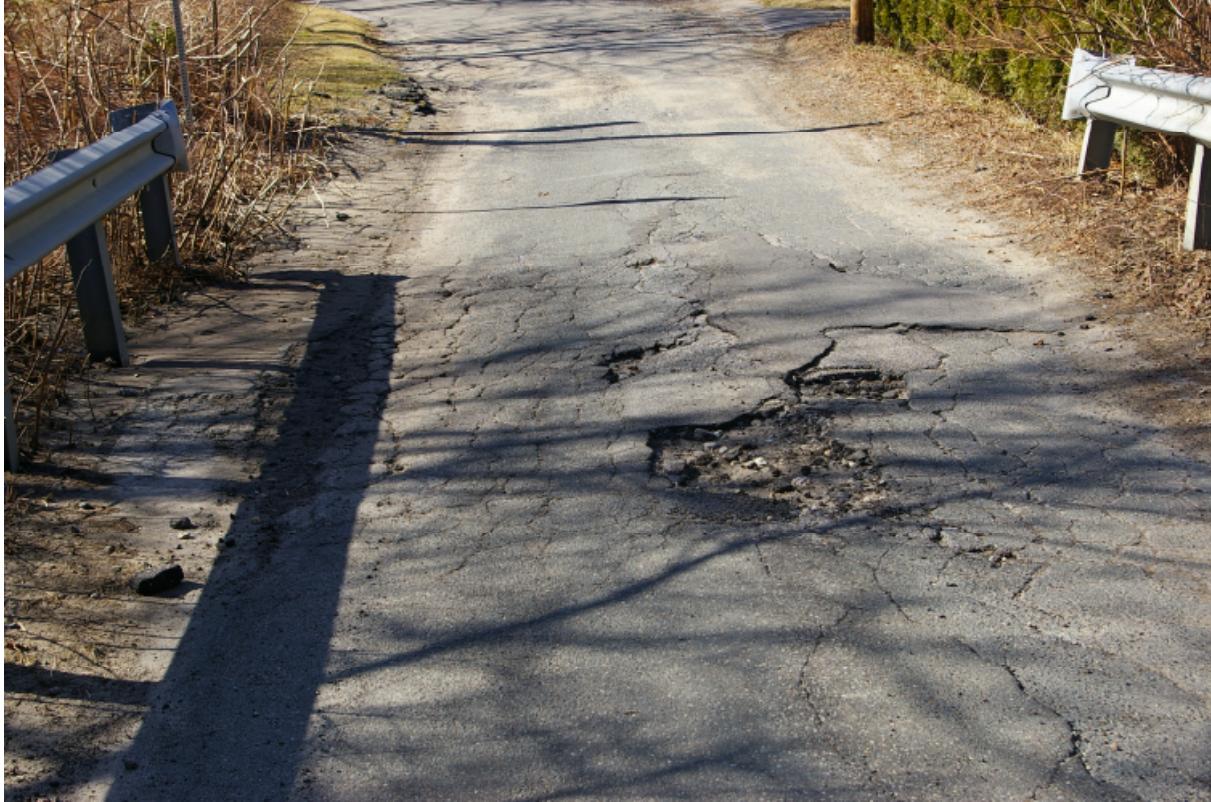
The approaches to the bridge were considered in poor condition. The east approach pavement exhibited alligator cracking with no roadway settlement noted. The West approach pavement severely cracked with areas of pavement failure. Approximately 1 inch of settlement was noted at the Northwest interface between the bridge deck and approach. Previous inspection reports indicate that warning and regulatory signs were obstructed by foliage. However, this condition was not noted at the time of inspection due to the seasonal lack of foliage.

**Figure 17 Pavement Failure West Approach**

- Repair of the failed pavement of the West approach is recommended. The settlement noted during the inspection at the Northern edge of the West approach appears to be a result of movement of the Northwest wing wall and West abutment. This movement may be continuing resulting in repairs to the pavement to be ineffective. CEI recommends continued monitoring of the condition.

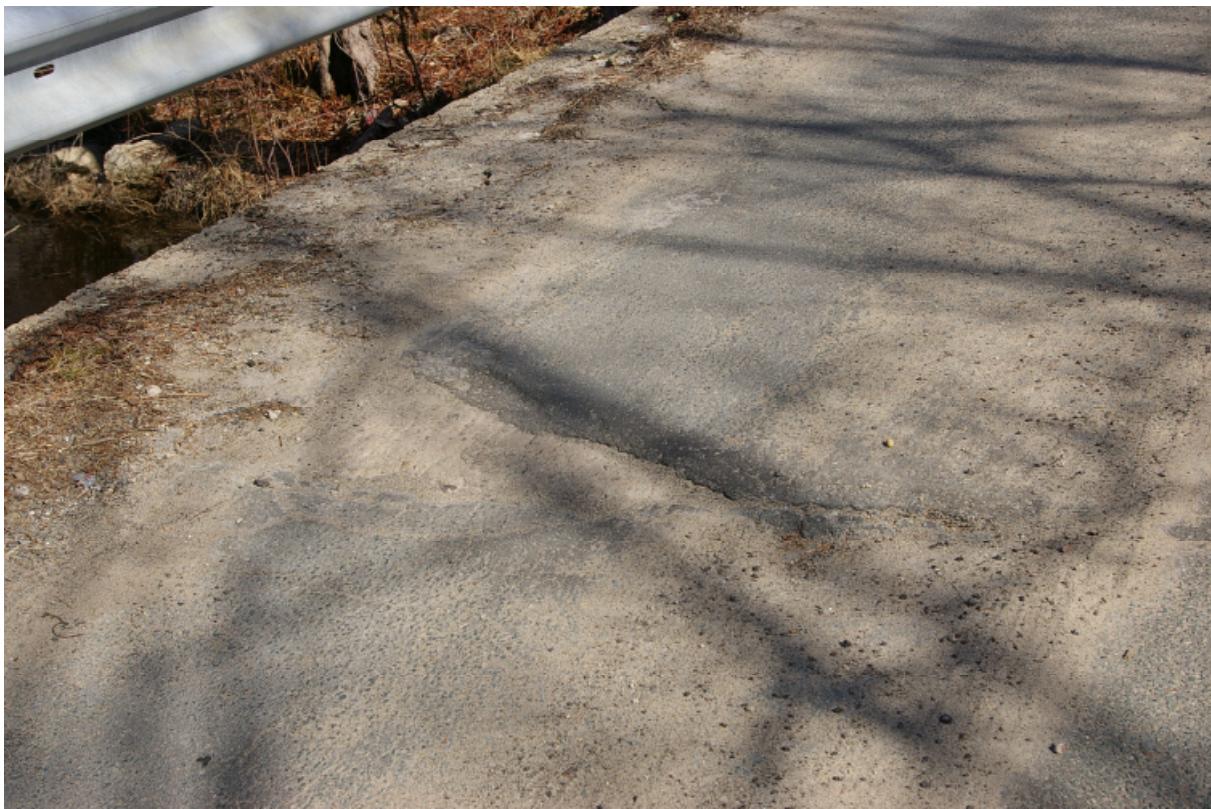
**Figure 18 Settlement North Side West Approach**

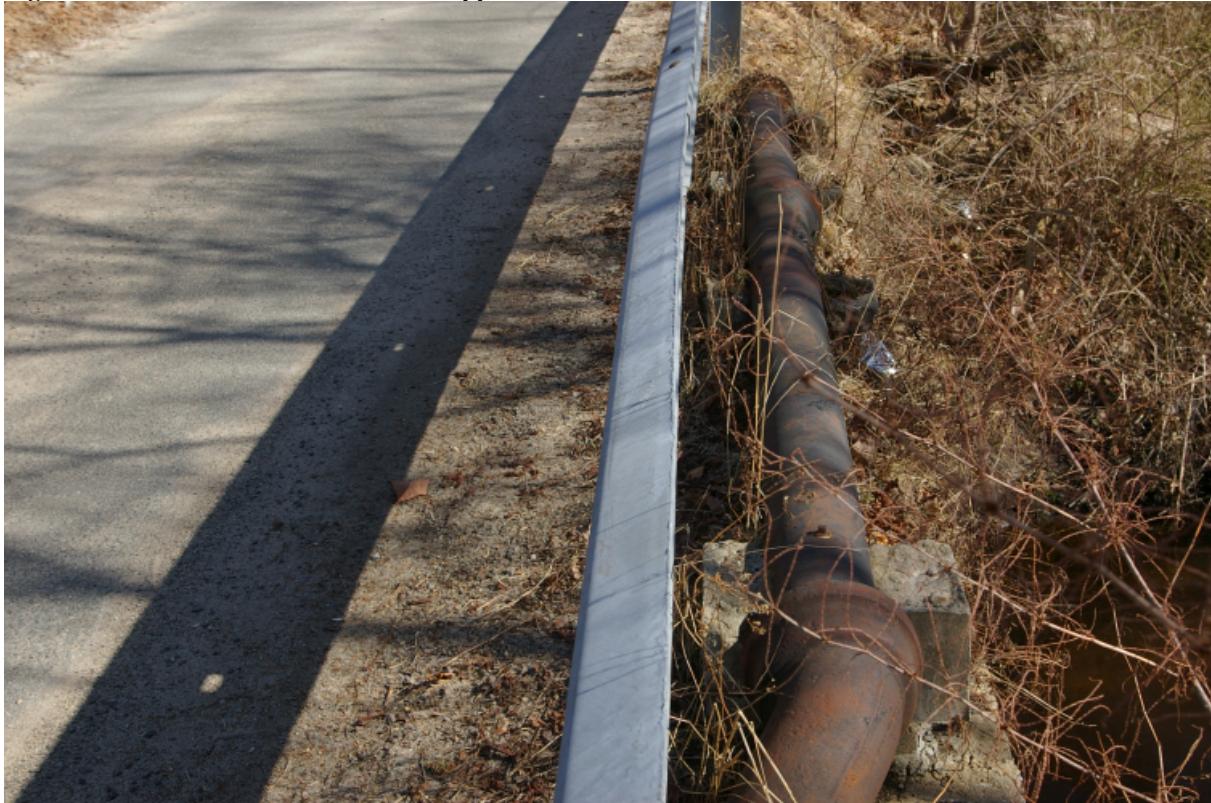
**Figure 19 Utility South Edge Bridge Deck**

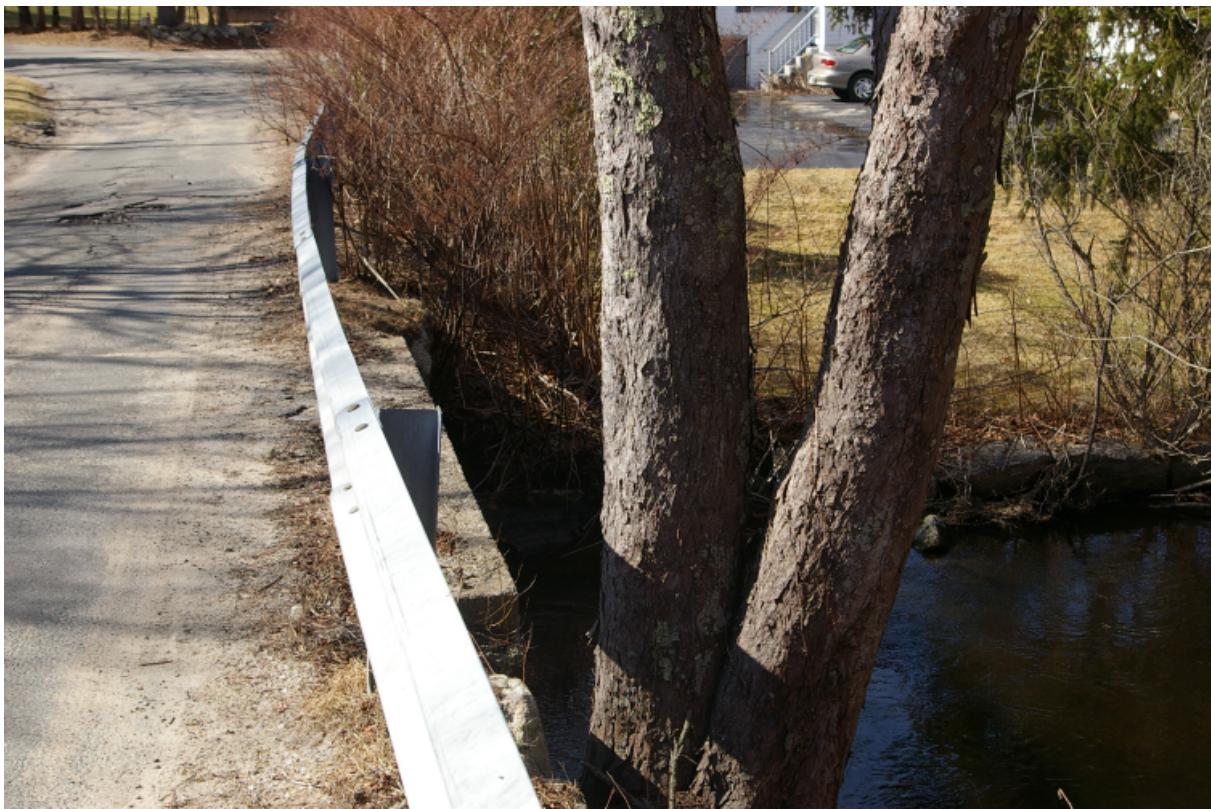
abutments. Roots of the vegetation growth were observed adjacent or into the masonry joints including a 30 inch diameter tree at the Northwest wing wall.

**Figure 20 Vegetation North Elevation (looking West)**

- Removal of trees and other vegetation around the substructure elements should be completed to prevent further degradation of the masonry components elements leading to potential life safety issues. Particular attention should be given to remove the root system of the trees and vegetation that may have infiltrated the masonry joints.

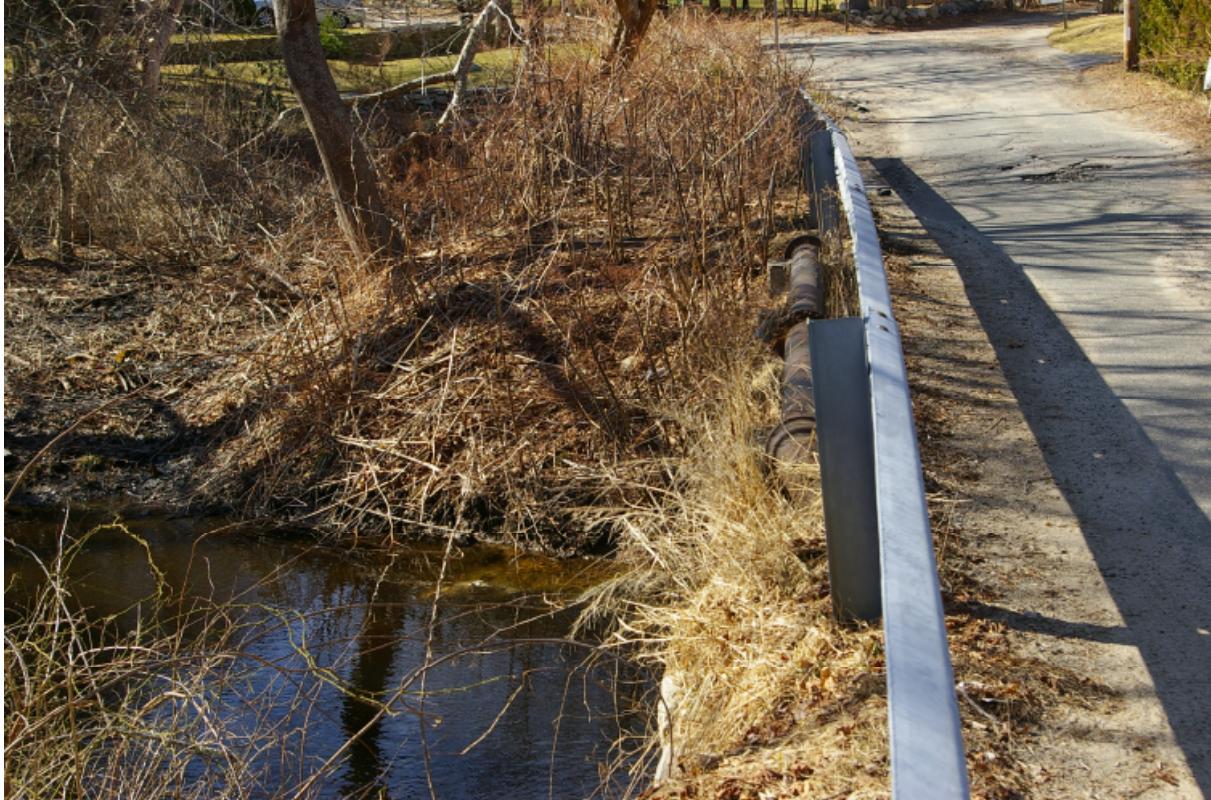
**Figure 21 Vegetation South Elevation (looking West)**

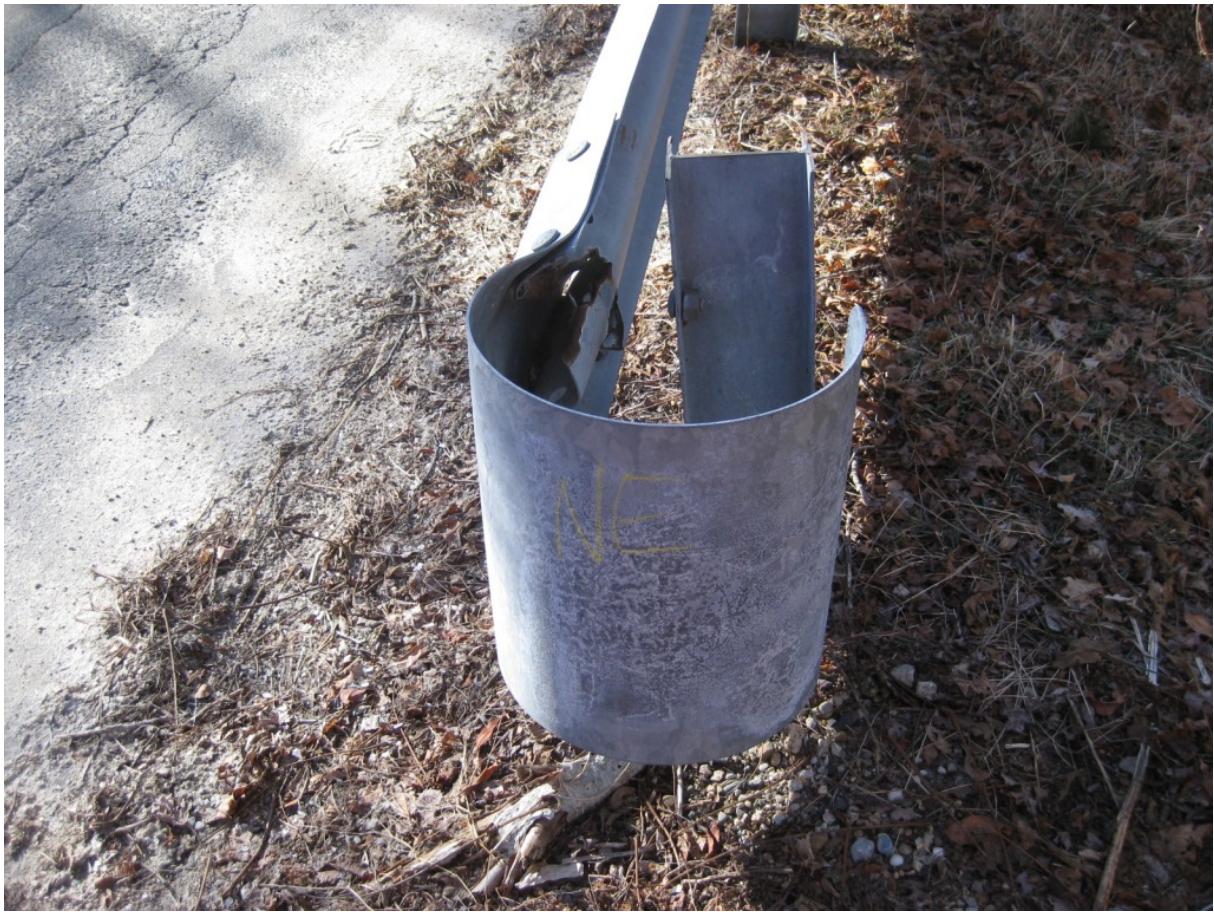
The northern guard rail at the East approach near the end treatment is also damaged.

**Figure 22 Damaged Guard Rail East Approach North Side**
