## STRUCTURES INSPECTION FIELD REPORT

## ROUTINE INSPECTION

| CITY/TOWN<br><b>PLYMOUTH</b> | 8.-STRUCTURE NO.<br><b>P13011-9KM-MUN-BRI</b> | 11-Kilo. POINT<br><b>000.000</b> | 41-STATUS<br><b>P:POSTED</b> | 90-ROUTINE INSP. DATE<br><b>AUG 10, 2020</b> |
| 07-FACILITY CARRIED<br><b>HWY BROOK RD</b> | MEMORIAL NAME/LOCAL NAME | 27-YR BUILT<br><b>1850</b> | 106-YR REBUILT<br><b>1900</b> | YR REHAB'D (NON 106)<br><b>0000</b> |

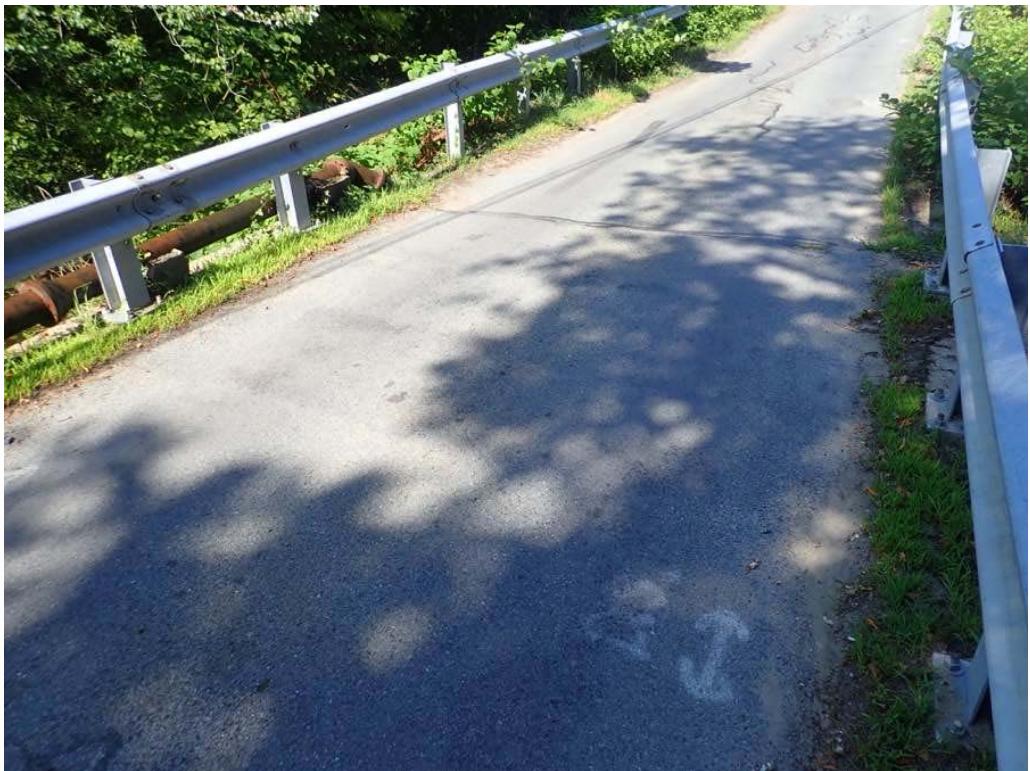
The bituminous wearing surface has transverse hairline cracks. **Photo 1.**

**Photo 1: General wearing surface looking west**

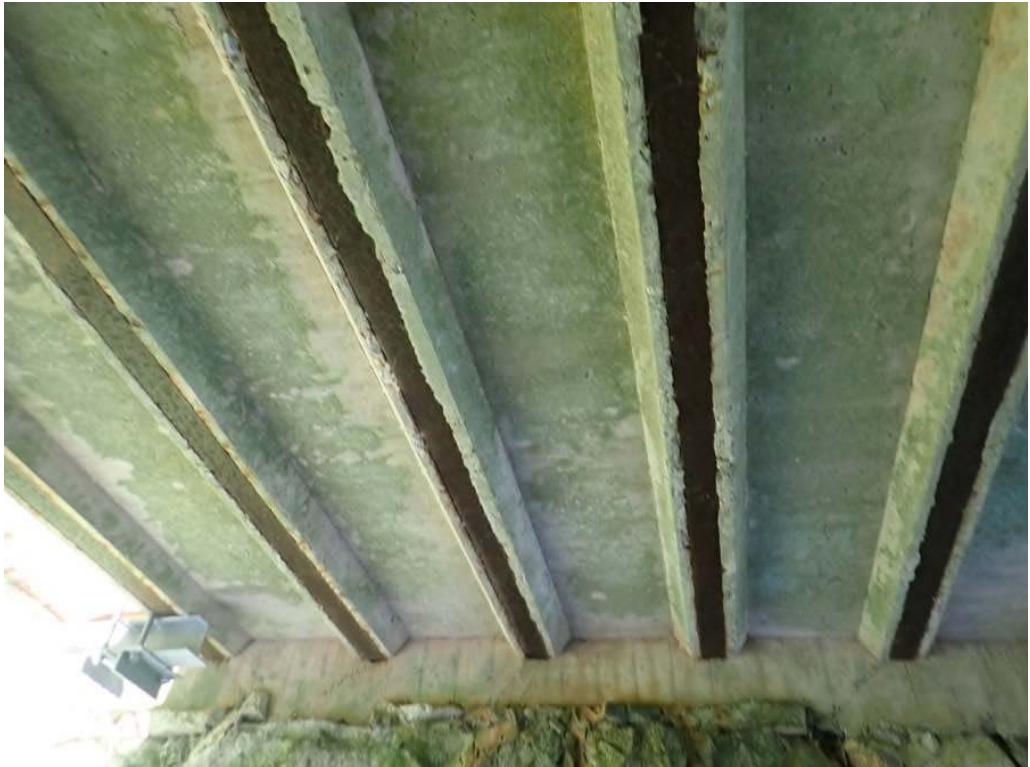
The reinforced concrete deck has areas of honeycomb up to 1/4" deep. **Photo 2.**

**Photo 2: General underside looking west.**

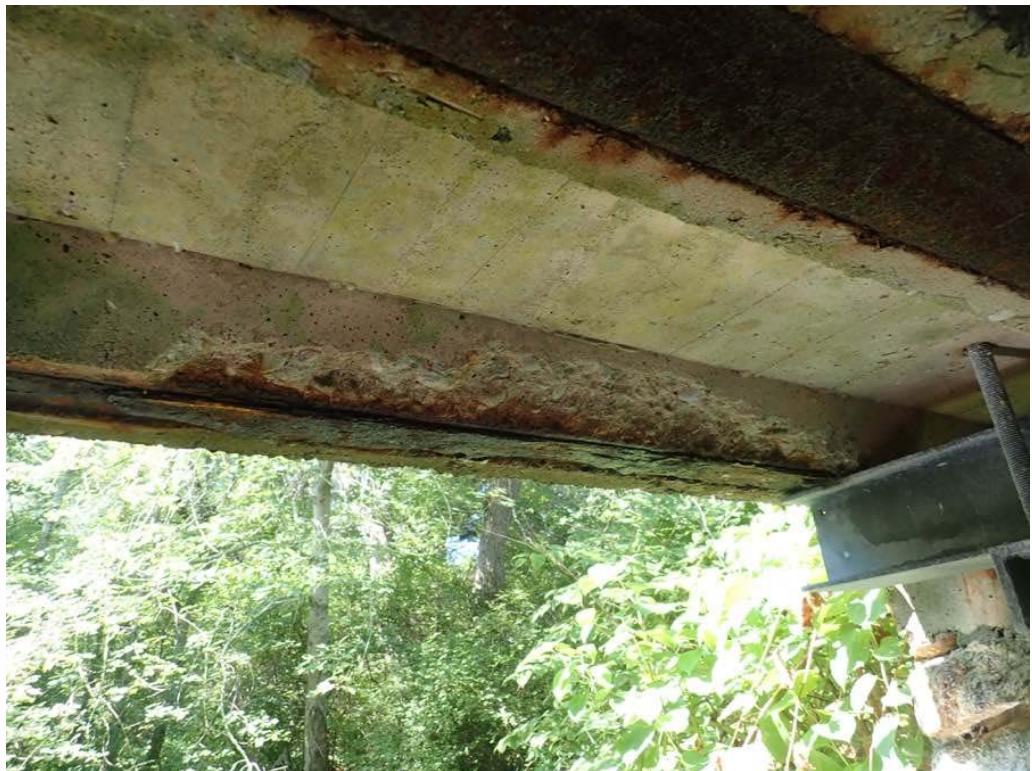
- The fascias of the concrete deck have areas of scale up to 1/4" deep.
- Beam 1 concrete encasement, north elevation, near the west abutment has a spall 4' long x 3" high x 1/2" deep. **Photo 3.**
- Beam 5 concrete encasement, south elevation, near east abutment was not observed this inspection.
- Beam 7 concrete encasement, south elevation, near east abutment has a spall 3' long x 2" high x 2 1/2" deep. **Photo 4.**
- Beam 7 concrete encasement, south elevation, near west abtment has a spall 1' long x 2" high x 2 1/2" deep. **Photo 5.**
- Bay 6 near the east abutment has a spall 4" long x 4" high x 1" deep with exposed rebar. **photo 6.**

**Photo 3: Beam 1 south elevation spall.**

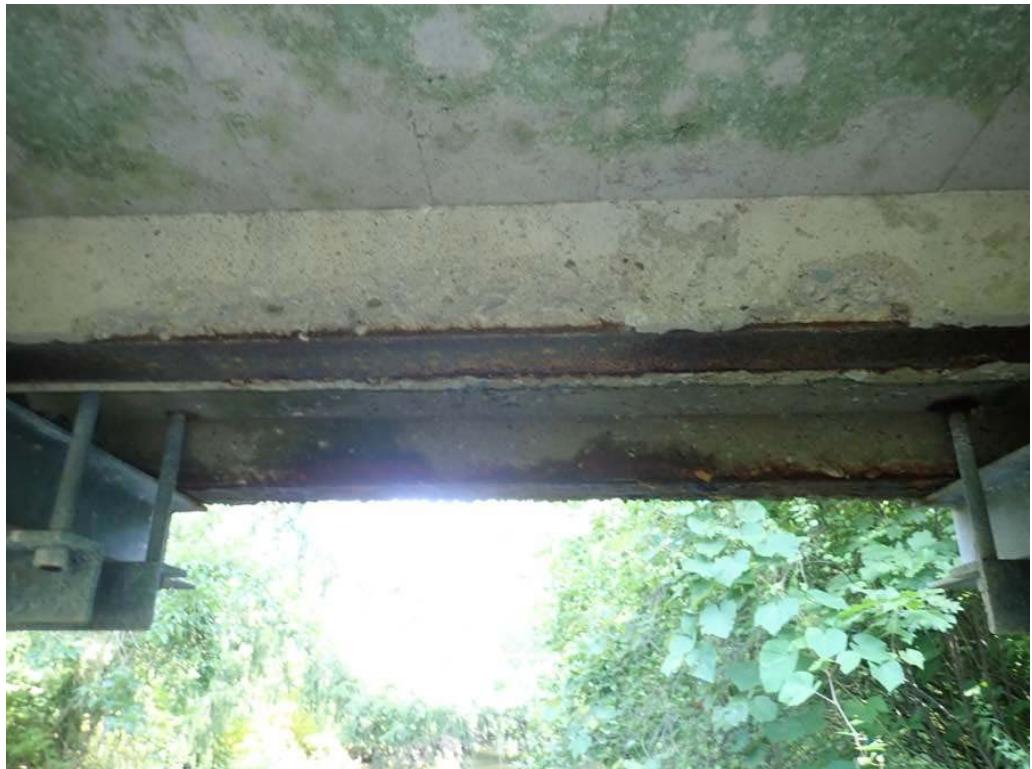
**Photo 4: Beam 7 south elevation near east abutment spall.**

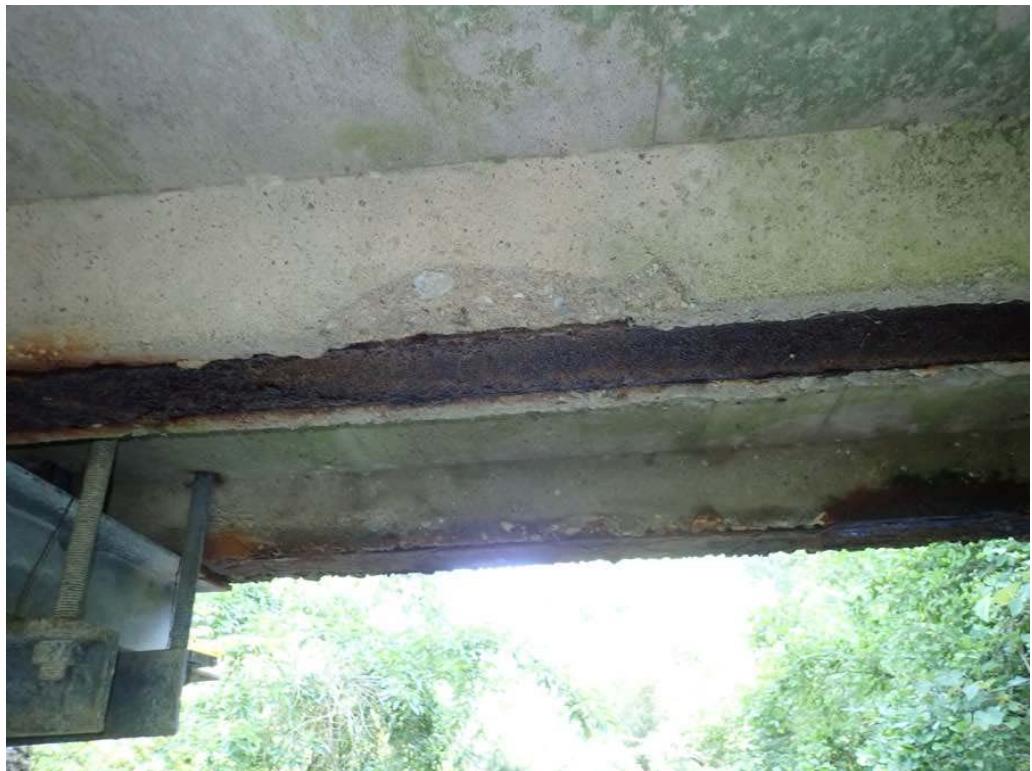
**Photo 5: Beam 7 near west abutment spall.**

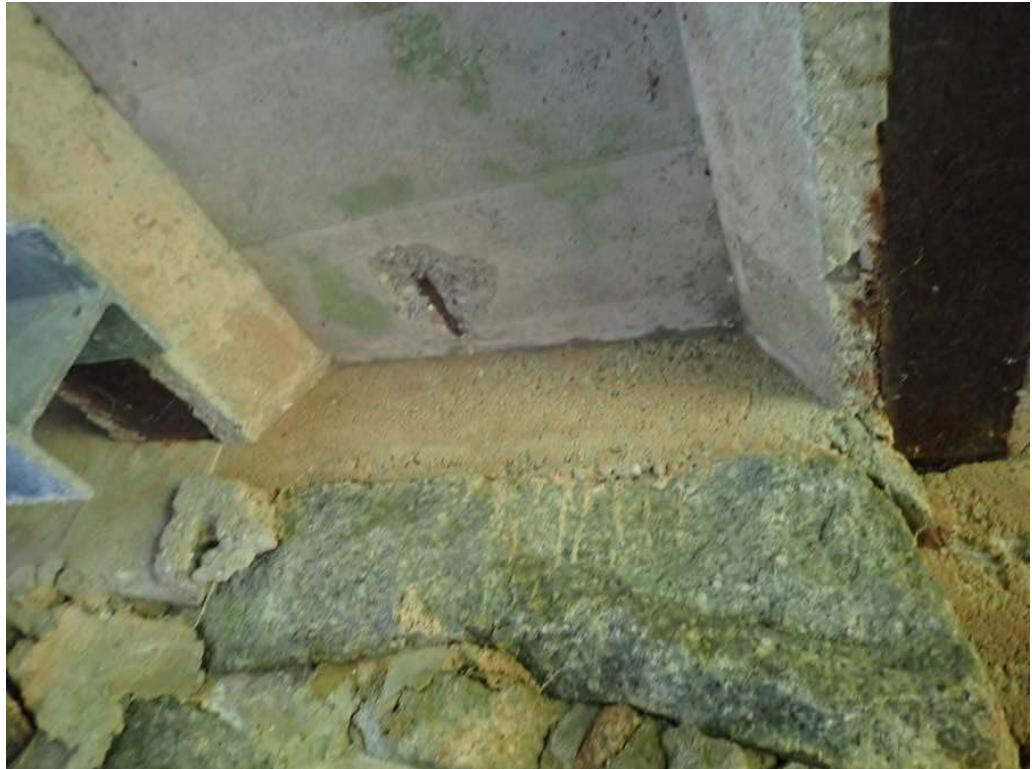
**Photo 6: Bay 6 at east abutment minor spall.**

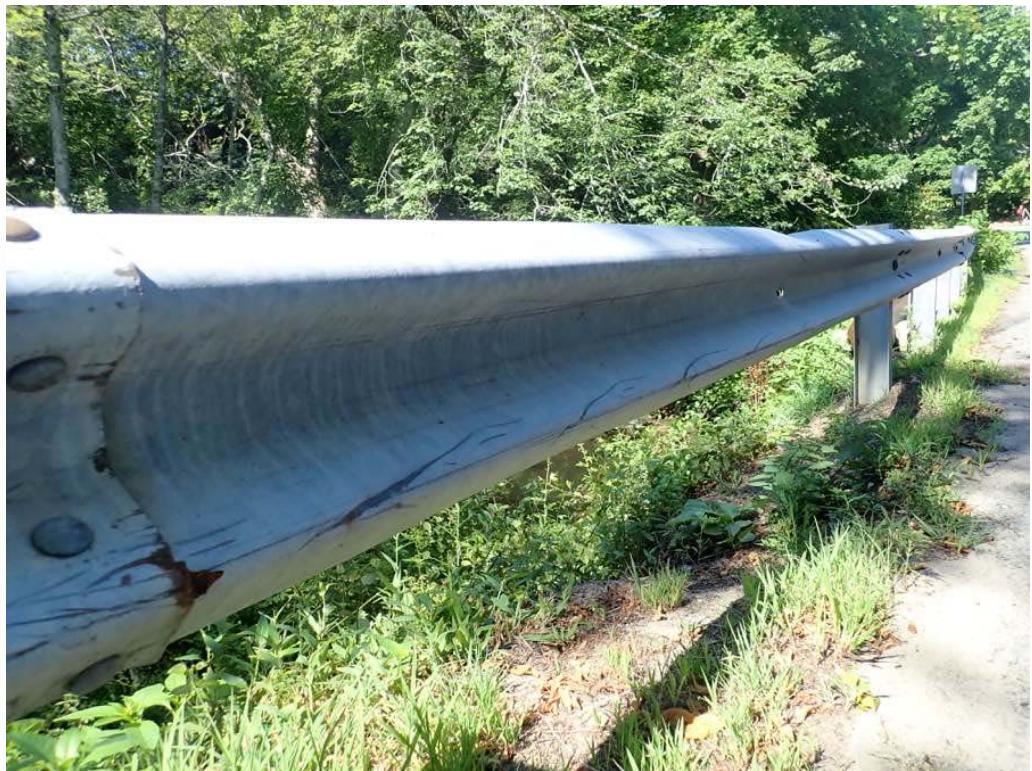
- Both rails have minor collisions scrapes throughout. **Photo 7 for typical conditions.**

**Photo 7: South rail minor collision damage scrapes.**

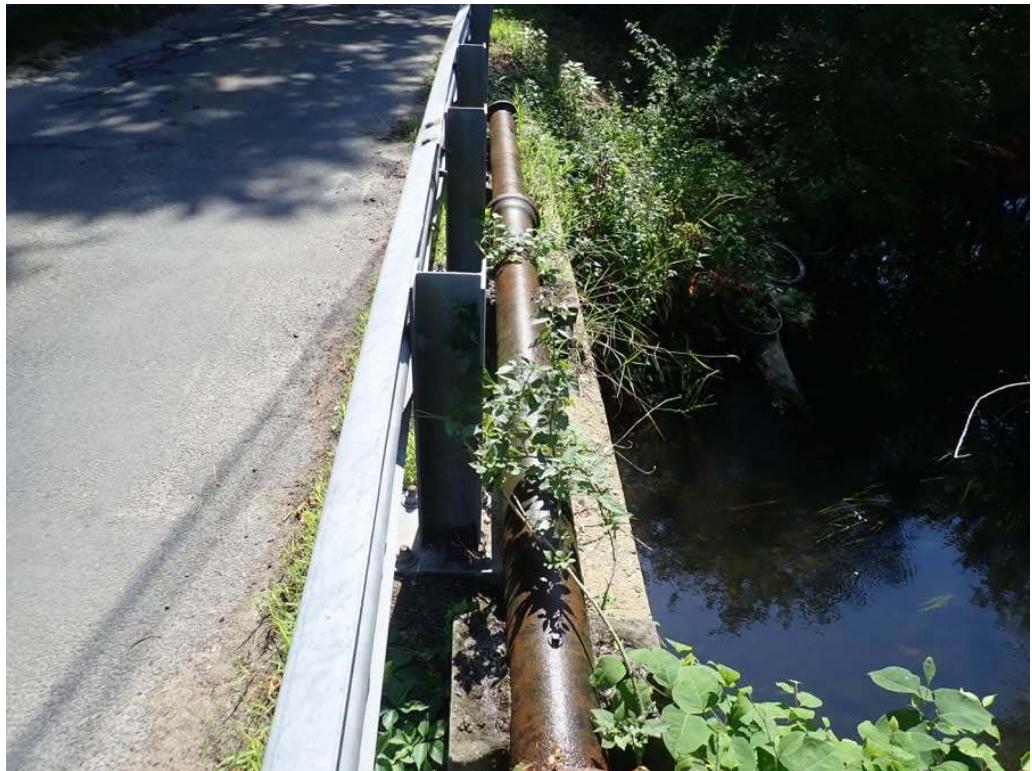
The steel water pipe along the south side of the bridge is resting on concrete. The water pipe has no insulation. **The water pipe has a moisture stain. Photo 8.**

**Photo 8: South utility looking east.**

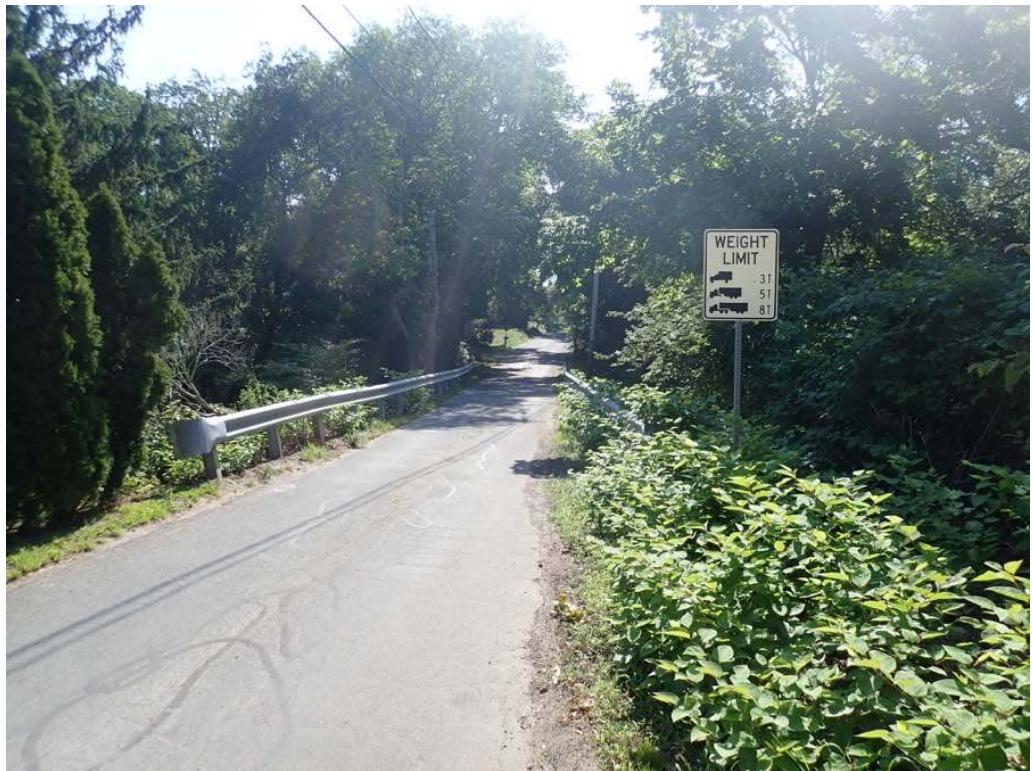
- The bituminous wearing surface has wheel ruts.
- The southwest has moderate vegetation growth that is starting to encroach toward the roadway. **Photo 9.**
- The east approach has sealed and unsealed cracking. **Photos 10 & 11.**

**Photo 9:** West approach, moderate vegetation growth.

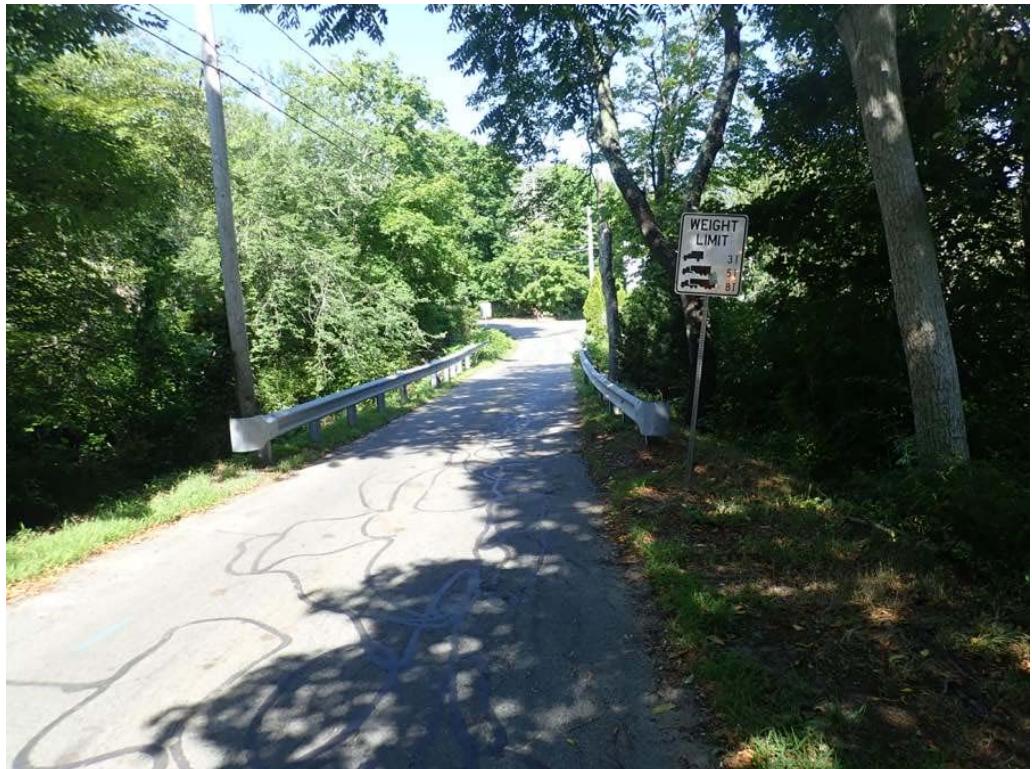
**Photo 10:** East approach sealed and unsealed cracking.

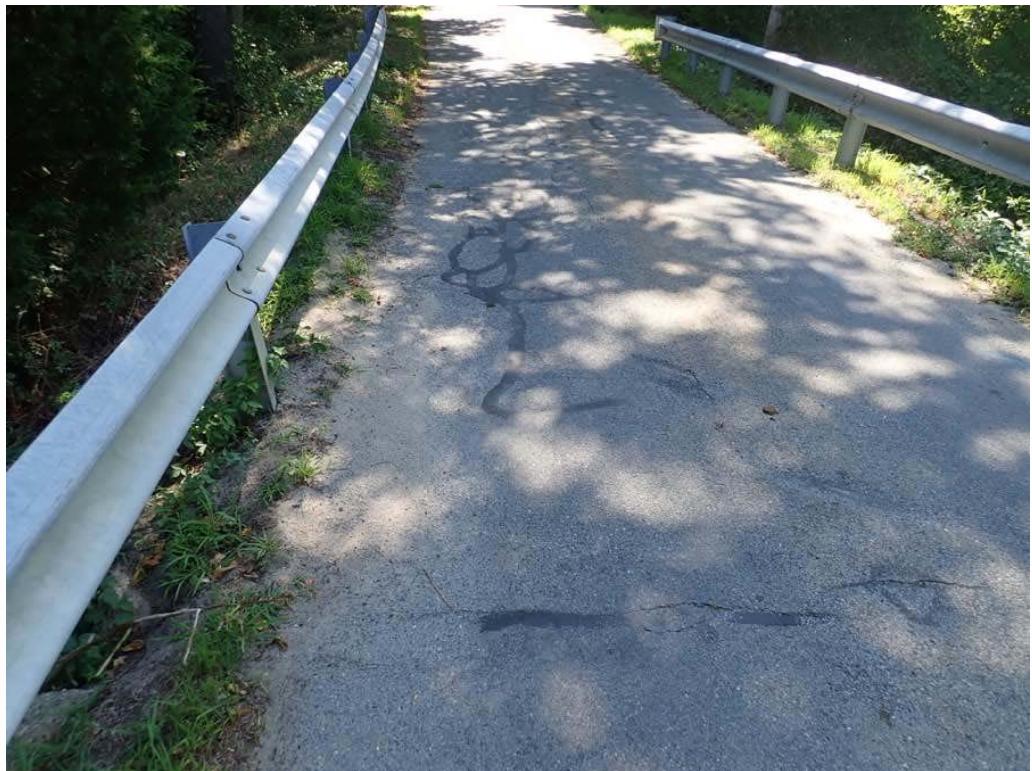
**Photo 11:** East approach looking east sealed and unsealed longitudinal cracking.

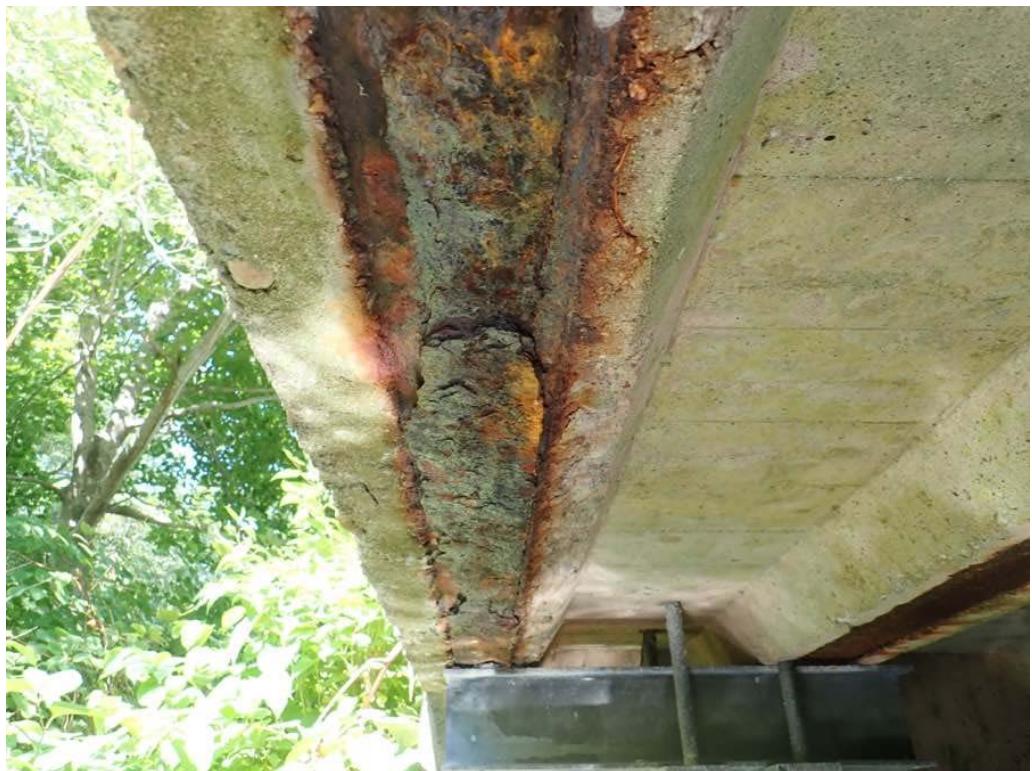
- **Beam 1 bottom flange has heavy rust and areas of 100% section loss up to 1' long x full width.**

**Photo 12:** Beam 1 looking west from midspan, section loss.

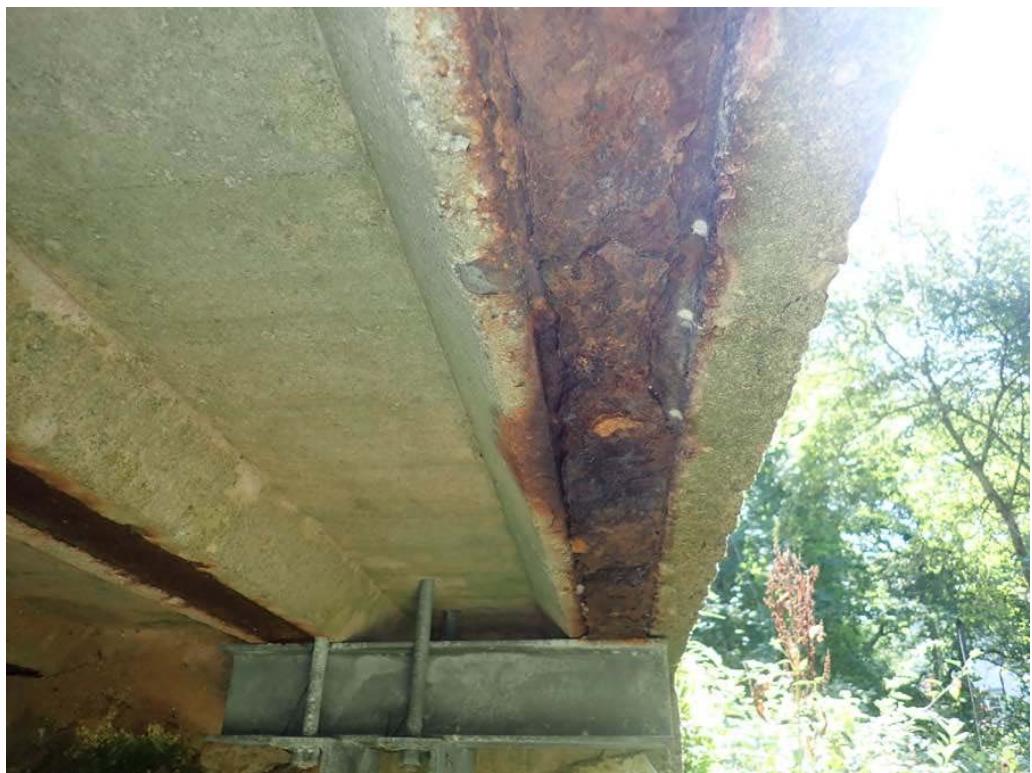
**Photo 13:** Beam 1 looking east from midspan, section loss.

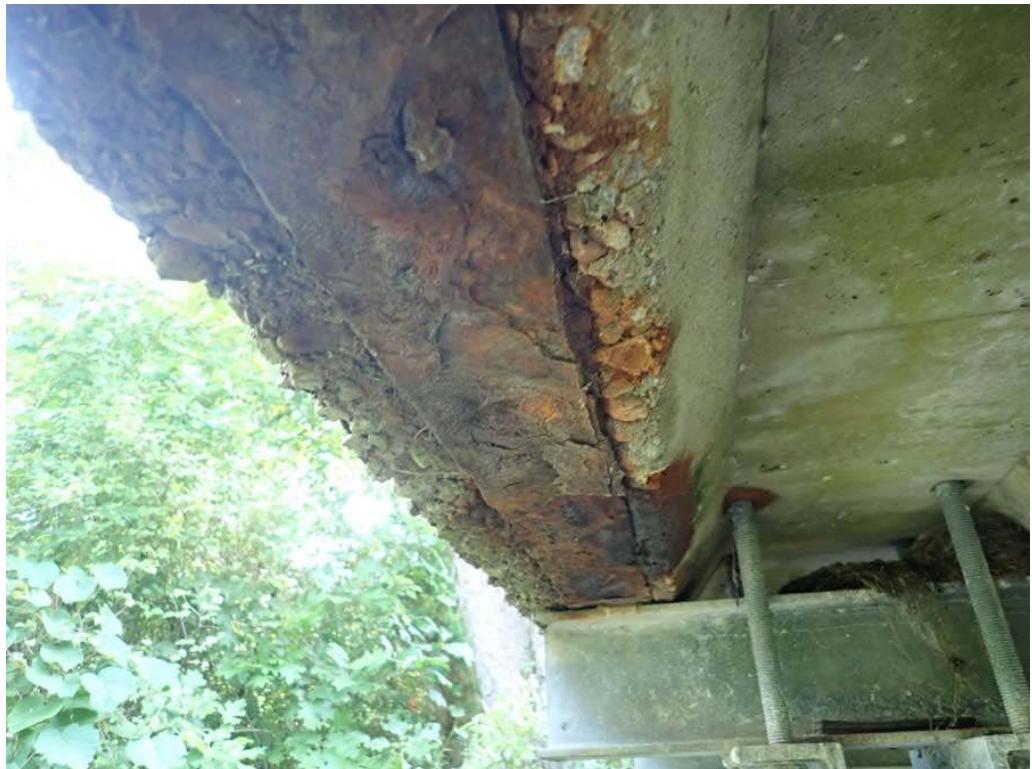
- Beam 8 bottom flange has areas of pitting up to full length. **Photo 14.**

**Photo 14:** Beam 8 looking east pitting.

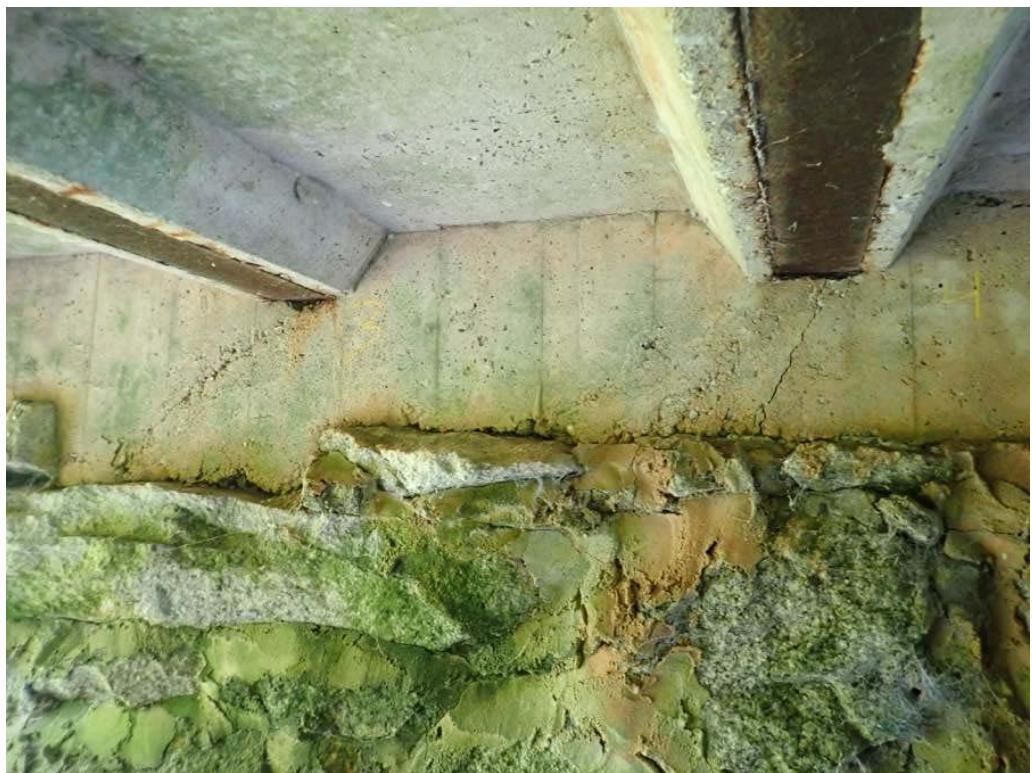
- Below Beam 3, at west abutment: The reinforced concrete cap has honeycombing.
- Below Beam 4, at west abutment: The reinforced concrete cap has full height diagonal crack up to 1/8" wide. **Photo 15.**
- Below Beam 3, at east abutment: The reinforced concrete cap has a full height vertical crack up to 1/8" wide. **Photo 16.**
- Below Beam 5: The reinforced concrete cap has areas of honeycomb up to 1/4" deep.
- The North End: The stone masonry and mortar has areas of missing stones up to 10" deep and areas of missing mortar. This portion has pulled away and the mortar has fallen out leaving a 2" vertical gap. **Photos 17 & 18.**
- The Northwest corner has multiple voids upto 22" deep. **Photo 19.**

**Photo 15: West abutment below beam 3 & 4, honeycombing and cracking.**

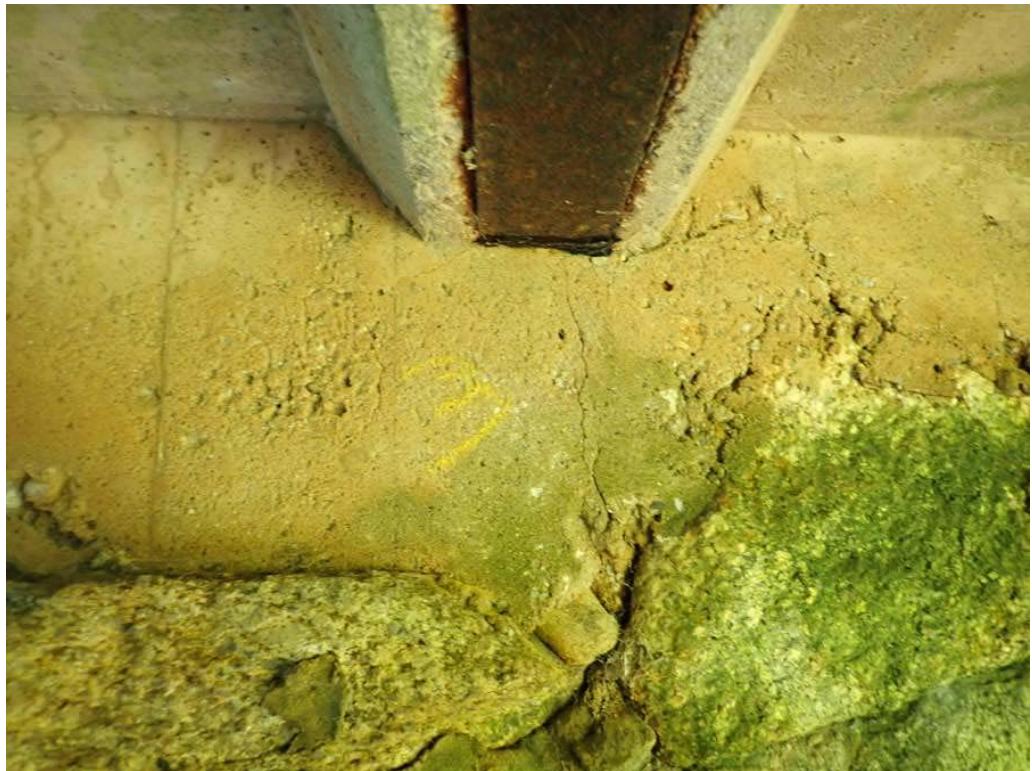
**Photo 16: East abutment below beam 3 hairline vertical crack.**

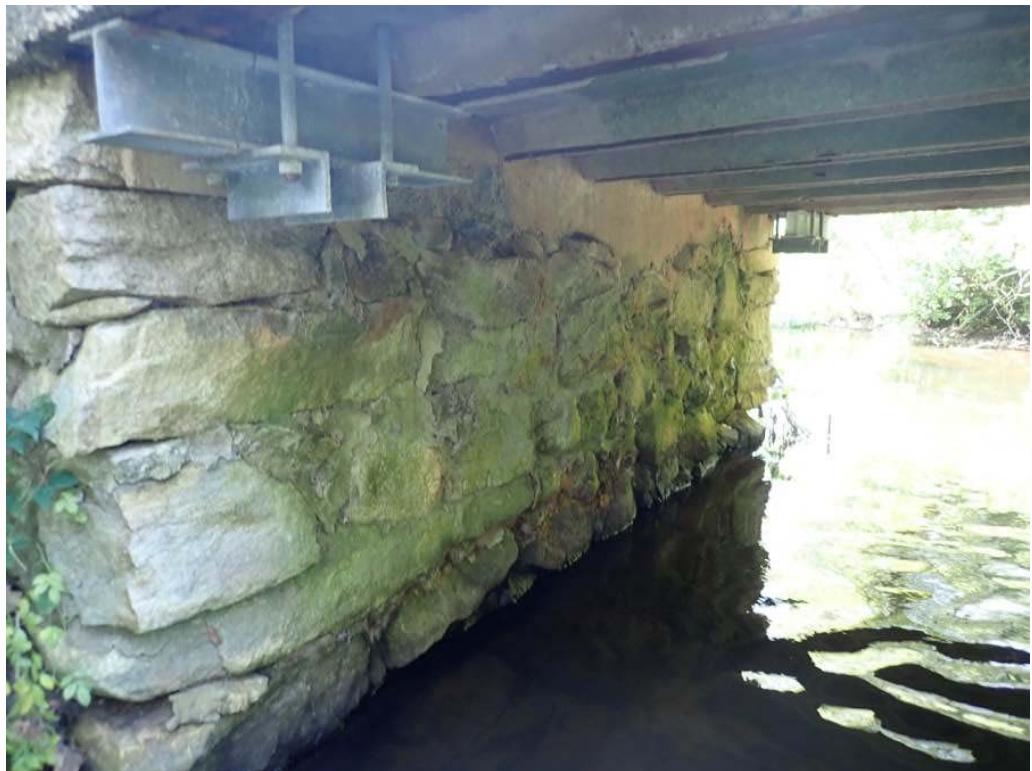
**Photo 17: East breastwall overview looking south.**

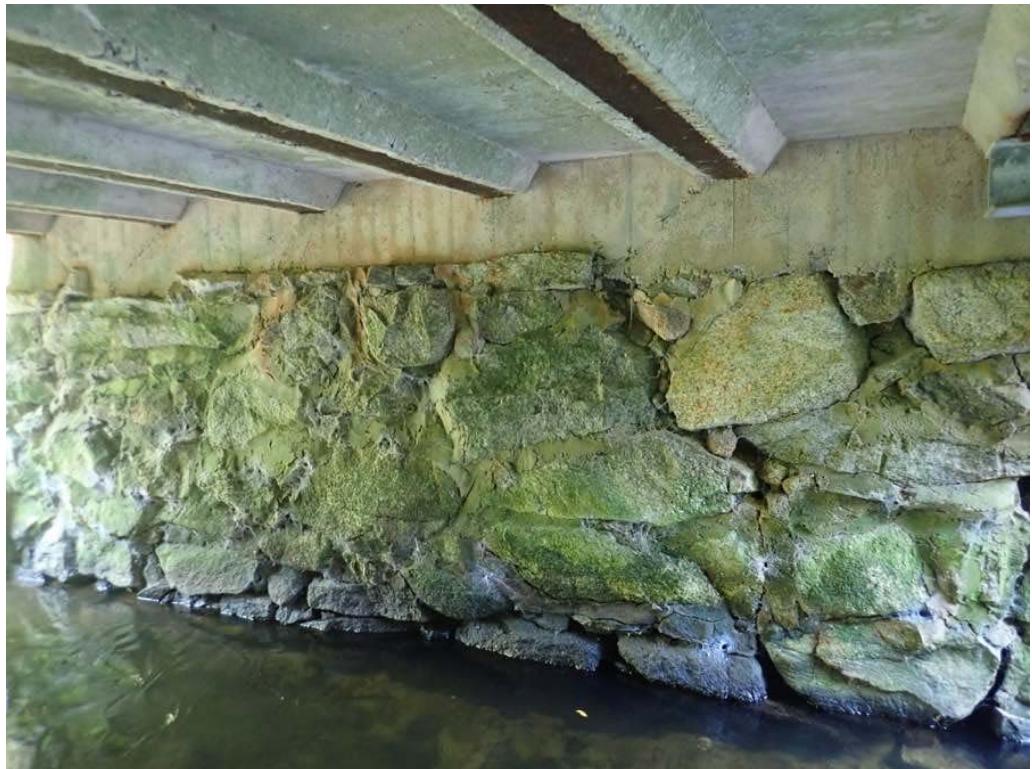
**Photo 18: West breastwall overview voids.**

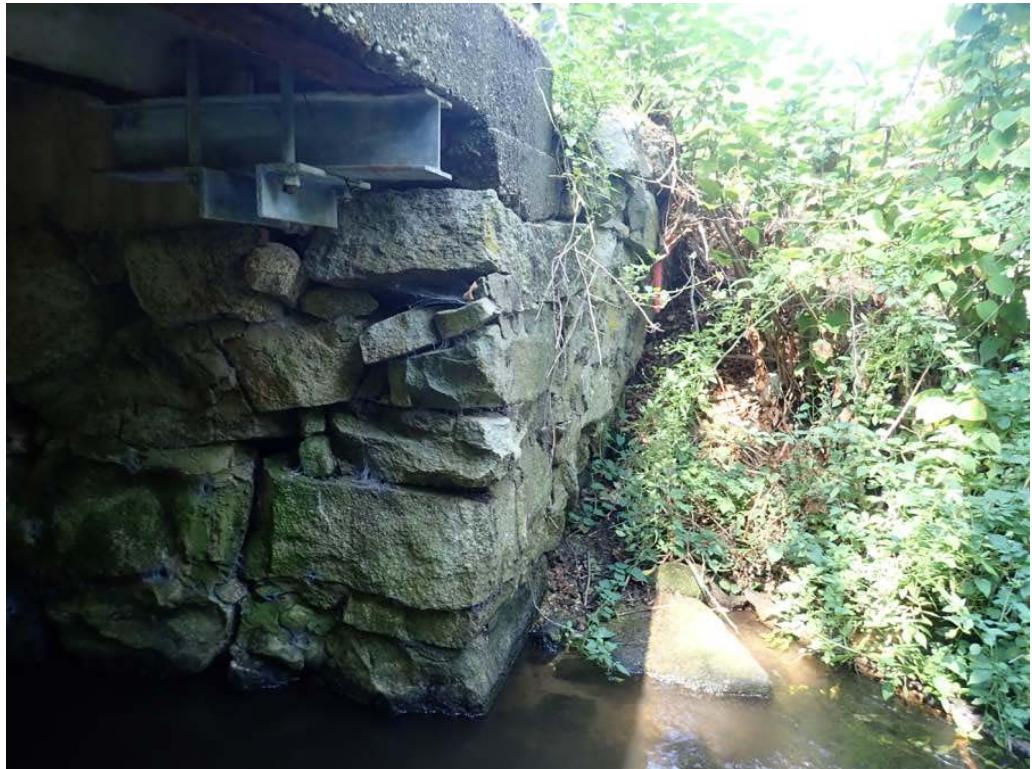
The wingwalls consists of stone masonry and reinforced concrete caps. The northwest wingwall is leaning outward up to 3" over 2' high. **Photo 19.**

**Photo 19: Northwest wingwall leaning and voids in breastwall.**

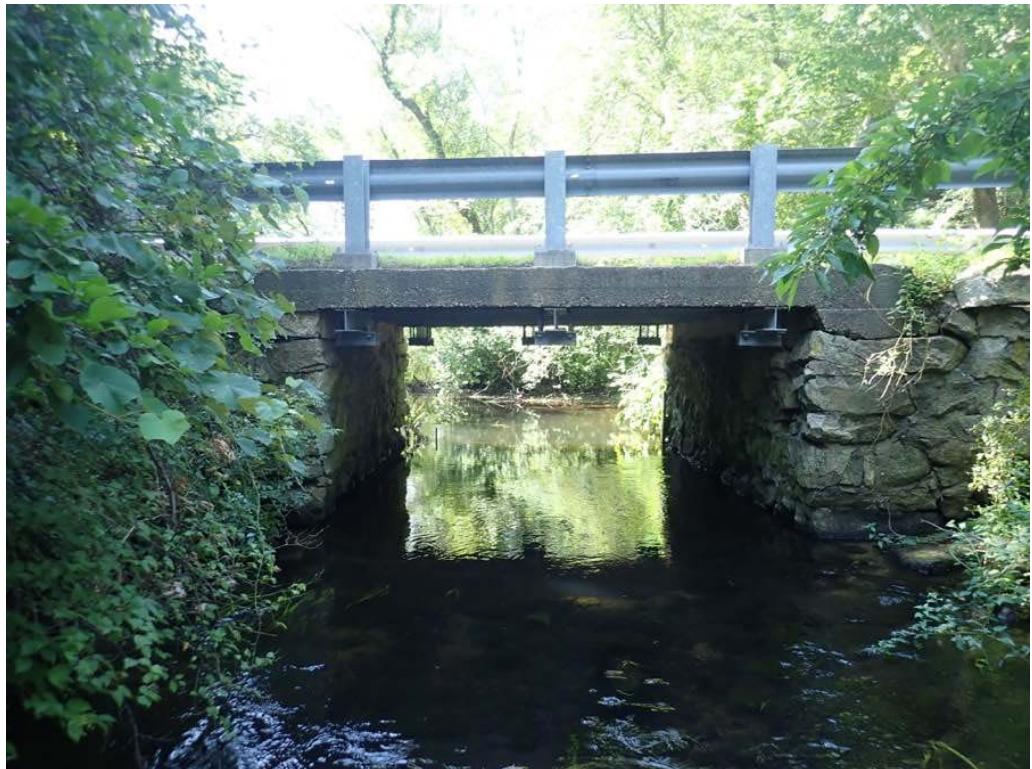
The wingwalls have moderate vegetation growth. **Photo 20.**

**Photo 20: North elevation, vegetation growth.**
