TOWN OF PLYMOUTH COMMUNITY PRESERVATION COMMITTEE

SPIRE CENTER FOR THE PERFORMING ARTS

CONDITIONS ASSESSMENT & CONCEPTUAL DESIGN

THE SPIRE CENTER FOR THE PERFORMING ARTS

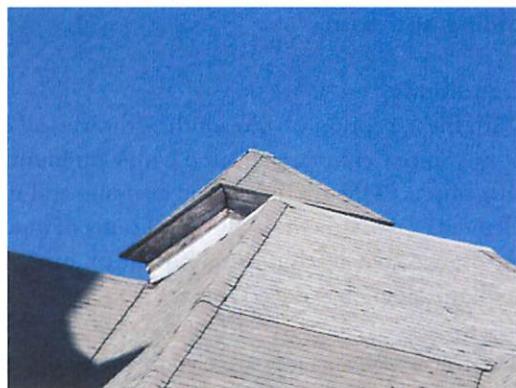
Aged asphalt roofing.

- The original roofing material was likely wood shingles; replacement of the asphalt roof with cedar shingles would be preferred. If wood is cost prohibitive, the roofing could be replaced with 3-tab or architectural asphalt shingles.
- Replace the wood shingles on the towers and spires with Alaskan Yellow Cedar shingles.

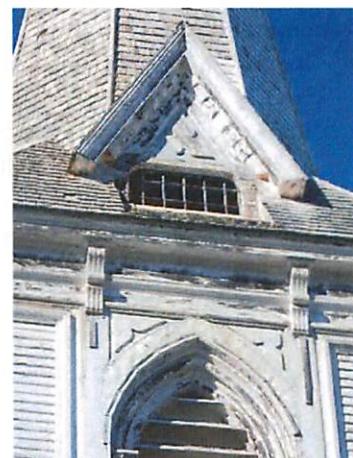
Worn and missing wood shingles at the tower and spire.

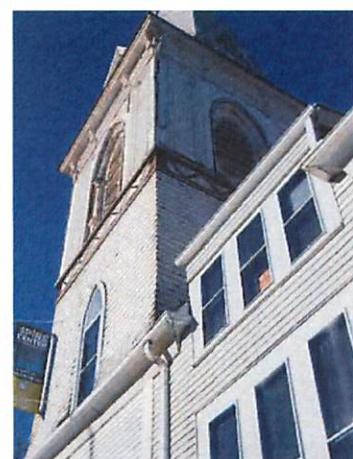
Aluminum gutter and downspout at the east elevation.

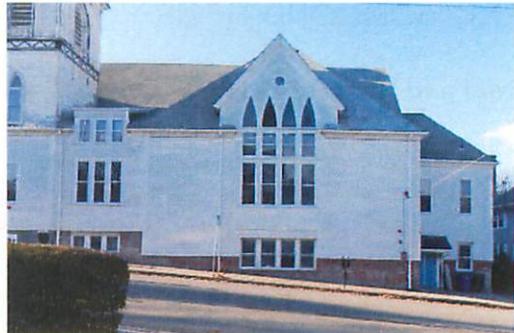
Wall surfaces and trim elements covered by aluminum siding.

- Remove aluminum siding and sheet aluminum over trim.
- Replace damaged clapboards and decorative shingles and trim with new parts milled to match the historic size.
- Strip, prep and repaint wood elements.
- Replicate missing carved ornaments in panels between the windows at the gable ends. These are seen in historic photographs.
- Replace missing trim, moldings, corbels and brackets.

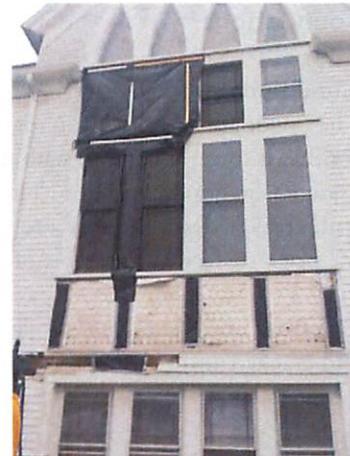
Grouped windows at the east transept. Aluminum siding partially removed.

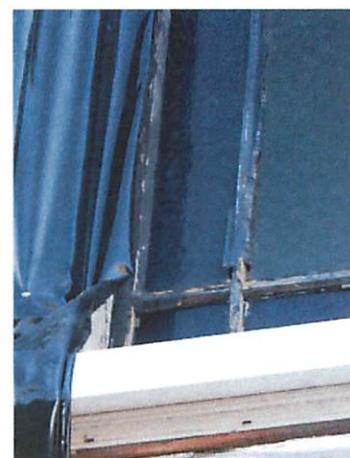
Paint failure at window muntins.

- Fully strip, repair, reglaze, prep and paint window sash.
- Fully strip, repair, prep and paint doors.

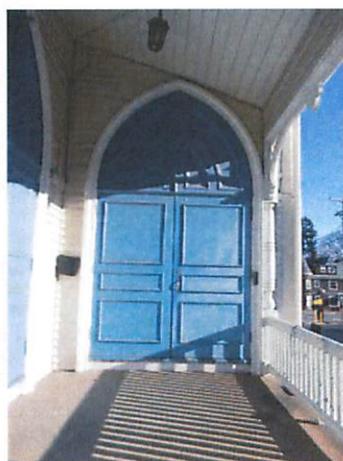
Double arched door at main entry showing weathered paint.

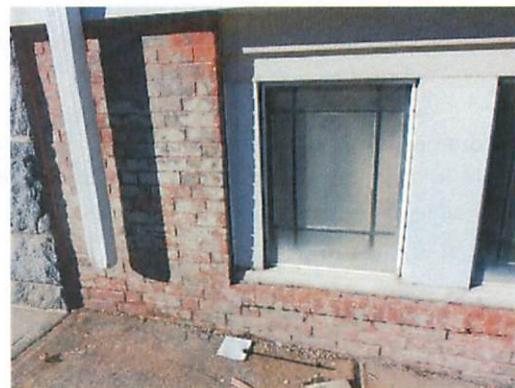
Failed mortar and paint remnants at east elevation.

- Repoint the brick selectively with correct mortar.
- Repoint granite facing stones.

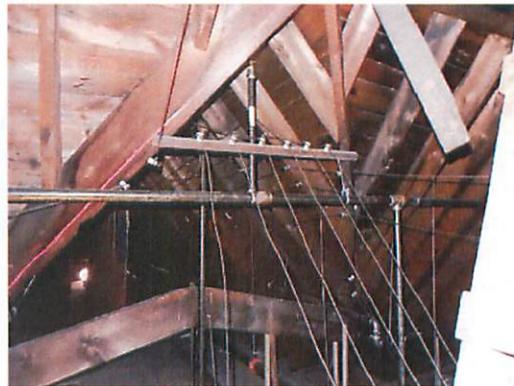
Wood framing at gable with wiring and new sprinkler system.

- Removed old knob and tube wiring and re-wire with code compliant wiring.
- Critical framing repairs:
 - Reinforce existing collar beams with new steel beams supported on new tube steel posts that are in turn supported on new transfer beams in the attic floor.
 - Introduce new tension tie elements and connections to join the two halves of the corbel trusses. (See the structural report that follows for detailed recommendations on framing repairs.)

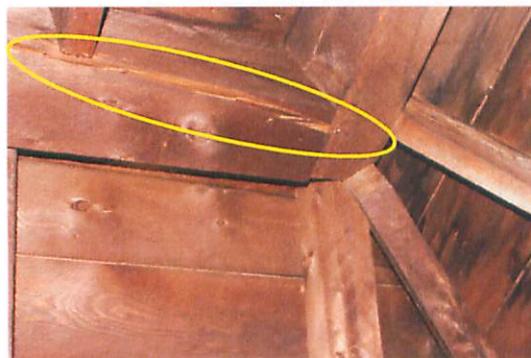
Split at roof collar beam at apex of main hip roof.

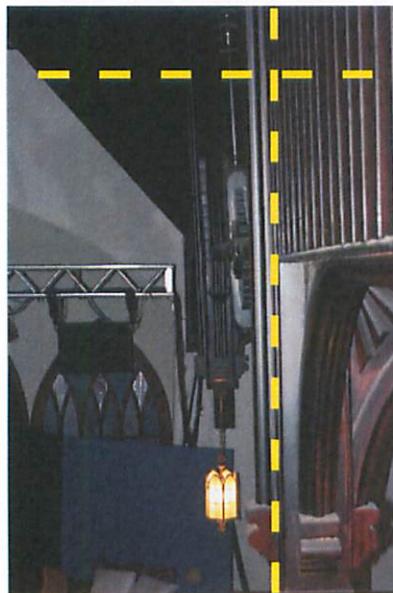
Superimposing the plans and sections revealed that the corbel trusses rely on the decorative wood tie as a tension element that holds the two bottom sections of the C-Truss together. How they are connected is subjected to further investigation, but it is apparent that a new tension tie element and connection is required to stabilize all four quadrants on either side of both gable window walls. The installation of a new tension rod behind the existing decorative element to tie the two C-Truss halves together is recommended. In doing so, it may be also possible to lift the deflected corbel truss corners by simultaneously jacking the corbel end as the tie rod is tensioned.

Deflection of the truss corners resulting from inadequate connection between the truss sections is seen in the corbel ends, which have dropped 3-4". Note degree out of plumb.

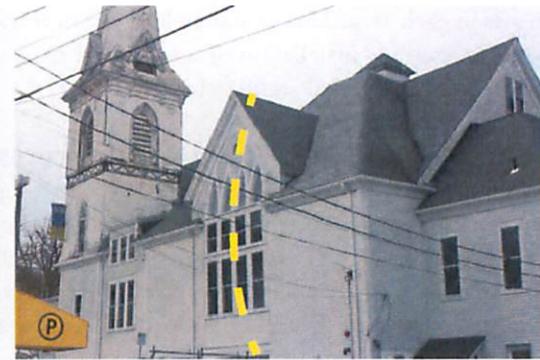
Bowing of window wall at the south transept is exacerbated by the framing deficits at the roof and corbel trusses. The wall is 6"- 9" out of plumb.

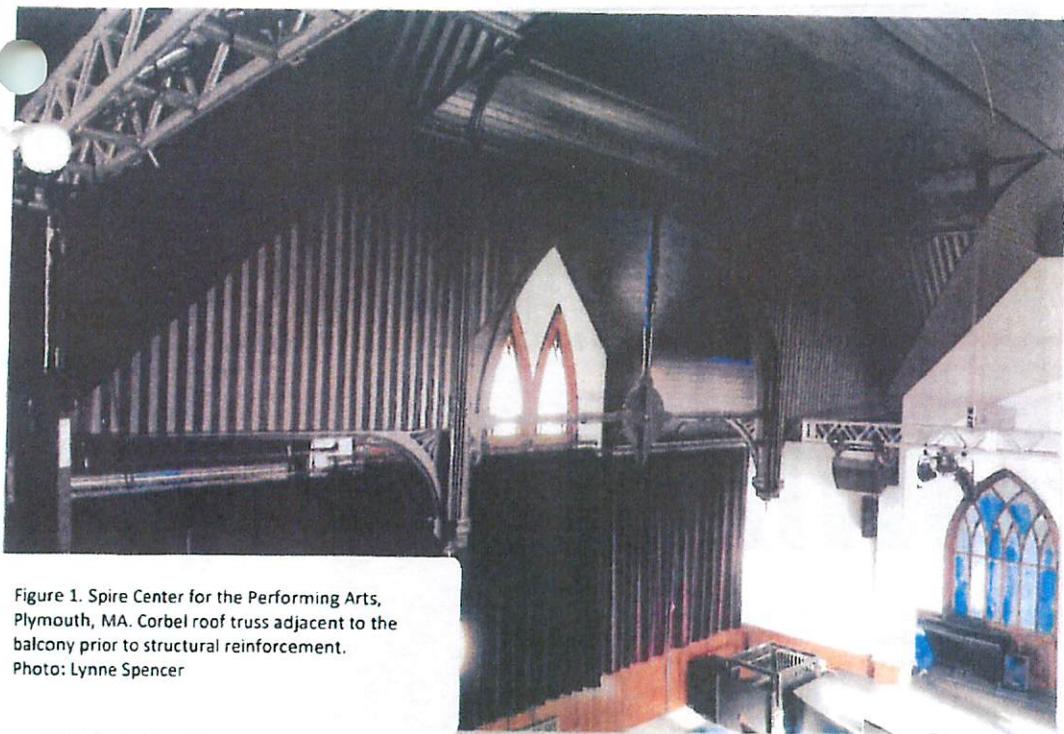
Figure 1. Spire Center for the Performing Arts, Plymouth, MA. Corbel roof truss adjacent to the balcony prior to structural reinforcement.

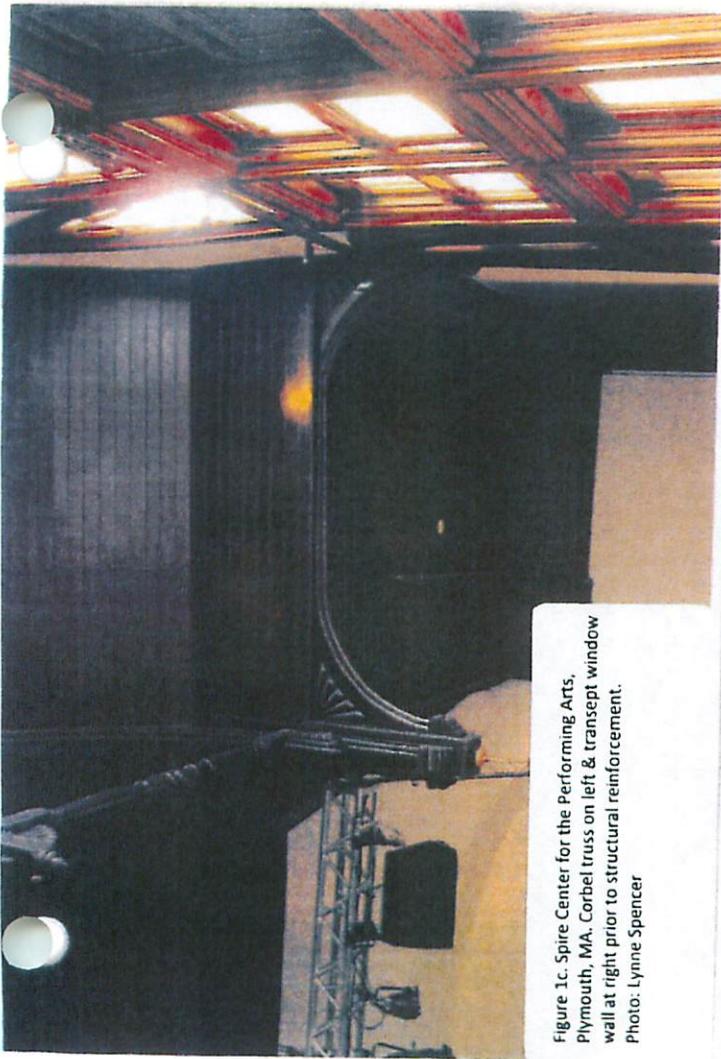
Figure 1c. Spire Center for the Performing Arts, Plymouth, MA. Corbel truss on left & transept window wall at right prior to structural reinforcement.
Photo: Lynne Spencer

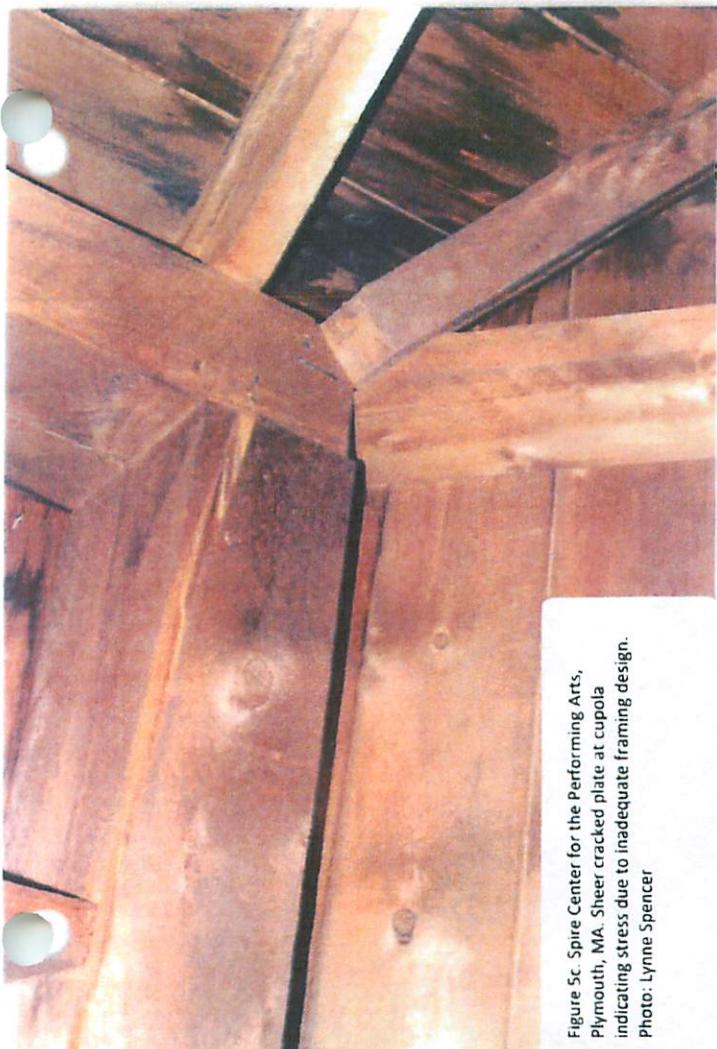
Figure 5c. Spire Center for the Performing Arts, Plymouth, MA. Sheer cracked plate at cupola indicating stress due to inadequate framing design.

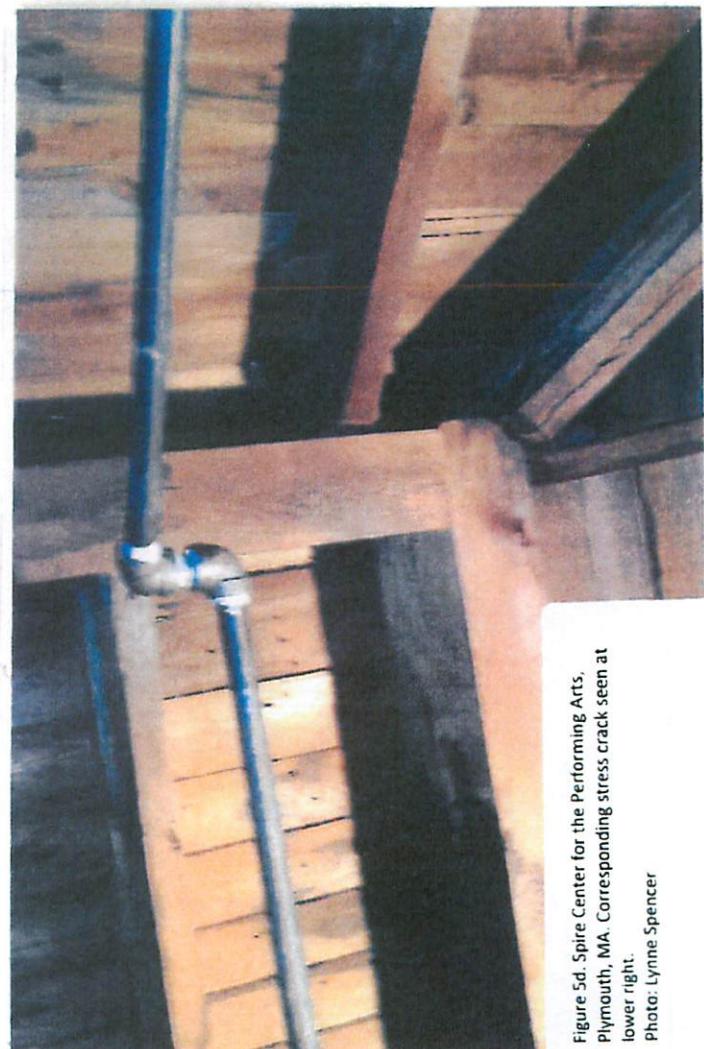
Figure 5d. Spire Center for the Performing Arts, Plymouth, MA. Corresponding stress crack seen at lower right.

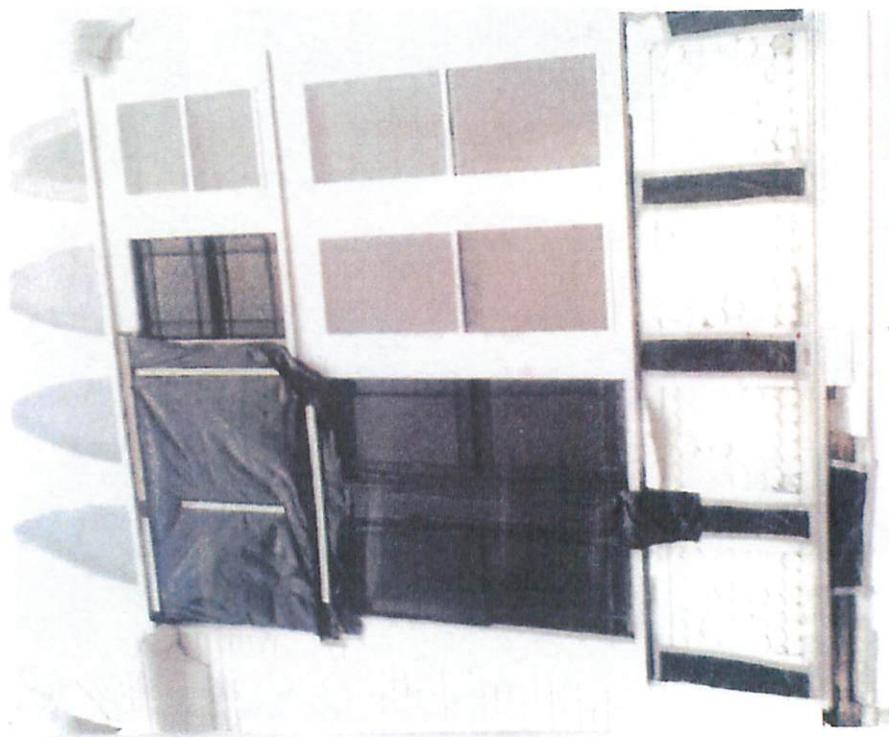
Figure 7c. Spire Center for the Performing Arts, Plymouth, MA. West transept gable - exploratory investigation of structural conditions.
Photo: Lynne Spencer
