Town of Plymouth, MA  
Department of Marine & Environmental Affairs

Nutrient Management Data Report  
Operational Monitoring Program  
Data Report for 2012

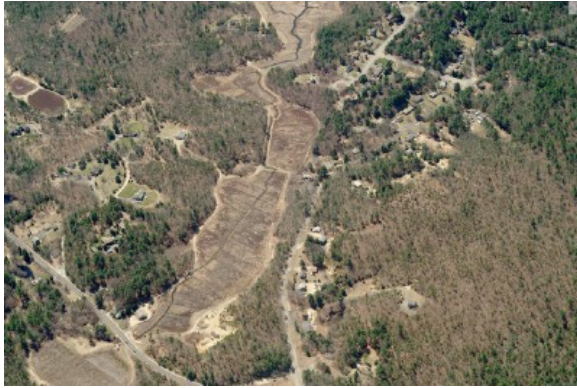
In October of 2010 the Town of Plymouth, with the assistance of State & Federal Project Partner Agencies, have completed river and wetland restoration activities in the headwaters of the Eel River, the small spring-fed system which drains into historic Plymouth Harbor. This State & Federal Listed Priority Project included dredging to construct a sinuous stream channel 1.7 miles in length to reestablish natural conditions and enhance river continuity, filling of former artificial side channels, reconstruction of a re-connected floodplain, removal of dikes and water control structures, replacement of undersized culverts at Long Pond Road and a driveway to enhance fish passage, extensive wetland plantings including 17,000 Atlantic white cedar (AWC) trees, and re-establishment of rare wetland communities. Sawmill Pond Dam site has been re-configured to allow fish passage, and a restored river channel and floodplain has been reconstructed in the existing impoundment.

*(Pre-restoration channel)*

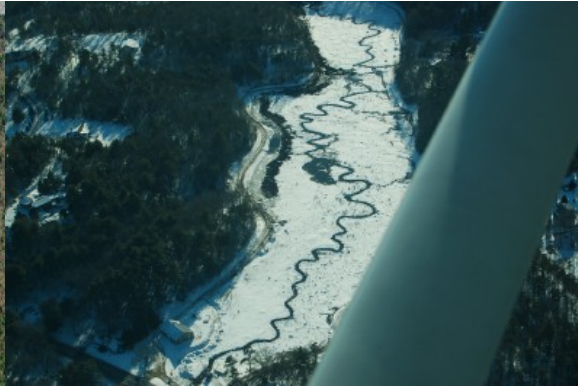
*(Post-restoration channel)*
