Town of Plymouth, MA  
Department of Marine & Environmental Affairs

Nutrient Management Data Report  
Operational Monitoring Program  
Data Report for 2019

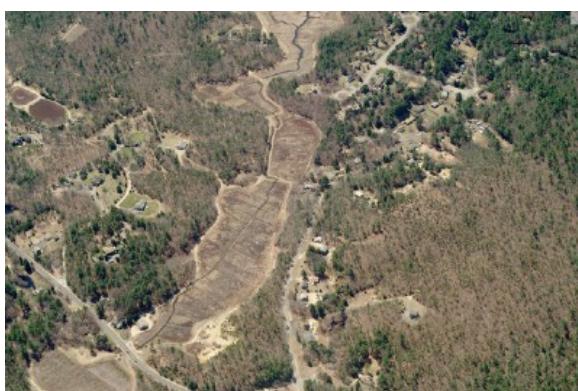
*(Pre-restoration channel)*

In October of 2010 the Town of Plymouth, with the assistance of State & Federal Project Partner Agencies, have completed river and wetland restoration activities in the headwaters of the Eel River, the small spring-fed system which drains into historic Plymouth Harbor. This State & Federal Listed Priority Project included dredging to construct a sinuous stream channel 1.7 miles in length to reestablish natural conditions and enhance river continuity, filling of former artificial side channels, reconstruction of a re-connected floodplain, removal of dikes and water control structures, replacement of undersized culverts at Long Pond Road and a driveway to enhance fish passage, extensive wetland plantings including 17,000 Atlantic white cedar (AWC) trees, and re-establishment of rare wetland communities. Sawmill Pond Dam site has been re-configured to allow fish passage, and a restored river channel and floodplain has been reconstructed in the existing impoundment.

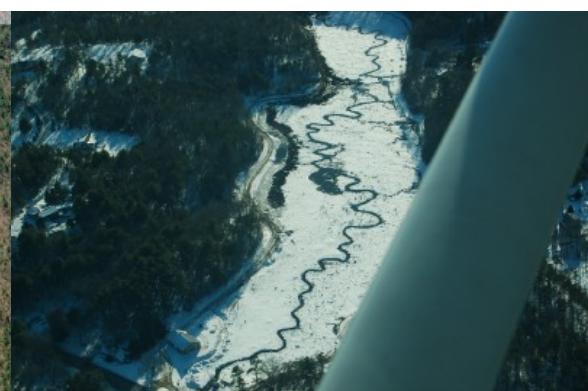
*(Post-restoration channel)*

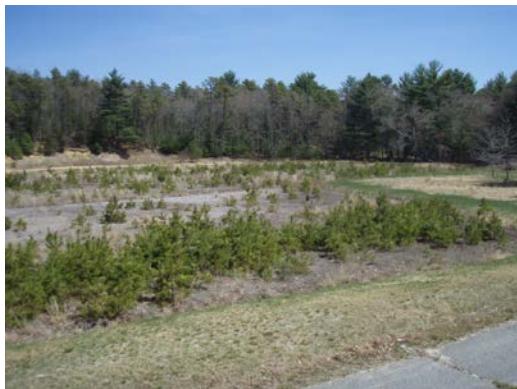
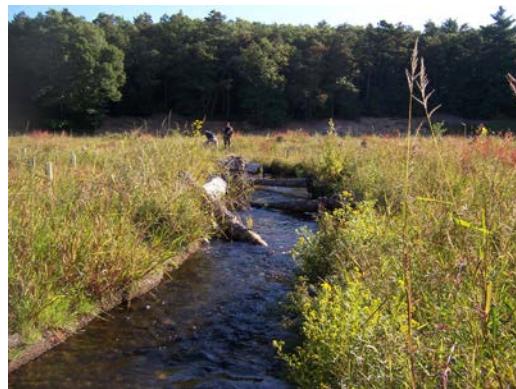
*(Bog 1 pre-restoration)*

*(Bog 2 pre-restoration)*

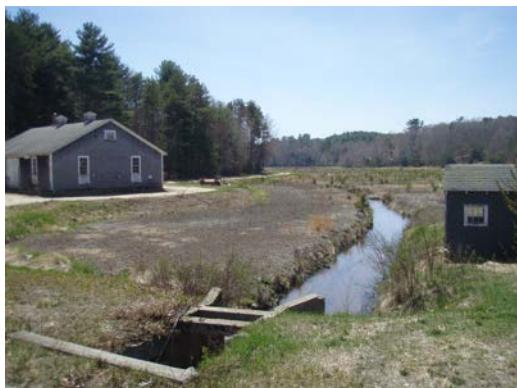
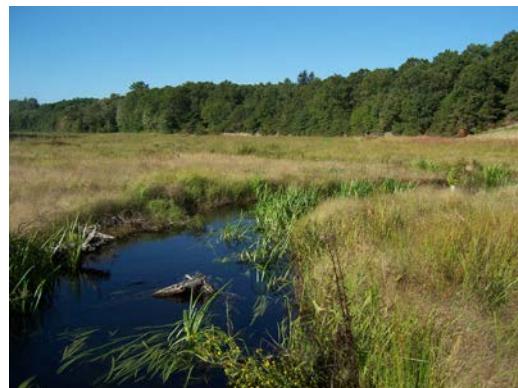
*(Bog 1 post-restoration)*

*(Bog 2 post-restoration)*
