# Nutrient Management Data Report

## Operational Monitoring Program

### Data Report for 2021

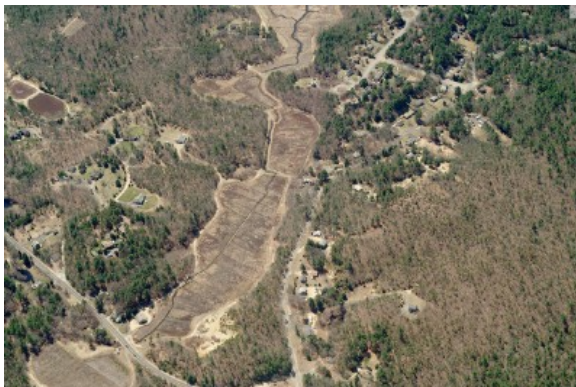
In October of 2010 the Town of Plymouth, with the assistance of State & Federal Project Partner Agencies, have completed river and wetland restoration activities in the headwaters of the Eel River, the small spring-fed system which drains into historic Plymouth Harbor. This State & Federal Listed Priority Project included dredging to construct a sinuous stream channel 1.7 miles in length to reestablish natural conditions and enhance river continuity, filling of former artificial side channels, reconstruction of a re-connected floodplain, removal of dikes and water control structures, replacement of undersized culverts at Long Pond Road and a driveway to enhance fish passage, extensive wetland plantings including 17,000 Atlantic white cedar (AWC) trees, and re-establishment of rare wetland communities. Sawmill Pond Dam site has been re-configured to allow fish passage, and a restored river channel and floodplain has been reconstructed in the existing impoundment.

***(Pre-restoration channel)***

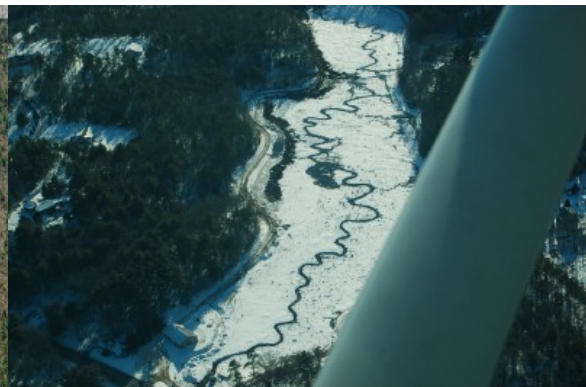
***(Post-restoration channel)***
