Town of Plymouth, MA
Department of Marine & Environmental Affairs

Nutrient Management Data Report
Operational Monitoring Program
Data Report for 2022

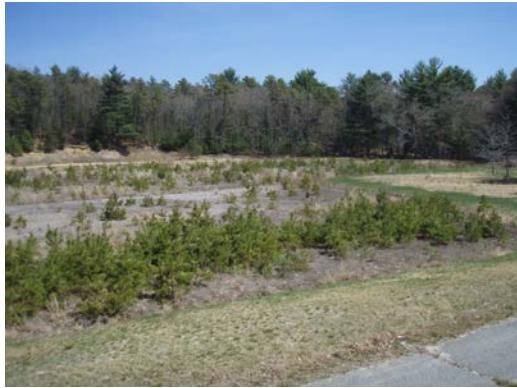
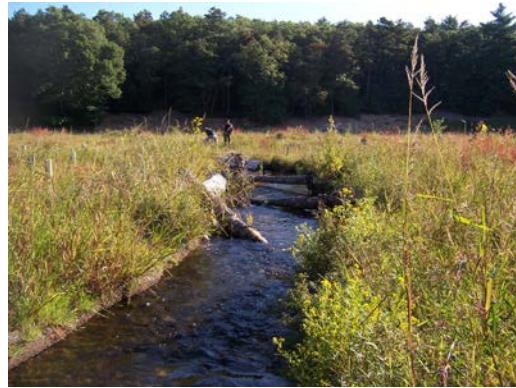
(Bog 1 pre-restoration)

(Bog 2 pre-restoration)

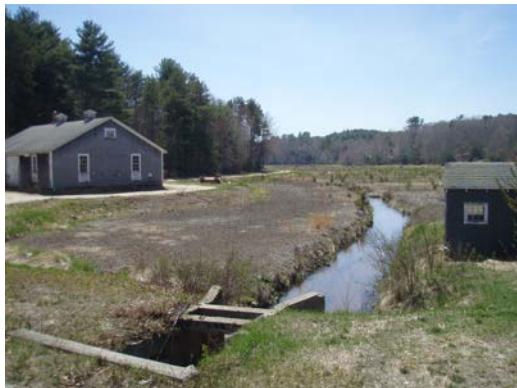
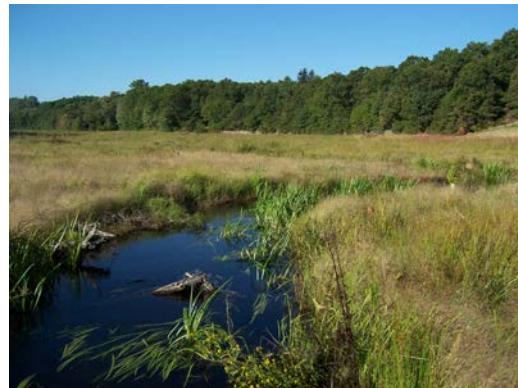
(Bog 1 post-restoration)

(Bog 2 post-restoration)
