Town of Plymouth, MA  
Department of Energy and Environment

Nutrient Management Data Report  
Operational Monitoring Program  
Data Report for 2023

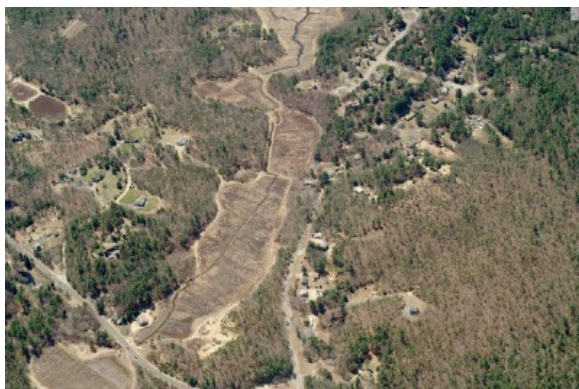
***(Pre-restoration channel)***

In October of 2010 the Town of Plymouth, with the assistance of State & Federal Project Partner Agencies, have completed river and wetland restoration activities in the headwaters of the Eel River, the small spring-fed system which drains into historic Plymouth Harbor. This State & Federal Listed Priority Project included dredging to construct a sinuous stream channel 1.7 miles in length to reestablish natural conditions and enhance river continuity, filling of former artificial side channels, reconstruction of a re-connected floodplain, removal of dikes and water control structures, replacement of undersized culverts at Long Pond Road and a driveway to enhance fish passage, extensive wetland plantings including 17,000 Atlantic white cedar (AWC) trees, and re-establishment of rare wetland communities. Sawmill Pond Dam site has been re-configured to allow fish passage, and a restored river channel and floodplain has been reconstructed in the existing impoundment.

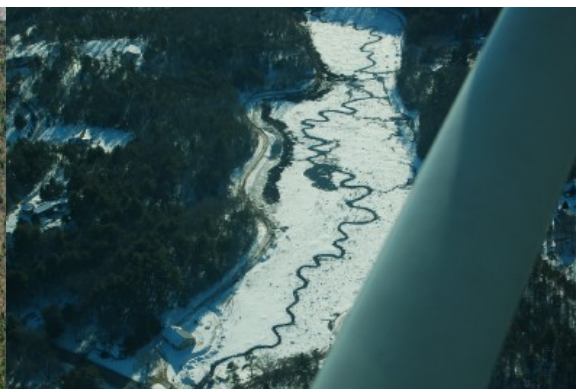
***(Post-restoration channel)***

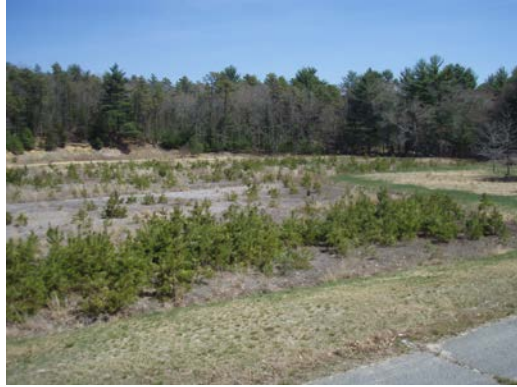
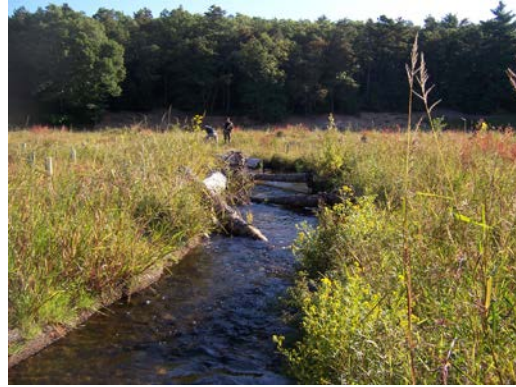
*(Bog 1 pre-restoration)*  
*(Bog 2 pre-restoration)*

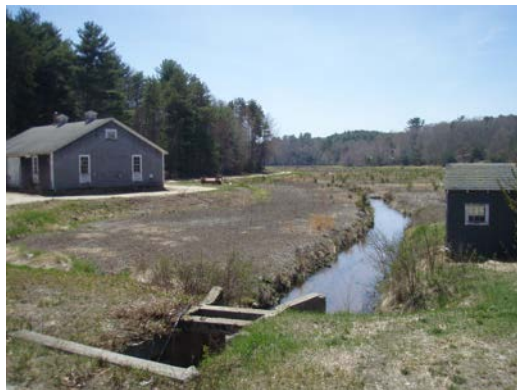
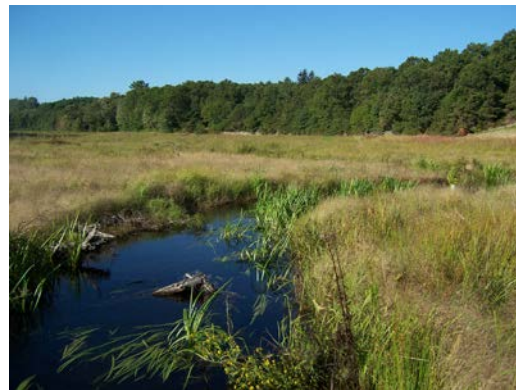
*(Bog 1 post-restoration)*  
*(Bog 2 post-restoration)*
