**ARTICLE 16B: To see if the Town will vote to transfer from the Community Preservation Historical Fund, estimated annual revenues, fund balance, or reserves, or otherwise fund, a sum of money for the preservation rehabilitation and restoration work of the identified forty stain glass windows, which are identified as #1 thought #40 in the Community Preservation Application submitted to the Community Preservation Committee on January 11, 2012 by the First Parish Meetinghouse Church for the stain glass windows in the First Parish Meetinghouse Church located at the Town Square as Lot 21, plat 19; in exchange for a Historic Preservation Restriction to be placed on the windows and also greater public access thought mutually agreed upon easement in the amount of \$300,000.00, and authorize the Board of Selectmen to accept said easement, or take any other action relative thereto.**

Project Name: First Parish Meetinghouse Restoration - Stained

Re: Repair and restoration of the stained glass windows at the First Parish Church

## STAINED GLASS WINDOW RESTORATION REPORT FIRST PARISH IN PLYMOUTH

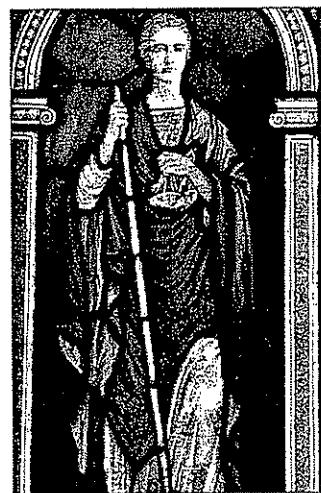
All of the windows in the Narthex are in very good condition and require no major work at this time. Some of the Narthex windows, most prominently Window #6, exhibit some pitting of the fired paint. This is clearly visible on the figure's face (see photo on the right). There could be several reasons why this has occurred. There could have been some remnants of oil on the glass, which later caused the fired paint in those areas to lift and disappear. Or, there could have been an issue with that particular batch of vitreous paint. I do believe that it will not deteriorate further. If the Church wishes to, we can infill the "spots" using artists' oil paint. This technique is safe and completely reversible.
