Town of Plymouth

Part A – Executive Summary

October 2019

Prepared by the
**Institute for
Human
Centered
Design**

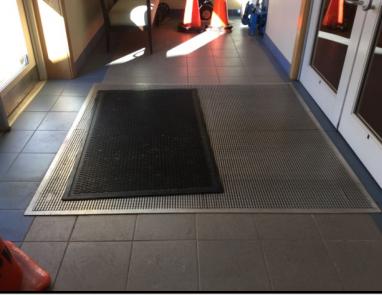
Mat not securely attached	-	Install an ADA-compliant walk-off mat.	1	324	\$324
Access to Goods and Services												
Means of Egress												
3	Function Hall	UL	105	Means of Egress	N/A

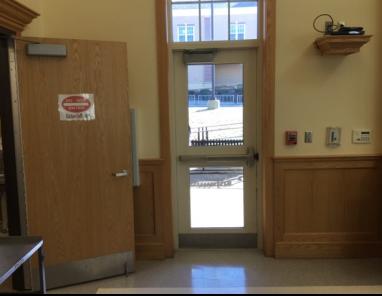
Illuminated exit sign not provided Tactile exit sign not provided	-	Ensure illuminated exit signs are provided at exits and exit doors. Provide a tactile exit sign with raised characters and braille. Mount sign between 48"- 60" above finish floor located on the latch side of the door.	1	216	\$216

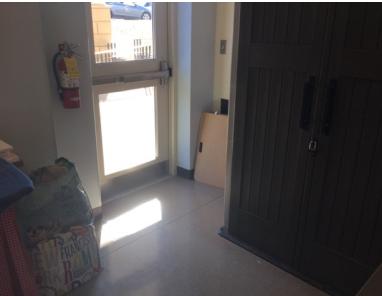
4	Arts and Crafts	UL	113	Means of Egress	N/A

Tactile exit sign not provided Door requires > 5 lbs. of force to open	- 20 lbs	Provide a tactile exit sign with raised characters and braille. Mount sign between 48"- 60" above finish floor located on the latch side of the door. Adjust closers so doors do not require more than 5 pounds of force to open. Relocate furniture to maintain the maneuvering clearance at the door.	1	116	\$116

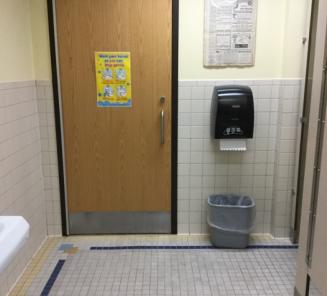
Maneuvering clearance(s) not provided	-	Remove trash can to maintain the maneuvering clearance at the door.	1	Labor	\$0
11	Men's Toilet Room	UL	108	Doors, Doorways, & Gates	Toilet Room

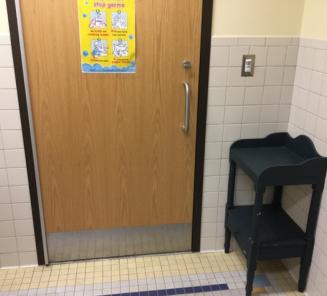
Maneuvering clearance(s) not provided Door requires > 5 lbs. of force to open	- 15 lbs	Remove table to maintain the maneuvering clearance at the door. Adjust closers so doors do not require more than 5 pounds of force to open.	1	Labor	\$0
12	Men's Toilet Room	LL	004	Doors, Doorways, & Gates	Toilet Room

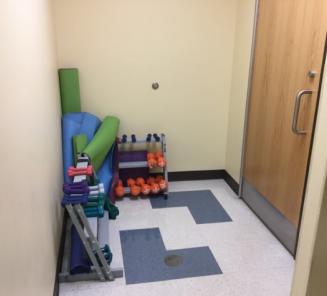
Maneuvering clearance(s) not provided Door requires > 5 lbs. of force to open	- 16 lbs	Remove equipment to maintain the maneuvering clearance at the door. Adjust closers so doors do not require more than 5 pounds of force to open.	1	Labor	\$0

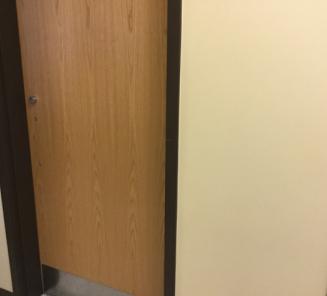
13	Women's Toilet Room	UL	111	Doors, Doorways, & Gates	Toilet Room

Door requires > 5 lbs. of force to open	15 lbs	Adjust closers so doors do not require more than 5 pounds of force to open.	1	Labor	\$0
14	Women's Toilet Room	LL	003	Doors, Doorways, & Gates	Toilet Room

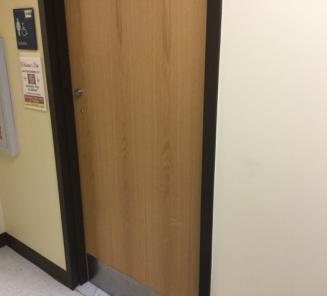
Door requires > 5 lbs. of force to open	18 lbs	Adjust closers so doors do not require more than 5 pounds of force to open.	1	Labor	\$0

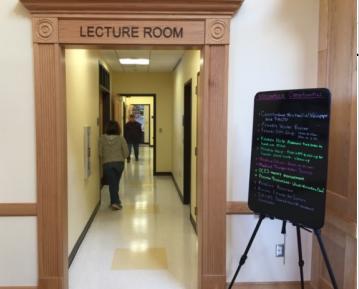
Raised characters not provided Braille not provided	-	Provide a sign with raised characters duplicated in braille. Locate sign alongside the door on the latch side.	1	116	\$116
Service Counter												
17	Lobby	UL		Service Counter	N/A

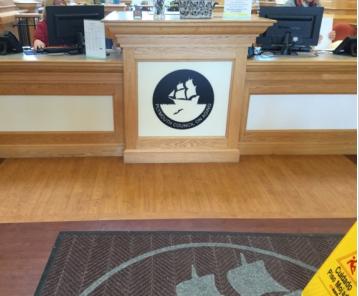
Accessible counter not maintain in operable working condition	-	Remove computer and other items from at least one of the accessible counters.	1	Labor	\$0
18	Lobby	UL		Service Counter	N/A

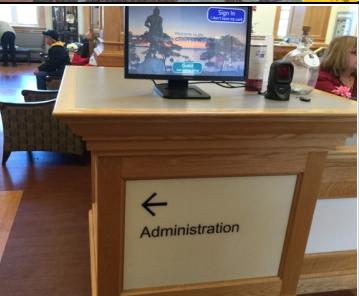
Counter > 36" high	42"	Provide a counter that is 36" max. above the ground or finish floor. Or locate computer on a table that is 34" max. above the floor.	1	Labor	\$0

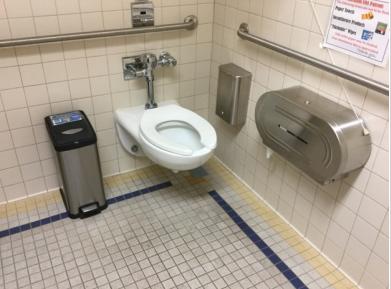
Clearance at toilet < 60" clear width	-	Relocate trash can to maintain the 60" min. clear floor space at the toilet.	1	Labor	\$0
20	Across From Health Room	UL		Single-User Toilet	N/A

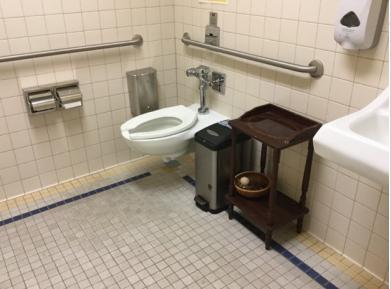
Clearance at toilet < 60" clear width	-	Relocate trash can and table to maintain the 60" min. clear floor space at the toilet.	1	Labor	\$0
21	Single-User Toilet Room	UL		Single-User Toilet	N/A

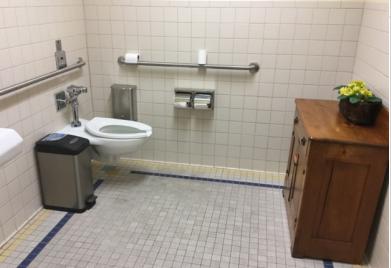
Clearance at toilet < 60" clear width Clearance at toilet < 72" clear depth	-	Relocate trash can and cabinet to maintain the 60" min. clear floor space at the toilet.	1	Labor	\$0
22	Single-User Toilet Room	UL		Single-User Toilet	N/A

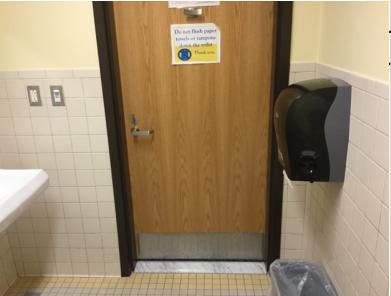
Hook located > 48" high Dispenser acts as a protruding object	63"	Locate hook no higher than 48" above the finish floor. Relocate dispenser so it does not protrude into the circulation path.	1	428	\$428

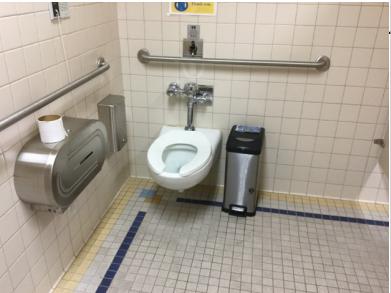
Toilet Compartment												
23	Women's Toilet Room	UL	111	Toilet Compartment	Accessible Compartment

Door has malfunctioning self-closing hinge	-	Repair hinge. Relocate trash can to maintain the 60" min. clear floor space at the toilet.	1	Labor	\$0

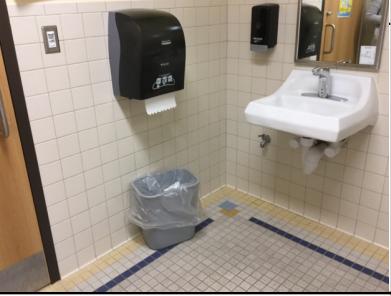
Dispenser acts as a protruding object	-	Relocate dispenser so it does not protrude into the circulation path.	1	353	\$353
26	Across From Health Room	UL		Dispensers	391

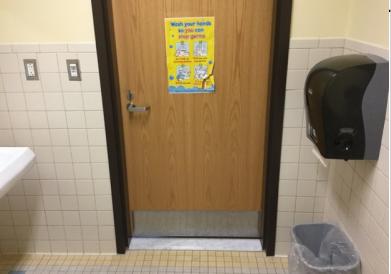
Dispenser acts as a protruding object		Relocate dispenser so it does not protrude into the circulation path.	1	353	\$353
27	Single-User Toilet Room	UL		Dispensers	Hand Dryer

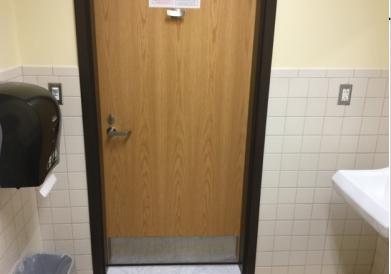
Dispenser acts as a protruding object	-	Relocate dispenser so it does not protrude into the circulation path.	1	353	\$353
Additional Access												
Drinking Fountains

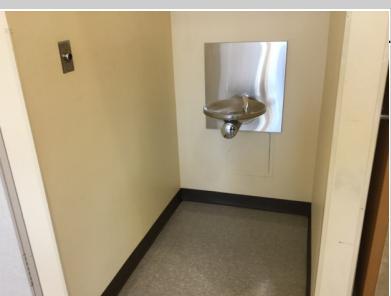
28	Function Hall	UL	105	Drinking Fountains	Low

No drinking fountain provided for standing users	-	Provide an additional drinking fountain for standing users or install a Hi-Lo drinking fountain.	1	2014	\$2014

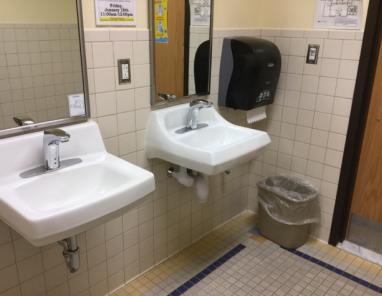
Plumbing underneath is exposed	-	Recommend Insulating pipes at both lavatories to prevent contact.	1	0	\$0

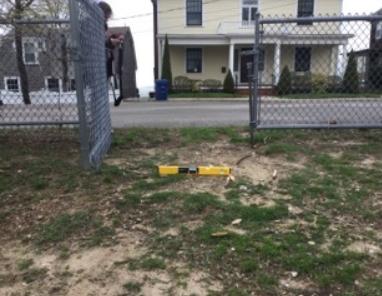
Cross slope > 1:50 (2.00%) (MAAB) Running slope > 1:20 (5.00%)	2.8 10.1	Reduce cross slope to be no steeper than 1:50 (2.00%). Reduce the running slope to be no steeper than 1:20 (5.00%).	1	50	\$50
2	Corner of Sever St. and Allerton St.	Ext		Exterior Access Route	Exterior

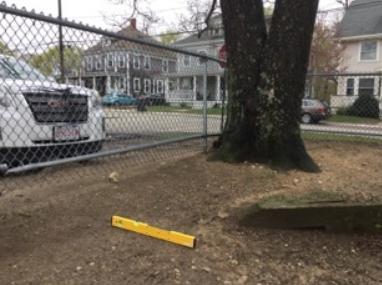
Running slope > 1:20 (5.00%) Accessible route not provided	12% 80'	Reduce the running slope to be no steeper than 1:20 (5.00%). Ensure an accessible route is provided.	1	911	\$911
3	Field	Ext		Exterior Access Route	Exterior

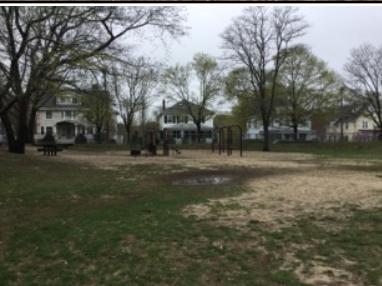
Accessible route not provided	355'	Ensure an accessible route is provided.	1	4044	\$4044
4	Sever St. Back Parking Lot	Ext		Exterior Access Route	Exterior

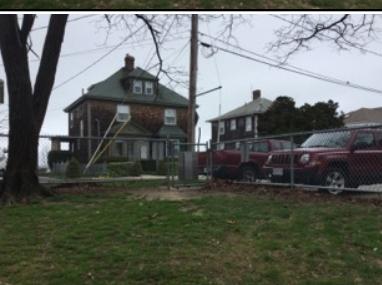
Accessible route not provided	355'	Ensure an accessible route is provided. (See ID number 3 for cost.)	1		\$0

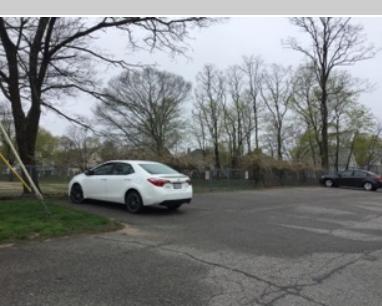
Off-Street Parking Lot or Garage												
5	Sever St. Back Parking Lot	Ext		Off-Street Parking Lot or Garage	Visitor

Total # of parking Total # of designated accessible parking spaces Total # of designated van accessible spaces Access aisle not provided Sign not provided	30 0 0 - -	Provide a van accessible parking space 132" wide min. and one car accessible space 96" wide min. with a marked access aisle that is at least 60" wide. Provide a sign with the International Symbol of Accessibility Add the designation "Van Accessible" to the sign located at the van accessible space.	2	925	\$1850

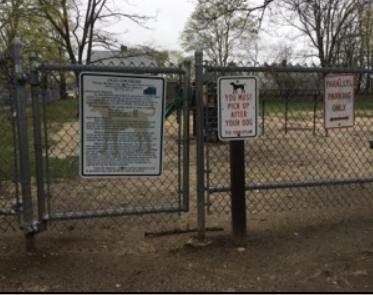
ID	Location	Floor	Room	Element	Type	Photo	Issues	Current Measure	Recommendations	Quantity	Price	Cost Estimation
Access to Goods and Services												
Doors, Doorways, & Gates												
6	Sever St. Parking Lot	Ext		Doors, Doorways, & Gates	Other

Hardware not operable with a closed fist		Provide hardware that can be operable with one hand and not require tight grasping, pinching, or twisting of the wrist. (Adjust gate latch to reduce required opening force.)	1	Labor	\$0
7	Sever St. Back Parking Lot	Ext		Doors, Doorways, & Gates	Other

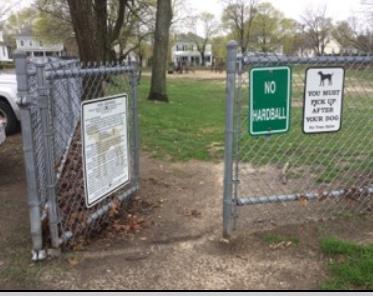
Hardware not operable with a closed fist		Provide hardware that can be operable with one hand and not require tight grasping, pinching, or twisting of the wrist. (Adjust gate latch to reduce required opening force.)	1	Labor	\$0
Picnic Tables												
8	Near Playground	Ext		Picnic Tables	N/A

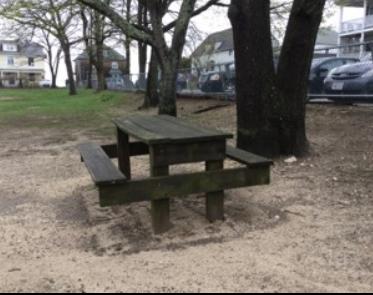
Number of seating spaces at picnic tables Number of accessible seating spaces Toe or knee clearance at table not provided Picnic table not on an accessible route	6 0 - -	Provide at least one picnic table with toe and knee clearance. Locate picnic table on an accessible route.	1	700	\$700

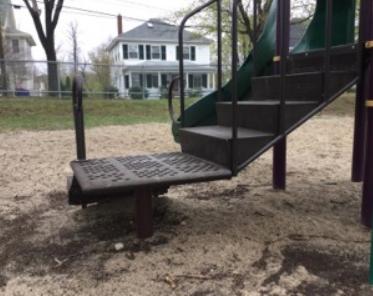
Play and Sport Areas												
Play Areas												
9	Playground	Ext		Play Areas	N/A

No compliant transfer system	22.5"	Alter height of transfer system to 18" max. aff.	1	Labor	\$0

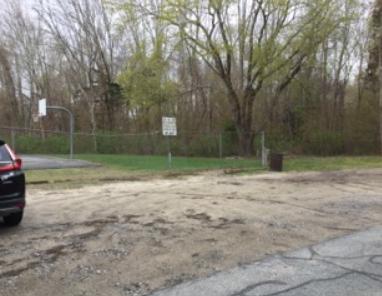
ID	Location	Floor	Room	Element	Type	Photo	Issues	Current Measure	Recommendations	Quantity	Price	Cost Estimation
Approach and Entrance												
Off-Street Parking Lot or Garage												
1	13 Brook Road	Ext		Off-Street Parking Lot or Garage	Visitor

Total # of parking Total # of designated accessible parking spaces Total # of designated van accessible spaces Access aisle not provided Sign not provided	10 0 0 - -	Provide an access aisle 96" wide min. Provide a sign with the International Symbol of Accessibility and the words "Van Accessible" with the bottom of the sign 60" min. above the ground and the top 96" max. above the ground.	1	400	\$400
Play and Sport Areas												
Play Areas												
2	Play Area Entrance	Ext		Play Areas	N/A

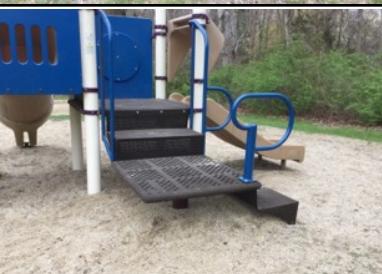
3	Play Area	Ext		Play Areas	N/A

Accessible route not provided to ground level play components	-	Ensure an accessible route is provided to one of each type of ground level play components. (Cost based on 250 square feet of poured in place rubber.)	1	3500	\$3500
4	Play Area Towards Swing Set and Slide	Ext		Play Areas	N/A

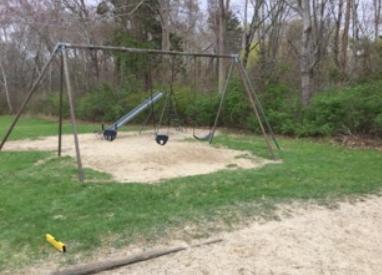
Accessible route not provided to ground level play components Surface not stable, firm, and slip-resistant	- -	Ensure an accessible route is provided to one of each type of ground level play components Repair surface. (Cost based on 115 square feet of poured in place rubber providing an accessible route to a swing, the slide and the use zone around the play components.)	1	1610	\$1610

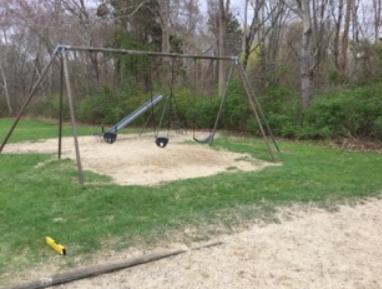
ID	Location	Floor	Room	Element	Type	Photo	Issues	Current Measure	Recommendations	Quantity	Price	Cost Estimation
5	Play Area Towards Swing Set and Slide	Ext		Play Areas	N/A

Running slope > 1:20 (5.00%) Accessible route not provided	17.2% 15'	Reduce the running slope to be no steeper than 1:20 (5.00%). Ensure an accessible route is provided. (Cost based on 36" wide min. 15' long stone dust path across grass with running slope of 5.00% (1:20) max. and cross slope of 2.00% (1:50) max.)	1	171	\$171
6	Behind Basketball Court	Ext		Play Areas	N/A

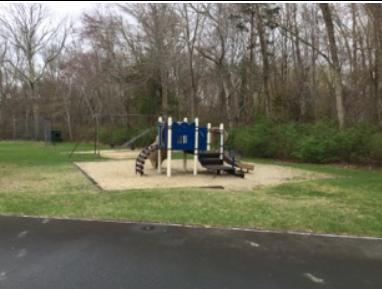
Accessible route not provided	30'	Ensure an accessible route is provided. (Cost based on 36" wide min. 30' long stone dust path across grass with running slope of 5.00% (1:20) max. and cross slope of 2.00% (1:50) max.)	1	342	\$342
Field												
7	Baseball Field	Ext		Field	Baseball

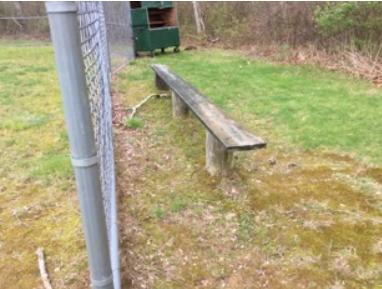
Accessible spaces are not provided at team seating	-	Provide a 36" x 48" clear floor space at team seating. (Cost for an asphalt patch by bench and adjoining accessible path to baseball field.)	2	52	\$104

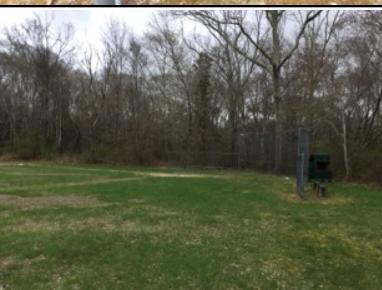
8	Baseball Field	Ext		Field	Baseball

Not connected to an accessible route	300'	Ensure baseball field is connected to an accessible route. (Cost based on 36" wide min. 300' long asphalt path across grass with running slope of 5.00% (1:20) max. and cross slope of 2.00% (1:50) max.)	1	3900	\$3900
Court												
9	Directly in Front of Parking Lot	Ext		Court	Basketball

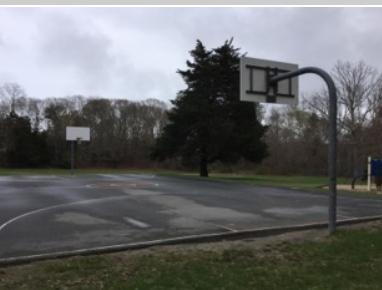
Not connected to accessible route	20'	Ensure basketball court is connected to an accessible route. (Cost based on 36" wide min. 20' long asphalt path from parking area to edge of sport activity (basketball court) with running slope of 5.00% (1:20) max. and cross slope of 2.00% (1:50) max.)	1	286	\$286

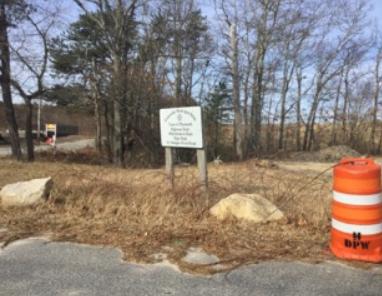
ID	Location	Floor	Room	Element	Type	Photo	Issues	Current Measure	Recommendations	Quantity	Price	Cost Estimation
Approach and Entrance												
Off-Street Parking Lot or Garage												
1	Parking Lot	Ext.		Off-Street Parking Lot or Garage	N/A

Total # of parking Total # of designated accessible parking spaces Access aisle not provided Sign not provided Sign does not have the designation "Van Accessible"	30 0 - - -	Provide a van accessible parking space 96" wide min. and a car accessible parking space. Provide a marked access aisle that is at least 96" wide for both spaces to share. Provide a sign with the International Symbol of Accessibility (ISA) with the bottom of the sign 60" min. and 96" max. above the ground. Add the designation "Van Accessible" to the sign at the van accessible space.	2	925	\$1850
Entrance												
2	Maintenance Entrance	Ext.		Entrance	Secondary Entrance

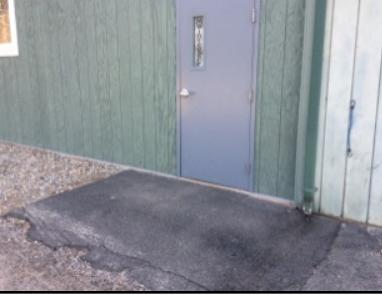
Directional sign to accessible entrance not provided	-	Provide a directional sign indicating the location of the nearest accessible entrance. (Provide a sign at the maintenance entrance indicating the location of the main entrance.)	1	173	\$173

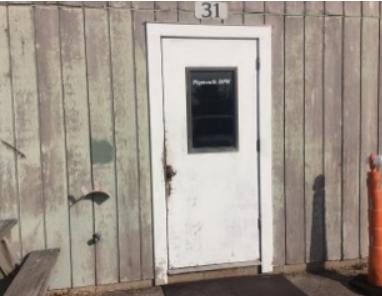
3	Main Entrance and Maintenance Entrance	Ext.		Entrance	Main Entrance

Threshold > 3/4" high	5"	Alter threshold to be 3/4" high max. (Cost based on 5' asphalt ramp at entrance.)	1	65	\$65
Access to Goods and Services												
Means of Egress												
4	Main Egress and Maintenance Egress	1		Means of Egress	N/A

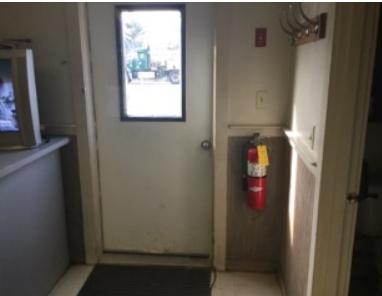
Tactile exit sign not provided	-	Ensure tactile exit signs with raised characters and braille are provided at exit doors. Mount signs between 48" - 60" above finished floor located on the latch side of the door.	2	116	\$232

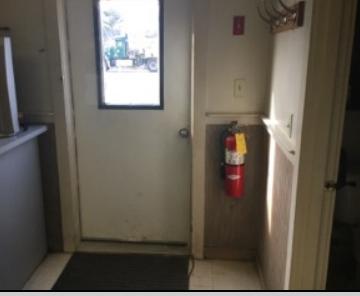
ID	Location	Floor	Room	Element	Type	Photo	Issues	Current Measure	Recommendations	Quantity	Price	Cost Estimation
Interior Access Route												
5	Main Entrance	1		Interior Access Route	N/A

Obstructed by protruding objects	-	Relocate coat hooks out of the circulation path.	1	128	\$128
Doors, Doorways, & Gates												
6	Main Entrance	1		Doors, Doorways, & Gates	N/A

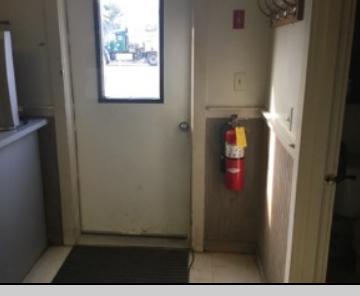
Hardware not operable with a closed fist	-	Provide hardware that can be operable with one hand and not require tight grasping, pinching, or twisting of the wrist.	1	242	\$242
Signage												
7	Toilet Room	1		Signage	Designation

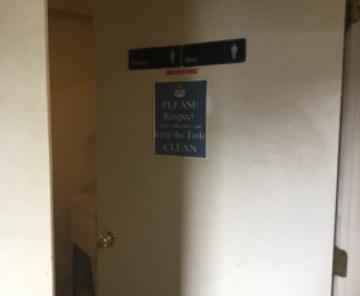
Raised characters not provided Braille not provided Sign not located on the latch side of the door International Symbol of Acc. not provided "All Gender" not provided.	- - - - -	Provide text with raised characters duplicated in braille. Locate sign at permanent rooms alongside the door on the latch side. Once toilet room is accessible, include the International Symbol of Accessibility (ISA) and the words "All Gender" on sign.	1	116	\$116

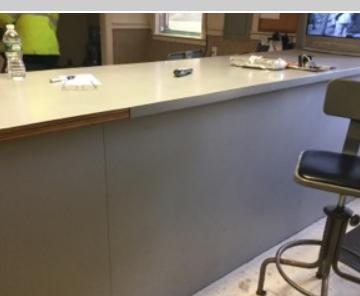
Service Counter												
8	Main Lobby	1		Service Counter	N/A

Counter > 36" high	40"	Provide a counter that is 36" max. above the ground or finished floor.	1	440	\$440

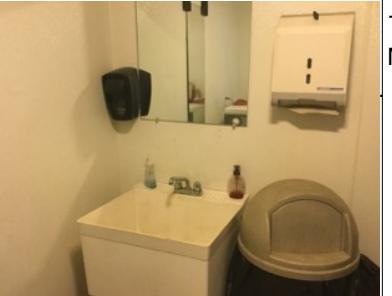
Toe or knee clearances not provided Mirror above lavatory w/reflective surface > 40" Dispensers not within reach range	20" 47" 52.5"	Provide at least one lavatory with knee and toe clearance positioned for a forward approach. Lower mirror so that the bottom surface is at 40" max. above finish floor. Relocate dispenser to 42" max. above the floor.	1	1324	\$1324
Single-User Toilet												
11	Toilet Room	1		Single-User Toilet	N/A

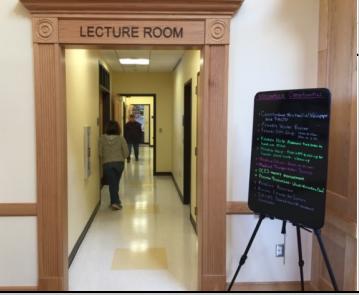
Raised characters not provided Braille not provided	-	Provide a sign with raised characters duplicated in braille. Locate sign alongside the door on the latch side.	1	116	\$116
Service Counter												
17	Lobby	UL		Service Counter	N/A

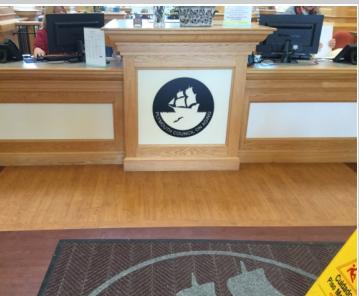
Accessible counter not maintain in operable working condition	-	Remove computer and other items from at least one of the accessible counters.	1	Labor	\$0
18	Lobby	UL		Service Counter	N/A

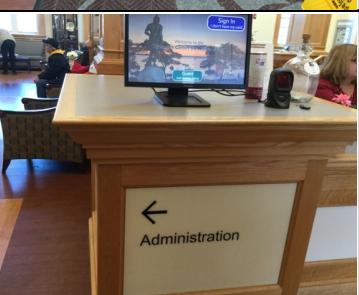
Counter > 36" high	42"	Provide a counter that is 36" max. above the ground or finish floor. Or locate computer on a table that is 34" max. above the floor.	1	Labor	\$0

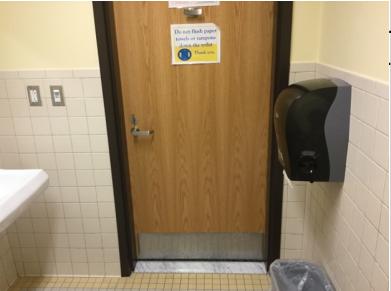
Hook located > 48" high Dispenser acts as a protruding object	63"	Locate hook no higher than 48" above the finish floor. Relocate dispenser so it does not protrude into the circulation path.	1	428	\$428

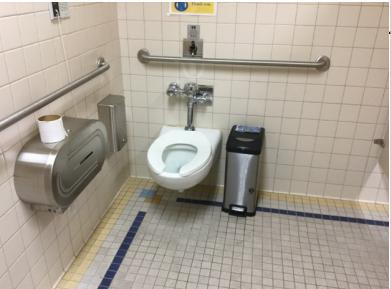
Toilet Compartment												
23	Women's Toilet Room	UL	111	Toilet Compartment	Accessible Compartment

Door has malfunctioning self-closing hinge	-	Repair hinge. Relocate trash can to maintain the 60" min. clear floor space at the toilet.	1	Labor	\$0

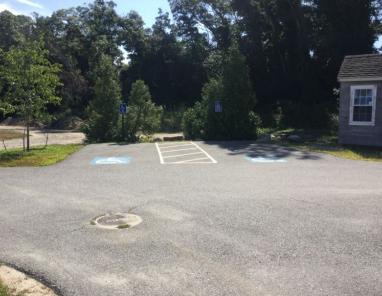
ID	Location	Floor	Room	Element	Type	Photo	Issues	Current Measure	Recommendations	Quantity	Price	Cost Estimation
Approach and Entrance												
Off-Street Parking Lot or Garage												
1	Parking Lot	Ext.		Off-Street Parking Lot or Garage	N/A

Total # of parking Total # of designated accessible parking spaces Total # of designated van accessible spaces Access aisle < 96" wide at van space Sign bottom < 60" above finished grade	10 2 1 60' 55.5"	Provide a marked access aisle that is at least 96" wide. Locate signs with the bottom of the signs 60" above the ground. (Cost based on restriping and 3' by 20' asphalt to allow for a wider access aisle.)	1	410	\$410
Entrance												
2	Emergency Exit Northwest Side	Ext.		Entrance	Secondary Entrance

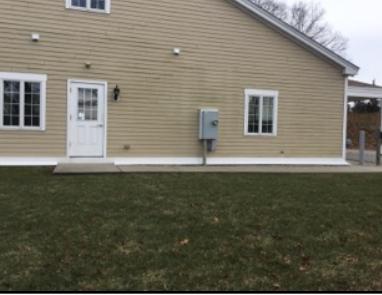
Directional sign to accessible entrance not provided	-	Provide a directional sign indicating the location of the nearest accessible entrance.	1	173	\$173

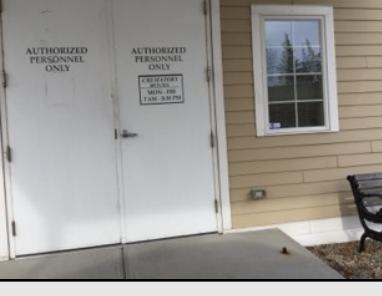
3	"Authorized Personnel" Door on South Side	Ext.		Entrance	N/A

Directional sign to accessible entrance not provided	-	Provide a directional sign indicating the location of the nearest accessible entrance.	1	173	\$173
Access to Goods and Services												
Means of Egress												
4	Northeast Side Entrance	1		Means of Egress	N/A

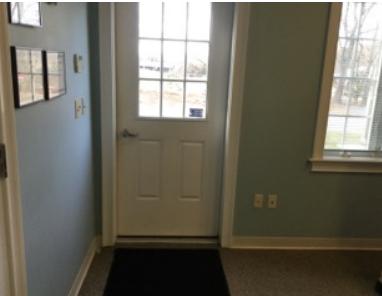
Tactile exit sign not provided Directional sign to accessible emergency exit not provided Mat not securely attached	-	Ensure tactile exit signs with raised characters and braille are provided at exit doors. Mount signs between 48" - 60" above finished floor located on the latch side of the door. Provide a directional sign indicating the location of the nearest emergency exit. Securely attach mat.	1	116	\$116

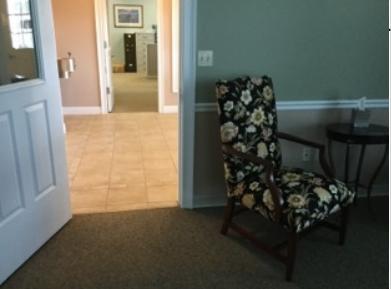
ID	Location	Floor	Room	Element	Type	Photo	Issues	Current Measure	Recommendations	Quantity	Price	Cost Estimation
Doors, Doorways, & Gates												
5	Family Room	1		Doors, Doorways, & Gates	Circulation

Maneuvering clearance(s) not provided	-	Relocate the chair to provide required maneuvering clearance.	1	Labor	\$0
6	Main Entrance	1		Doors, Doorways, & Gates	N/A

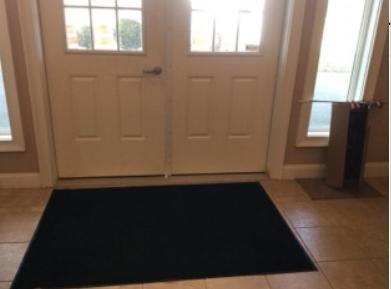
Mat not securely attached Tactile exit sign not provided	-	Securely attach mat. Ensure tactile exit signs with raised characters and braille are provided at exit doors. Mount signs between 48"- 60" above finished floor located on the latch side of the door.	1	116	\$116
Signage												
7	Single-User Toilet Rooms	1		Signage	Designation

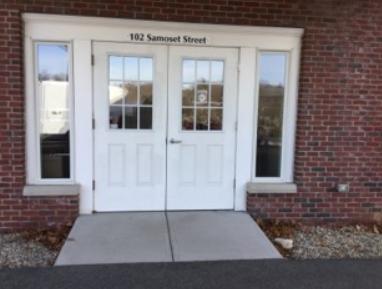
Level changes > 1/4"	6"	Recommend providing handrails on both sides of the main entrance to ensure safety of all visitors.	2	0	\$0

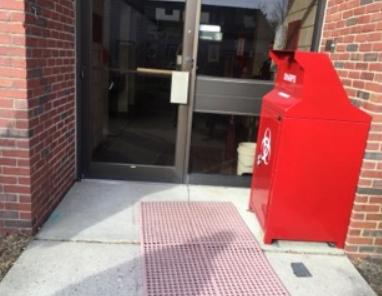
ID	Location	Floor	Room	Element	Type	Photo	Issues	Current Measure	Recommendations	Quantity	Price	Cost Estimation
Approach and Entrance												
Exterior Access Route												
1	Main Entrance	Ext.		Exterior Access Route	Walkway

Mat not securely attached	-	Securely attach mat.	1	Labor	\$0
Off-Street Parking Lot or Garage												
2	Parking Lot, Northeast	Ext.		Off-Street Parking Lot or Garage	Employee

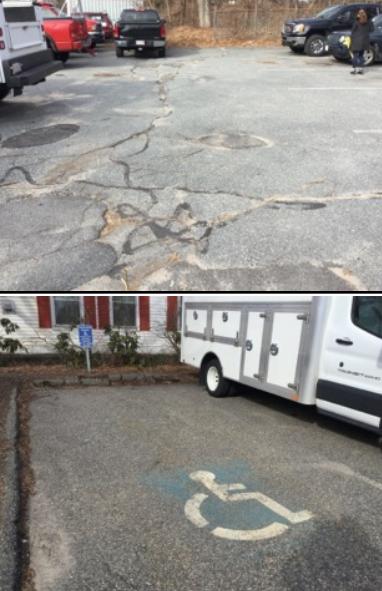
Total # of parking Total # of designated accessible parking spaces Total # of designated van accessible spaces	16 - -	Provide one van accessible space that is at least 96" side with a marked access aisle that is at least 96" wide. Provide a sign with the International symbol of Accessibility (ISA). Add the designation "Van Accessible" Locate sign 60" min. and 96" max. above the ground.	1	925	\$925
3	Parking Lot, Southwest	Ext.		Off-Street Parking Lot or Garage	Visitor

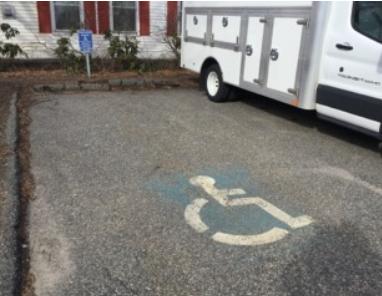
Access aisle not provided Sign does not have the designation "Van Accessible" Sign bottom < 60" above finished grade	- - 21"	Provide a van accessible parking space that is at least 96" wide with a marked access aisle that is at least 96" wide (re-stripe existing space.) Add the designation "Van Accessible" to the International Symbol of Accessibility (ISA) sign located at the van accessible space. Locate sign with the bottom of the sign 60" min. and 96" max. above the ground.	1	400	\$400

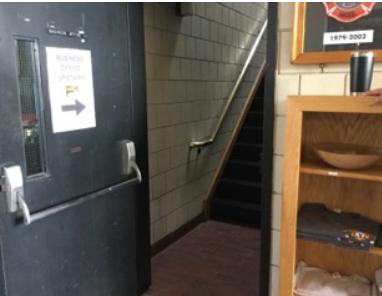
Access to Goods and Services												
Means of Egress												
4	Lobby	1		Means of Egress	N/A

Tactile exit sign not provided	-	Ensure tactile exit signs with raised characters and braille are provided at exit doors. Mount signs between 48" - 60" above finished floor located on the latch side of the door.	1	116	\$116

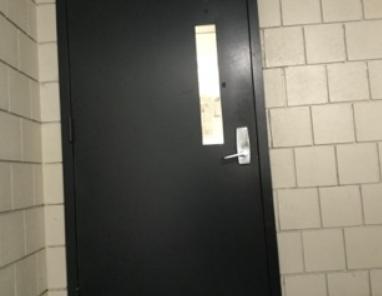
ID	Location	Floor	Room	Element	Type	Photo	Issues	Current Measure	Recommendations	Quantity	Price	Cost Estimation
5	In Stairway, to Offices	2		Means of Egress	N/A

Tactile exit sign not provided	-	Ensure tactile exit signs with raised characters and braille are provided at exit doors. Mount signs between 48"- 60" above finished floor located on the latch side of the door.	1	116	\$116
Interior Access Route												
6	Offices	2		Interior Access Route	N/A

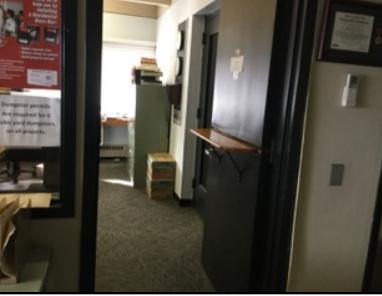
Obstructed by protruding objects	7.75"	Remove existing service counter. If a new service counter is provided, select a location where it does not protrude into the circulation path. Ensure any new service counter has a section that is at least 36" long and no more than 36" above the finished floor. (Cost based on removing current service counter and providing a new service counter in a different location.)	1	793	\$793
7	Fire Station #1	2		Interior Access Route	N/A

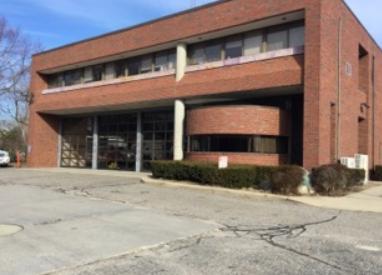
Interior vertical accessible route not provided	-	To provide program accessibility IHCD recommends moving any public programs or services provided on the second floor to an accessible location. (Alternately, an elevator may be installed to provide accessible vertical access.)	1	0	\$0

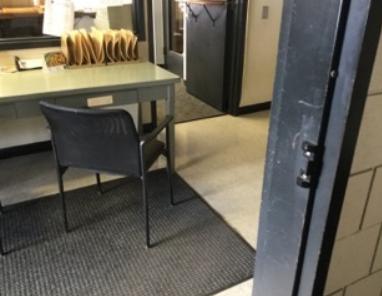
8	Hallway to Offices	2		Interior Access Route	N/A

Mat not securely attached	-	Securely attach mat.	1	Labor	\$0
Doors, Doorways, & Gates												
9	Main Entrance	1		Doors, Doorways, & Gates	N/A

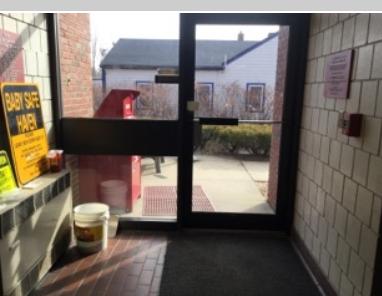
Mat not securely attached	-	Securely attach mat.	1	Labor	\$0

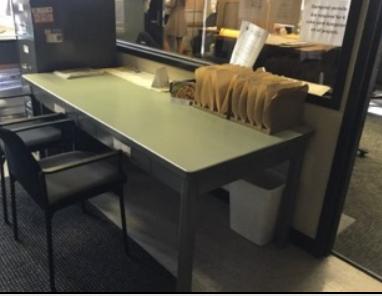
Knee or toe clearance not provided	23.5"	Provide at least 1 work surface with 27" min. knee and toe clearance.	1	350	\$350
Best Practice												
N/A												
12	Route to Main Entrance	Ext.		N/A	N/A

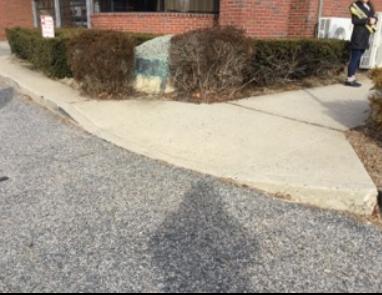
Recommend providing a detectable warning.	1	0	\$0
13	Stairway	1		N/A	N/A

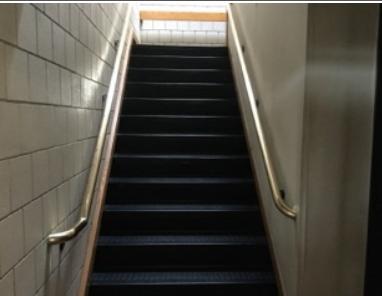
Recommend providing contrast on treads.	1	0	\$0

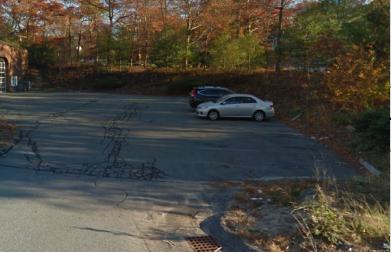
Total # of parking Total # of designated accessible parking spaces Total # of designated van accessible spaces Access aisle not provided Sign not provided	8 - - - -	Provide a van accessible parking space 96" wide min. with a marked access aisle that is at least 96" wide. Provide a sign with the International Symbol of Accessibility (ISA) and the words "Van Accessible". Mount the sign 60" min. above the ground and the top 96" max. above the ground.	1	925	\$925

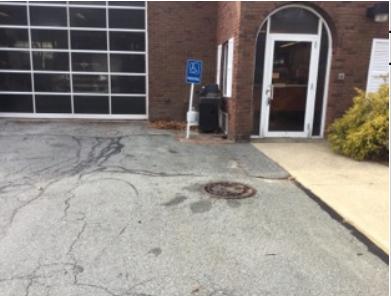
3	Parking Lot by Main Entrance	Ext.		Off-Street Parking Lot or Garage	Visitor

Access aisle not provided Sign does not have the designation "Van Accessible" Sign bottom < 60" above finished grade	- - 45"	Provide a van accessible parking space (in a location that does not block access to the main entrance) 96" wide min. with a marked access aisle that is at least 96" wide. Provide a sign with the International Symbol of Accessibility (ISA) and the words "Van Accessible". Mount the sign 60" min. above the ground and the top 96" max. above the ground.	1	925	\$925
Entrance												
4	Main Entrance, East Side	1		Entrance	Main Entrance

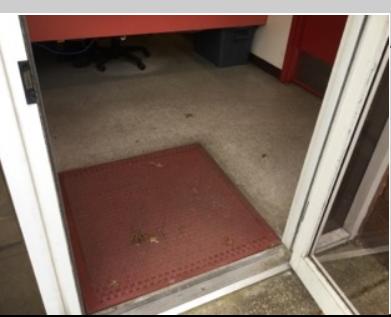
Mat not securely attached	-	Securely attach mat.	1	Labor	\$0
Access to Goods and Services

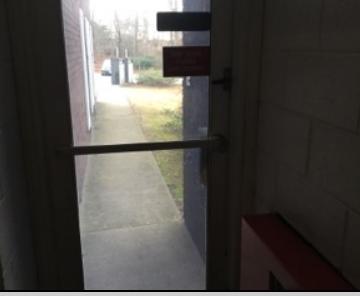
ID	Location	Floor	Room	Element	Type	Photo	Issues	Current Measure	Recommendations	Quantity	Price	Cost Estimation
Means of Egress												
5	Main Entrance East Side and Emergency Exit West Side	1		Means of Egress	N/A

Tactile exit sign not provided	-	Ensure tactile exit signs with raised characters and braille are provided at exit doors. Mount signs between 48"- 60" above finished floor located on the latch side of the door.	2	116	\$232
Doors, Doorways, & Gates												
6	Employee Lounge, Route to Toilet Room	1		Doors, Doorways, & Gates	Circulation

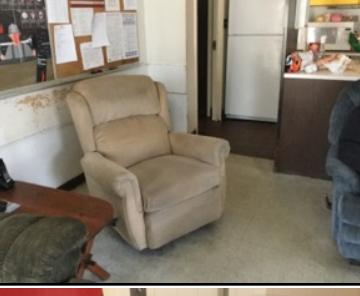
Maneuvering clearance(s) not provided	-	Relocate the chair to provide required minimum maneuvering clearance at door.	1	Labor	\$0
7	Toilet Room	1		Doors, Doorways, & Gates	Toilet Room

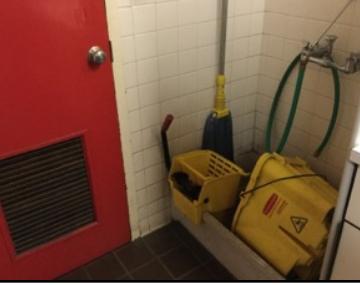
Maneuvering clearance(s) not provided	-	Remove the items blocking maneuvering clearance at the door.	1	Labor	\$0
8	Emergency Exit West Side	1		Doors, Doorways, & Gates	Emergency Egress

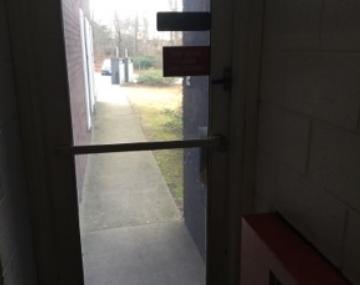
Maneuvering clearance(s) not provided	-	Provide an automatic door opener. (Lack of minimum required maneuvering clearance at door.) (Cost based on an automatic door opener.)	1	1530	\$1530

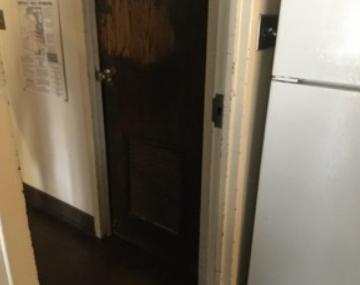
9	Toilet Room	1		Doors, Doorways, & Gates	Toilet Room

Hardware not operable with a closed fist	-	Provide hardware that can be operable with one hand and not require tight grasping, pinching, or twisting of the wrist. Ensure door hardware has a lock that can be operated from inside the toilet room so the toilet room can be made an "All Gender" toilet room with an accessible compartment.	1	242	\$242

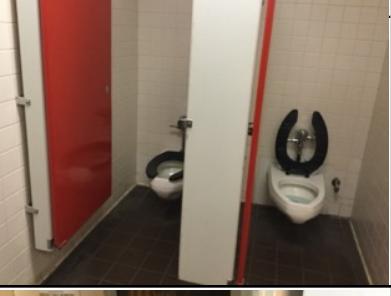
Accessible plumbing fixtures or stalls not provided	-	Provide one accessible wheelchair stall.	1	3091	\$3091
12	Toilet Room	1		Overall Access	Toilet Room

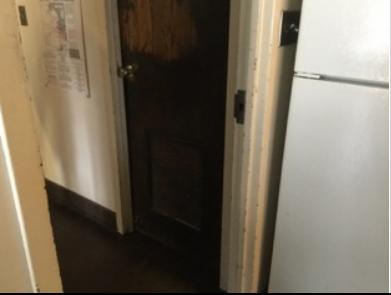
International Symbol of Acc. not provided	-	Provide an all gender toilet room sign with the International Symbol of Accessibility mounted on the latch side of the door. (Provide sign once an accessible compartment is provided in the multi-user toilet room.)	1	116	\$116
Lavatory												
13	Toilet Room	1		Lavatory	N/A

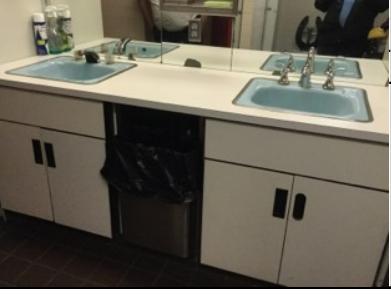
Toe or knee clearances not provided Lavatory rim or counter > 34" high Dispensers not within reach range	- 36" 52"	Provide at least one lavatory with knee and toe clearance positioned for a forward approach. Ensure the rim of the counter is no higher than 34". Relocate dispenser to 42" max. above the floor.	1	1196	\$1196

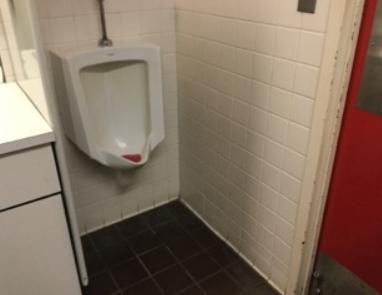
ID	Location	Floor	Room	Element	Type	Photo	Issues	Current Measure	Recommendations	Quantity	Price	Cost Estimation
Urinal												
14	Toilet Room	1		Urinal	N/A

Rim > 15" high (MAAB)	22"	Provide at least one urinal with the rim no higher than 15" above the finished floor.	1	1624	\$1624
Best Practice												
15	By Main Entrance, East Side	Ext.			N/A

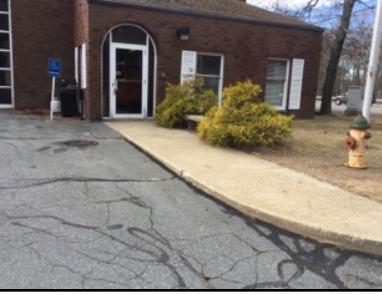
Lack of clear floor space of < 36" x 48" alongside bench.		Recommend that 20% of benches (and at least one (1)) have a clear floor space of 36" wide min. by 48" deep min. alongside bench positioned to allow shoulder alignment with someone seated on the bench. (Provide a concrete or asphalt patch.)	1	0	\$0

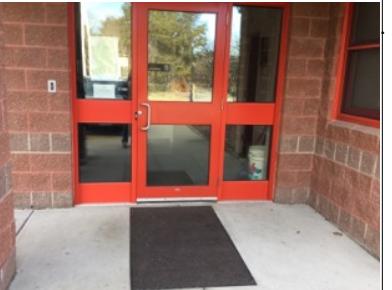
ID	Location	Floor	Room	Element	Type	Photo	Issues	Current Measure	Recommendations	Quantity	Price	Cost Estimation
Approach and Entrance												
Exterior Access Route												
1	Main Entrance	Ext.		Exterior Access Route	Exterior

Mat not securely attached	-	Securely attach mat.	1	Labor	\$0
Off-Street Parking Lot or Garage												
2	North Side Parking by Main Entrance	Ext.		Off-Street Parking Lot or Garage	Visitor

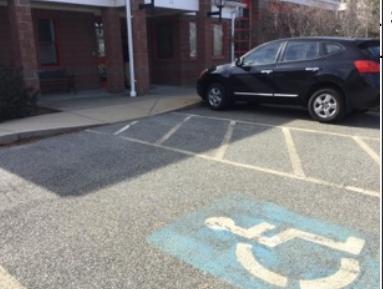
Sign not provided Sign does not have the designation "Van Accessible"	-	Provide a sign with the International Symbol of Accessibility (ISA) with the bottom of the sign 60" min. above the ground and the top 96" max. above the ground. Add the designation "Van Accessible" to the sign located at the van accessible space.	1	250	\$250
Access to Goods and Services												
Means of Egress												
3	Main Entrance and East Side Egress Door	Ext.		Means of Egress	N/A

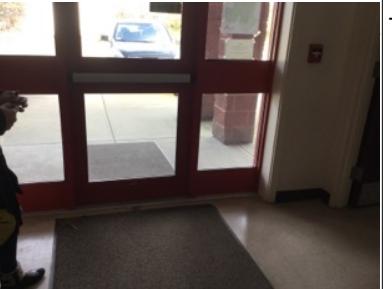
Tactile exit sign not provided	-	Ensure tactile exit signs with raised characters and braille are provided at exit doors. Mount signs between 48"- 60" above finished floor located on the latch side of the door.	2	116	\$232

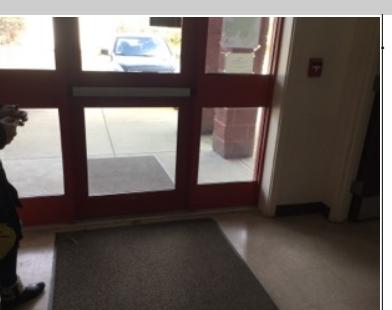
Interior Access Route												
4	Main Entrance	1		Interior Access Route	N/A

Mat not securely attached	-	Securely attach mat.	1	Labor	\$0

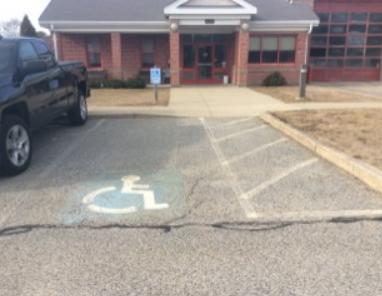
ID	Location	Floor	Room	Element	Type	Photo	Issues	Current Measure	Recommendations	Quantity	Price	Cost Estimation
Approach and Entrance												
Off-Street Parking Lot or Garage												
1	Parking Lot, Near Main Entrance			Off-Street Parking Lot or Garage	Visitor

Sign bottom < 60" above finished grade	24.75"	Locate sign with the bottom of the sign 60" above the ground.	1	Labor	\$0
Emergency Exit												
3	Apparatus Floor, North Side Exit	1		Emergency Exit	N/A

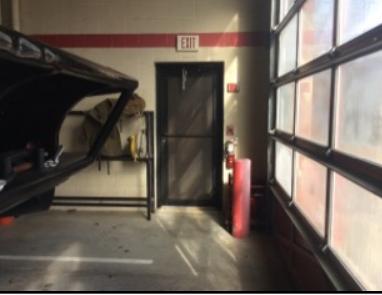
Tactile exit sign not provided	-	Ensure tactile exit signs with raised characters and braille are provided at exit doors. Mount signs between 48"- 60" above finished floor located on the latch side of the door.	1	116	\$116
2	Main Entrance	1		Emergency Exit	N/A

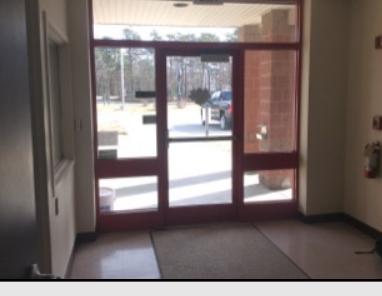
Tactile exit sign not provided Illuminated International Symbol of Acc. not provided	-	Ensure tactile exit signs with raised characters and braille are provided at exit doors. Mount signs between 48"- 60" above finished floor located on the latch side of the door. Provide the International Symbol of Accessibility (ISA) on the illuminated exit sign above the exit door.	1	216	\$216

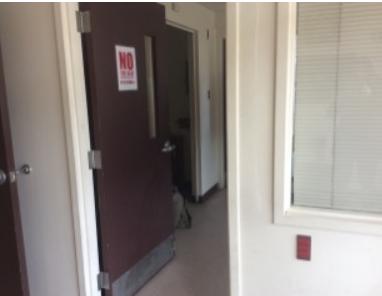
Access to Goods and Services												
Signage												
4	Call Center	1		Signage	Designation

Not provided	-	Locate sign alongside the door on the latch side.	1	116	\$116

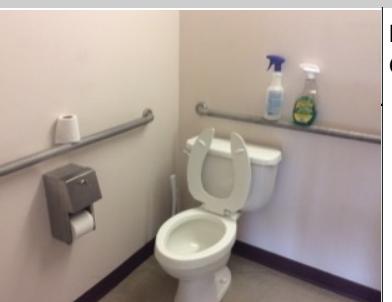
Flush control not on open side Grab bar not provided Hook located > 48" high	- - 67"	Relocate the flush control to the open side. Ensure clutter is clear of the grab bar to ensure ease of use by all. Locate hook no higher than 48" above the finished floor.	1	262	\$262

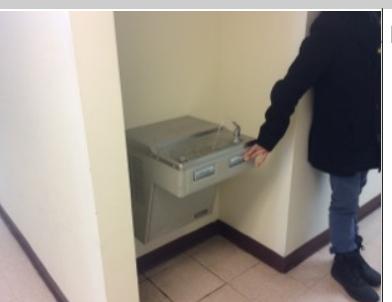
Additional Access												
Drinking Fountains												
8	Fountain In Main Hall	1		Drinking Fountains	Low

No drinking fountain provided for standing users	-	Provide an additional drinking fountain for standing users.	1	2014	\$2014

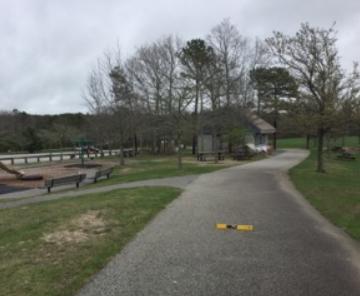
ID	Location	Floor	Room	Element	Type	Photo	Issues	Current Measure	Recommendations	Quantity	Price	Cost Estimation
Approach and Entrance												
Exterior Access Route												
1	Pathway Between Playground and Football Field	Ext.		Exterior Access Route	Walkway

Cross slope > 1:50 (2.00%) (MAAB)	3.8%	Reduce cross slope to be no steeper than 1:50 (2.00%). (Cost based on 36" wide min. 115' long of concrete to correct path cross slope to 2.00% (1:50) max.)	1	1725	\$1725
2	Pathway to Soccer Fields From Soccer Parking Area	Ext.		Exterior Access Route	Walkway

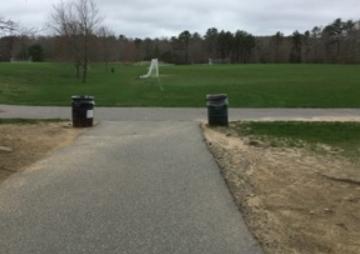
Cross slope > 1:50 (2.00%) (MAAB) Running slope > 1:20 (5.00%)	4.7% 7.1%	Reduce cross slope to be no steeper than 1:50 (2.00%). Reduce the running slope to be no steeper than 1:20 (5.00%). (Cost based on 36" wide min. 253' long of concrete to correct path cross slope to 2.00% (1:50) max. and running slope to 5.00% (1:20) max.)	1	3795	\$3795

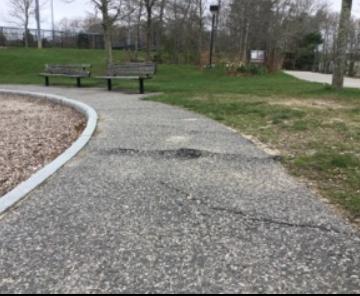
3	Playground	Ext.		Exterior Access Route	Walkway

Not maintained in an operable working condition		Ensure the accessible route is maintained in operable working condition. (Cost based on 3'x3' concrete patch to repair surface.)	1	103	\$103
4	Pathway to Softball Field (West) From Main Parking Area	Ext.		Exterior Access Route	Walkway

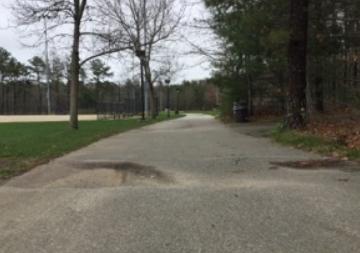
Not maintained in an operable working condition		Ensure the accessible route is maintained in operable working condition. (Cost based on 3'x3' concrete patch to repair surface.)	1	103	\$103
5	Pathway to Senior Baseball Field (West) From Soccer Fields	Ext.		Exterior Access Route	Walkway

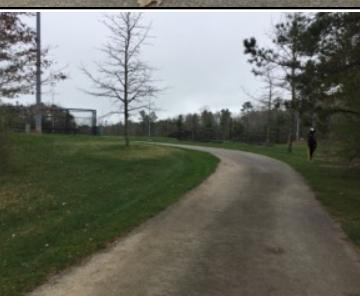
Running slope > 1:20 (5.00%)	7.6%	Reduce the running slope to be no steeper than 1:20 (5.00%). (Cost based on 36" wide min. 42' long of concrete to correct path running slope to 5.00% (1:20) max.)	1	630	\$630

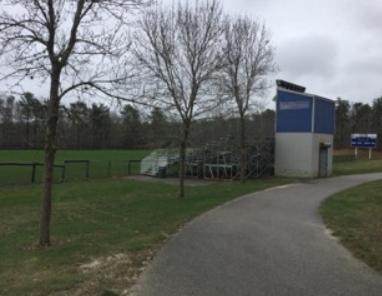
ID	Location	Floor	Room	Element	Type	Photo	Issues	Current Measure	Recommendations	Quantity	Price	Cost Estimation
6	Football Field	Ext.		Exterior Access Route	Walkway

Running slope > 1:20 (5.00%)	6%	Reduce the running slope to be no steeper than 1:20 (5.00%). (Cost based on 36" wide min. 90' long of concrete to correct path running slope to 5.00% (1:20) max.)	1	1350	\$1350
Off-Street Parking Lot or Garage												
7	Main Parking Area	Ext.		Off-Street Parking Lot or Garage

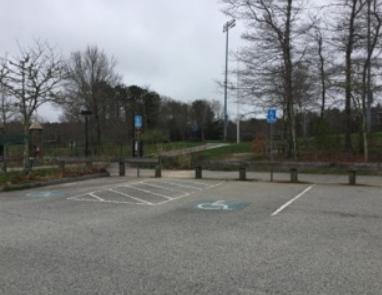
Total # of parking Total # of designated accessible parking spaces Total # of designated van accessible spaces Vehicle space < 132" wide at van space Sign does not have the designation "Van Accessible"	200 10 0 108" -	Provide two (2) van accessible parking spaces. Ensure van accessible spaces are at least 132" wide. Add the designation "Van Accessible" to the signs located at the van accessible spaces. (Cost based on repainting stripes and adding "Van Accessible" designation to two (2) signs.)	1	800	\$800

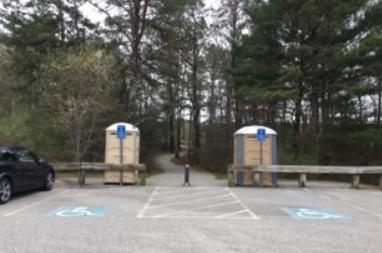
8	Soccer Parking Area	Ext.		Off-Street Parking Lot or Garage	Visitor

Total # of parking Total # of designated accessible parking spaces Total # of designated van accessible spaces	82 2	Provide two (2) additional accessible spaces. Provide a van accessible space that is at least 132" wide and has an adjoining access aisle at least 60" wide. Provide a sign at each accessible space with the bottom of the sign 60" min. above the ground and the top 96" max. above the ground. Add the designation "Van Accessible" to the sign located at the van accessible space.	2	925	\$1850
9	Baseball Parking Area	Ext.		Off-Street Parking Lot or Garage	Visitor

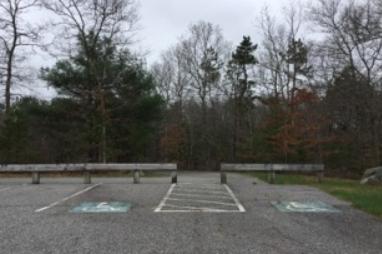
Total # of parking Total # of designated accessible parking spaces Sign not provided Total # of designated van accessible spaces	324 8 0	Provide a van accessible space for every six accessible parking spaces. Provide a sign with the bottom of the sign 60" min. above the ground and the top 96" max. above the ground. Add the designation "Van Accessible" to the sign located at the van accessible space. (Cost based on repainting stripes and providing	1	2150	\$2150

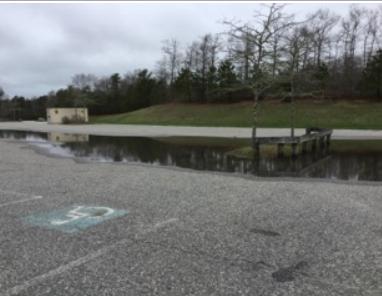
10	Baseball Parking Area	Ext.		Off-Street Parking Lot or Garage	Visitor

Does not prevent accumulation of water		Repair surface.	1		\$0

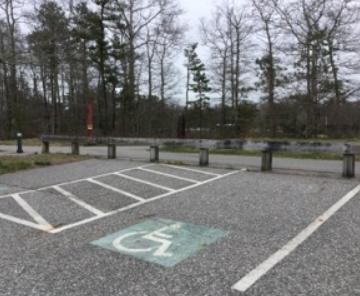
ID	Location	Floor	Room	Element	Type	Photo	Issues	Current Measure	Recommendations	Quantity	Price	Cost Estimation
11	Baseball Parking Area	Ext.		Off-Street Parking Lot or Garage	Visitor

Access aisle does not adjoin an accessible route		Remove barrier to ensure access aisle adjoins to the accessible route.	1	Labor	\$0
Access to Goods and Services												
Service Counter												
12	Concessions Near Playground	Ext.		Service Counter

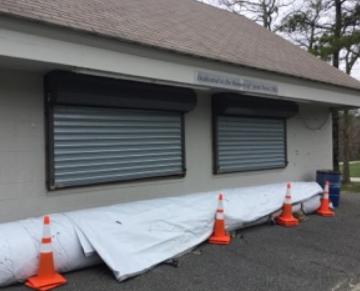
Counter > 36" high	38"	Provide a counter that is 36" max. above the ground.	1	440	\$440
13	Concessions Near Playground	Ext.		Service Counter	N/A

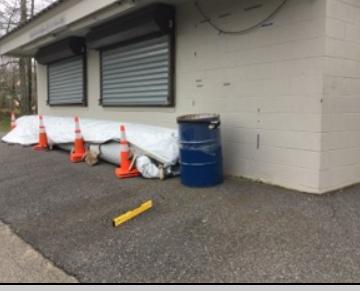
Running slope > 1:20 (5.00%)	11.8%	Reduce the running slope to be no steeper than 1:20 (5.00%). (Cost based on 36" wide min. 10' long of concrete to correct path running slope to 5.00% (1:20) max.)	1	150	\$150
Picnic Tables												
14	Playground	Ext.		Picnic Tables

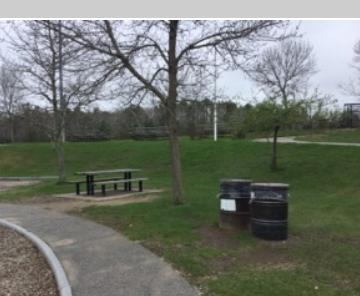
Toe or knee clearance at table not provided Picnic table not on an accessible route		Provide at least one picnic table with toe and knee clearance. Locate picnic table on an accessible route. (Cost based on one accessible picnic table and a new 36" wide min. 4' long concrete path.)	1	796	\$796

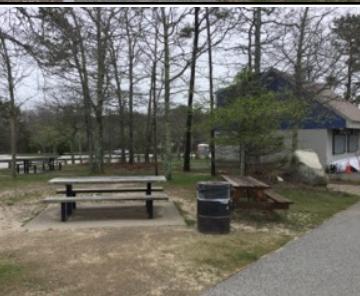
15	Concessions Near Playground	Ext.		Picnic Tables	N/A

Toe or knee clearance at table not provided Picnic table not on an accessible route		Provide at least one picnic table with toe and knee clearance. Locate picnic table on an accessible route. (Cost based on one accessible picnic table and a new 36" wide min. 10' long concrete path.)	1	930	\$930

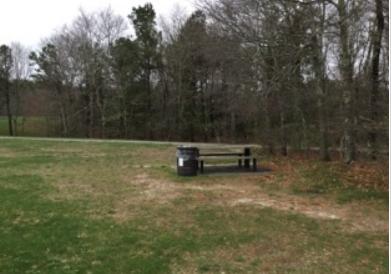
Toe or knee clearance at table not provided Picnic table not on an accessible route		Provide at least one picnic table with toe and knee clearance. Locate picnic table on an accessible route. (Cost based on one accessible picnic table and a new 36" wide min. 12' long concrete path.)	1	976	\$976
18	Soccer Fields	Ext.		Picnic Tables

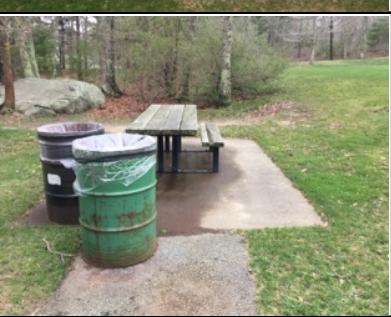
Trash cans block accessible route to picnic table		Remove trash cans to ensure 36" width min. for accessible route to picnic table.	1	Labor	\$0

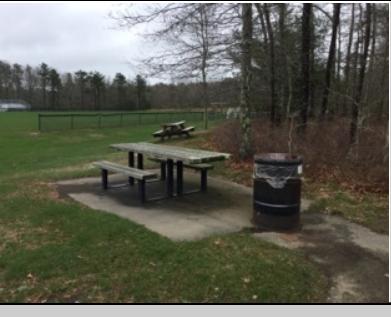
19	Pathway to Football Field From Senior Baseball Field (West)	Ext.		Picnic Tables

Trash cans block accessible route to picnic table		Remove trash cans to ensure 36" width min. for accessible route to picnic table.	1	Labor	\$0
Benches												
20	Baseball Park Pathway	Ext.		Benches	N/A

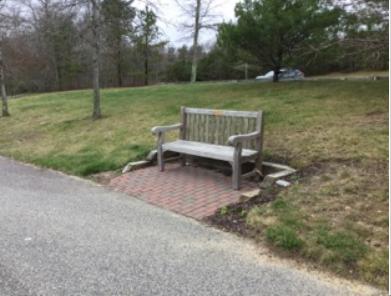
20% of benches have clear space < 36" x 48" Shoulder alignment not provided at bench - (12") back		Ensure that 20% of benches have a clear floor space of 36" wide min. by 48" deep min. Provide shoulder alignment with the adjacent wheelchair space. The shoulder alignment of the wheelchair space shall be measured 36" from the front of the wheelchair space. (Cost based on 3' wide x 4' concrete patch.)	1	92	\$92
