Town of Plymouth

Part A – Executive Summary

October 2019

Prepared by the
**Institute for
Human
Centered
Design**

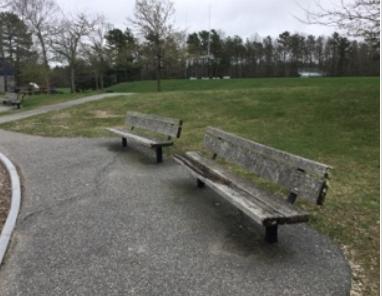
ID	Location	Floor	Room	Element	Type	Photo	Issues	Current Measure	Recommendations	Quantity	Price	Cost Estimation
21	Playground	Ext.		Benches

Shoulder alignment not provided at bench - (12" back Surface not maintained in operable condition		Provide shoulder alignment with the adjacent wheelchair space. The shoulder alignment of the wheelchair space shall be measured 36" from the front of the wheelchair space. Repair bench seat surface. (Cost based on 3' x 4' concrete patch.)	1	92	\$92
Toilet & Bathing Rooms												
Portable Toilet												
22	Main Parking by Picnic Pavilion	Ext.		Portable Toilet	N/A

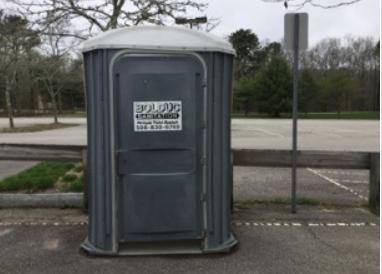
Non-compliant toilet paper dispenser	50"	Relocate toilet paper dispenser so that it is between 15"- 48" above the floor and between 7"- 9" in front of the toilet. Ensure dispensers and other devices are not mounted above grab bars.	1	353	\$353
23	Baseball Parking Area	Ext.		Portable Toilet	N/A

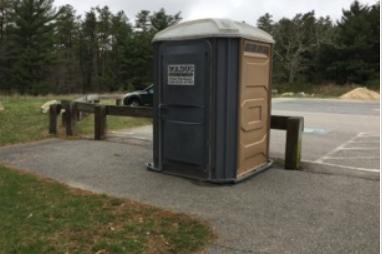
24	Soccer Parking Area	Ext		Portable Toilet	N/A

Non-compliant toilet paper dispenser	50"	Relocate toilet paper dispenser so that it is between 15"- 48" above the floor and between 7"- 9" in front of the toilet. Ensure dispensers and other devices are not mounted above grab bars.	1	353	\$353
Play and Sport Areas

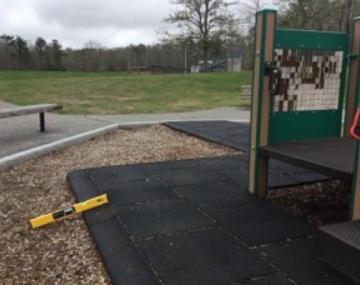
ID	Location	Floor	Room	Element	Type	Photo	Issues	Current Measure	Recommendations	Quantity	Price	Cost Estimation
Play Areas												
25	Playground	Ext.		Play Areas	N/A

Accessible route < 60" wide at ground level	49"	At ground level, ensure the clear width of accessible routes is 60" minimum. (Cost based on adding 12" wide 15' long rubber mats interlocking over concrete.)	1	85	\$85
26	Playground	Ext.		Play Areas	N/A

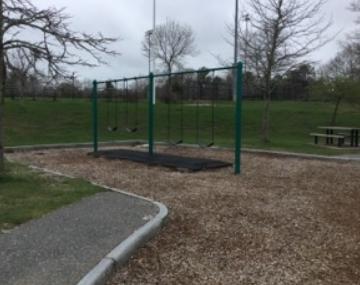
Accessible route not provided to ground level play components	14'	Provide an accessible impact-attenuating surface to and around the play components. NB: Engineered wood chips are allowed but must be inspected and maintained regularly to ensure continued compliance with the ASTM F 1951 standard. The type of surface material selected & play area use levels will determine the frequency of inspection and maintenance	1	396	\$396
27	Playground	Ext.		Play Areas

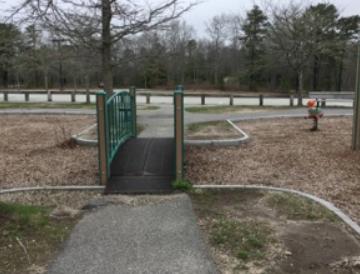
Accessible route not provided to ground level play components		Ensure an accessible route is provided to one of each type of ground level play components. NB: The running slope of the bridge is not compliant. In order to create an accessible route, consider providing a flat path adjacent to the bridge. (Cost based on 36" wide min. 12' long rubber	1	204	\$204

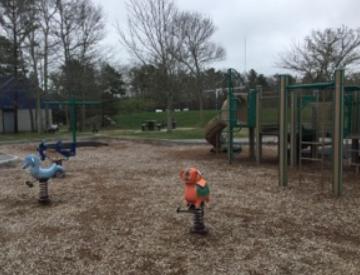
28	Playground	Ext.		Play Areas

Accessible route not provided to ground level play components		Provide an accessible impact-attenuating surface to and around the play components. NB: Engineered wood chips are allowed but must be inspected and maintained regularly to ensure continued compliance with the ASTM F 1951 standard. The type of surface material selected & play area use levels will determine the frequency of inspection and maintenance	1	226	\$226
29	Playground	Ext.		Play Areas	N/A

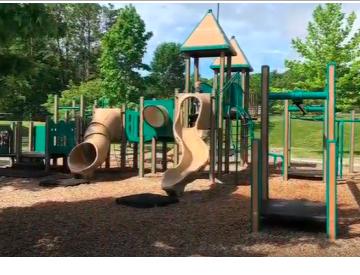
Accessible route not provided to ground level play components		Provide an accessible impact-attenuating surface to and around the play components. NB: Engineered wood chips are allowed but must be inspected and maintained regularly to ensure continued compliance with the ASTM F 1951 standard. The type of surface material selected & play area use levels will determine the frequency of inspection and maintenance	1	1700	\$1700

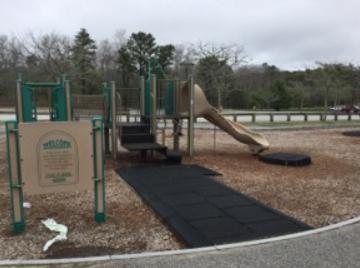
ID	Location	Floor	Room	Element	Type	Photo	Issues	Current Measure	Recommendations	Quantity	Price	Cost Estimation
30	Playground - Younger Children	Ext.		Play Areas	N/A

Surface not stable, firm, and slip-resistant	7'	Provide an accessible impact-attenuating surface to and around the play components. NB: Engineered wood chips are allowed but must be inspected and maintained regularly to ensure continued compliance with the ASTM F 1951 standard. The type of surface material selected & play area use levels will determine the frequency of inspection and maintenance	1	200	\$200
31	Playground	Ext.		Play Areas	N/A

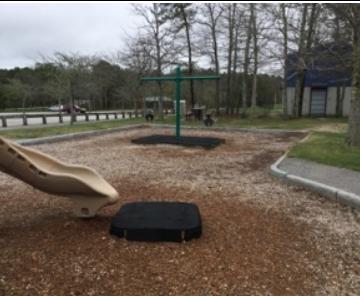
Surface not stable, firm, and slip-resistant		Provide an accessible impact-attenuating surface to and around the play components. NB: Engineered wood chips are allowed but must be inspected and maintained regularly to ensure continued compliance with the ASTM F 1951 standard. The type of surface material selected & play area use levels will determine the frequency of inspection and maintenance	1	1190	\$1190

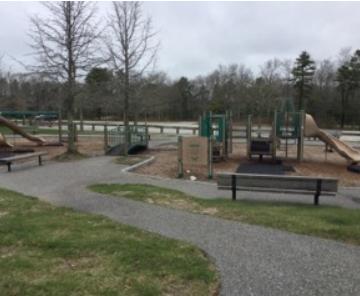
32	Playground	Ext.		Play Areas	N/A

Running slope > 1:20 (5.00%)	7.1%	Reduce the running slope to be no steeper than 1:20 (5.00%). (Cost based on 36" wide min. 32' long of concrete to correct path running slope to 5.00% (1:20) max.)	1	480	\$480
Field												
33	Little League Field 1 (East)	Ext.		Field	Baseball

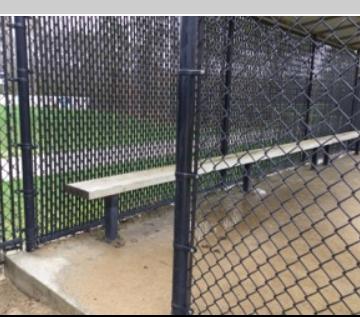
Accessible spaces are not provided at team seating		Remove a section of the existing bench to provide a 36" x 48" clear floor space at team seating. (Cost based on removing a bolted item.)	6	128	\$768
34	Youth Softball Field 2 (East)	Ext.		Field	Baseball

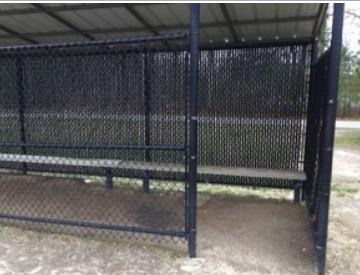
Accessible spaces are not provided at team seating		Remove a section of the existing bench to provide a 36" x 48" clear floor space at team seating. (Cost based on removing a bolted item and providing a 36" x 48" asphalt patch.)	2	180	\$360

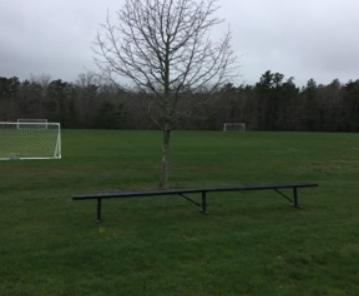
Accessible spaces are not provided at team seating Not connected to an accessible-route	352'	Provide a 36" x 48" clear floor space at team seating. Ensure soccer field team seating is connected to an accessible route. (Cost based on 36" x 48" stone dust patch at three (3) benches and a 36" wide min. 352' long stone dust path.)	1	4144	\$4144
36	Football Field	Ext.		Field	Football

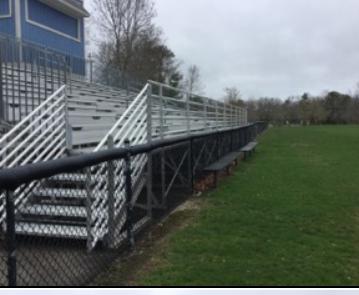
Accessible spaces are not provided at team seating Not connected to an accessible-route		Provide a 36" x 48" clear floor space at team seating. Ensure football team seating is connected to an accessible route. (Cost based on 36" x 48" stone dust patch at two (2) benches (one for home team and one for visitor team) and a 36" wide min. 55' long stone dust path.)	1	716	\$716

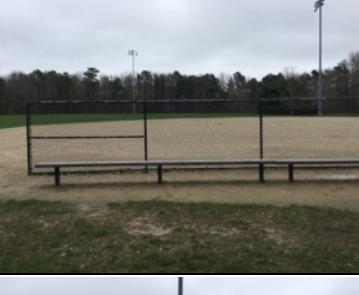
37	Softball Field (West)	Ext.		Field	Softball

Accessible spaces are not provided at team seating Not connected to an accessible-route	21'	Provide a 36" x 48" clear floor space at team seating. Ensure softball team seating is connected to an accessible route. (Cost based on 36" x 48" concrete patch and a 36" wide min. 21' long concrete path from the accessible route to team seating.)	2	575	\$1150
38	Senior Baseball Field (West)	Ext.		Field	Baseball

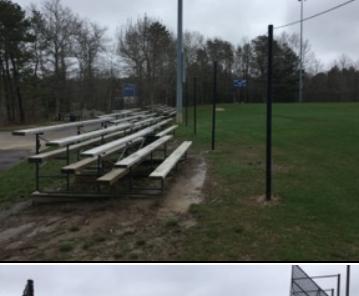
Accessible spaces not provided at sidelines seating Not connected to an accessible-route	17'	Provide a 36" x 48" clear floor space at sidelines seating. Ensure baseball field sideline seating is connected to an accessible route. (Cost based on 36" x 48" concrete patch and a 36" wide min. 17' long concrete path from the accessible route to team seating.)	1	347	\$347
39	Little League Field 1 (East)	Ext.		Field	Baseball

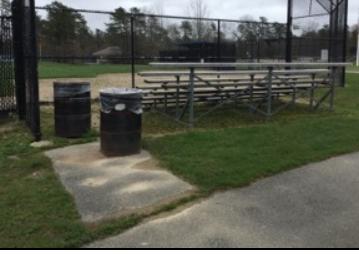
Accessible spaces not provided at sidelines seating Not connected to an accessible-route		Provide a 36" x 48" clear floor space at sidelines seating. Ensure baseball field sideline seating is connected to an accessible route. (Cost based on 36" x 48" concrete patch and 36" wide min. 10' long concrete path.)	2	322	\$644

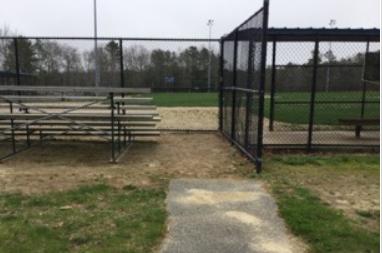
Not connected to an accessible-route		Ensure baseball field sideline seating is connected to an accessible route. (Cost based on 36" wide min. 12' long concrete path with running slope of 5.00% (1:20) max. and a cross slope of 2.00% (1:50) max.)	1	276	\$276
41	Senior Baseball Field (West)	Ext.		Field	Baseball

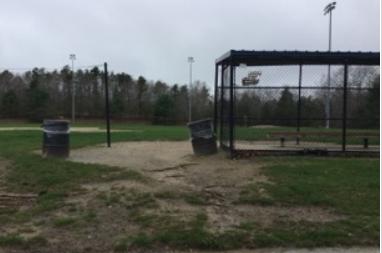
Not connected to an accessible-route		Ensure baseball field and team seating is connected to an accessible route. (Cost based on 36" wide min. 21' long concrete path with running slope of 5.00% (1:20) max. and a cross slope of 2.00% (1:50) max.)	2	483	\$966
42	Football Field	Ext.		Field	Football

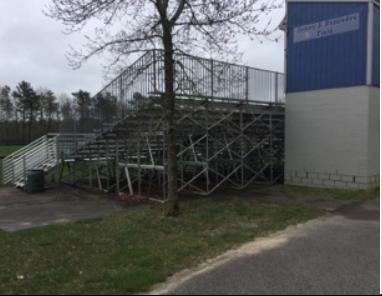
Not connected to an accessible-route		Ensure football field sideline seating is connected to an accessible route. (Cost based on 36" wide min. 17' long concrete path with running slope of 5.00% (1:20) max. and cross slope of 2.00% (1:50) max.)	1	391	\$391

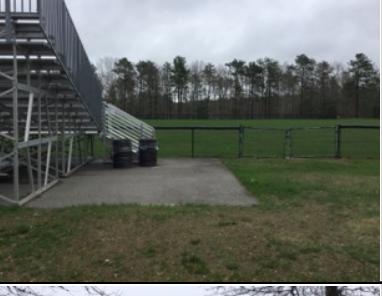
43	Football Field	Ext.		Field	Football

Not connected to an accessible-route		Ensure football field is connected to an accessible route. (Cost based on 36" wide min. 46' long concrete path with running slope of 5.00% (1:20) max. and cross slope of 2.00% (1:50) max.)	1	1058	\$1058
44	Visitor Section for Football Field	Ext.		Field	Football

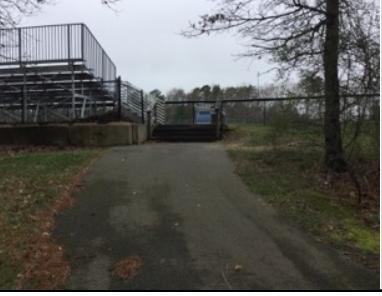
Not connected to an accessible-route	214'	Ensure visitor team sideline seating is connected to an accessible route. IHCD proposes providing a route from the concessions to the north side of the seating area. This will avoid running slope issues that are present at the current route. (Cost based on a 36" wide min. 214' long concrete path with a running slope of 5.00% (1:20) max. and a cross slope of 2.00% (1:50))	1	4922	\$4922

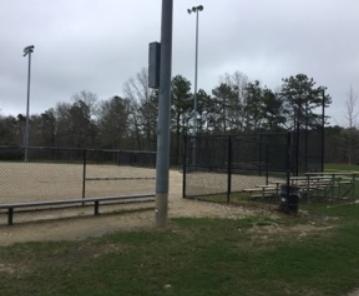
Not connected to an accessible-route		Ensure softball field is connected to an accessible route. (Cost based on 36" wide min. 25' long concrete path with running slope of 5.00% (1:20) max. and cross slope of 2.00% (1:50) max.)	1	575	\$575
46	Multi-Purpose Field	Ext.		Field	Football

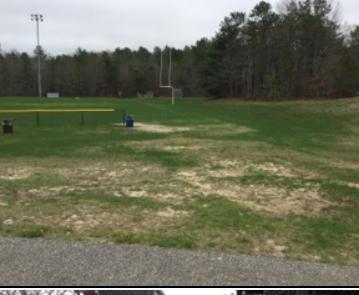
Not connected to an accessible-route		Ensure multi purpose field is connected to an accessible route. (Cost based on 36" wide min. 90' long concrete path with running slope of 5.00% (1:20) max. and cross slope of 2.00% (1:50) max.)	1	2070	\$2070
47	Youth Softball Field 1 (East)	Ext.		Field	Baseball

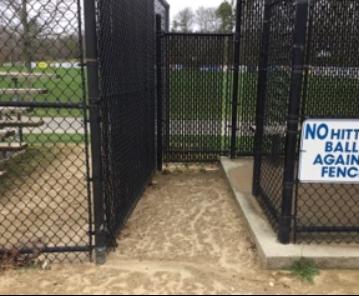
Not connected to an accessible-route	4"	Ensure baseball team seating is connected to an accessible route and that level change is 1/4" high max. (Cost based on 3' x 3' concrete path to alter change in level.)	6	103	\$618

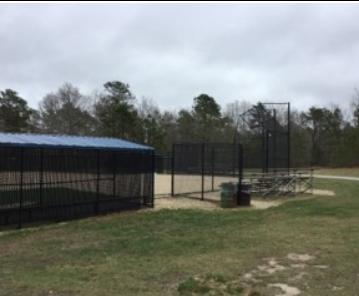
48	Youth Softball Field 2 (East)	Ext.		Field	Baseball

Not connected to an accessible-route		Ensure softball field is connected to an accessible route. (Cost based on 36" wide min. 40' long concrete path with running slope of 5.00% (1:20) max. and cross slope of 2.00% (1:50) max.)	1	920	\$920
49	Batting Cages	Ext.		Field	Baseball

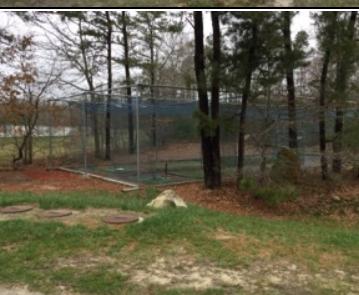
Practice areas are not on an accessible route		Provide an accessible route to practice areas. (Cost based on 36" wide min. 26' long concrete path with running slope of 5.00% (1:20) max. and cross slope of 2.00% (1:50) max.)	1	598	\$598

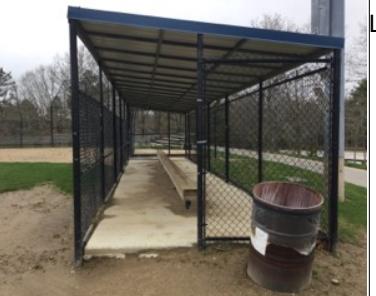
Level changes > 1/4"	4"	Alter change in level to be 1/4" high max. (Cost based on 3' x 3' concrete patch.)	2	103	\$206
Announcement Booth												
51	Senior Baseball Field (West)	Ext.		Announcement Booth	452

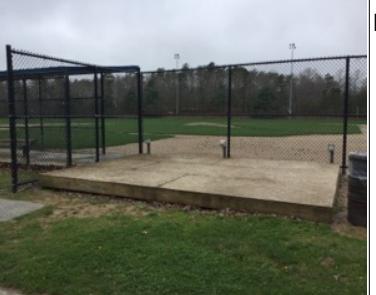
Booth not connected to an accessible route	9"	If this platform is used as an announcement booth then ensure there is an accessible route onto the platform.	1		\$0
Bleachers												
52	Football Field	Ext.		Bleachers	N/A

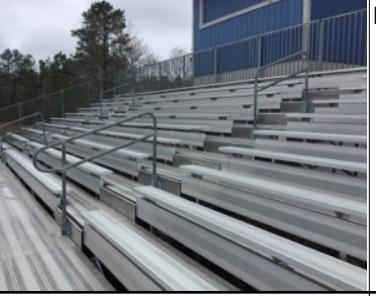
Min. # of designated wheelchair spaces not provided		Provide the required number of accessible wheelchair spaces. (Cost based on accessible ramp to raised bleachers and new bleachers with required number of accessible spaces.)	1	51000	\$51000
53	Visitor Section for Football Field	Ext.		Bleachers	N/A

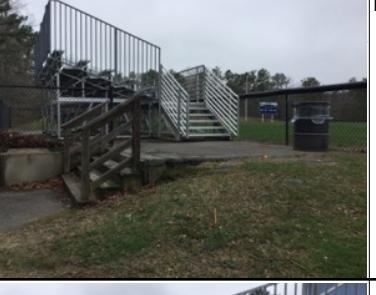
Min. # of designated wheelchair spaces not provided Seats not connected by accessible route		Provide the required number of accessible wheelchair spaces. Provide an accessible route to the seating area. (Cost based on accessible ramp to raised bleachers and new bleachers with required number of accessible spaces.)	1	20350	\$20350

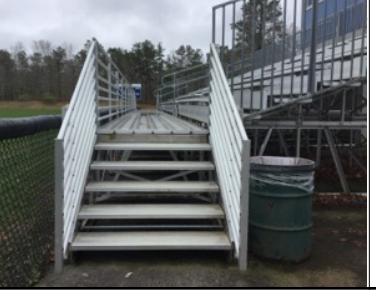
54	Football Field	Ext.		Bleachers	N/A

Seats not connected by accessible route		Provide an accessible route to the seating area. See ID #52 for cost.	1		\$0

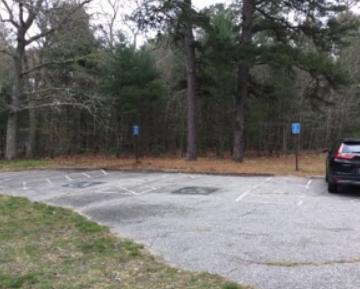
Total # of parking Total # of designated accessible parking spaces Total # of designated van accessible spaces Access aisle < 60" wide at car/van space Sign not provided	4 4 0 57"	Provide one van accessible parking space 132" wide min. with an access aisle 60" wide min. Provide a sign with the bottom of the sign 60" min. above the ground and the top 96" max. above the ground at each accessible space. Add the words "Van Accessible" to the sign at the van space. Position sign centered in space. (Cost based on re-painting striping and 2 signs.)	1	650	\$650
7	Parking Lot at Entrance	Ext		Off-Street Parking Lot or Garage	Visitor

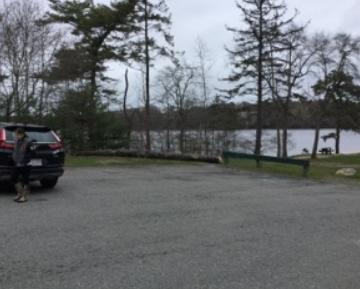
Total # of parking Total # of designated accessible parking spaces Total # of designated van accessible spaces Access aisle not provided Sign not provided	15 1 0	Provide a van accessible space that is 132" wide min. and a marked access aisle that is at least 60" wide. Provide a sign with the bottom of the sign 60" min. above the ground and the top 96" max. above the ground. Add the words 'Van Accessible' to the sign at the van accessible space.	1	925	\$925

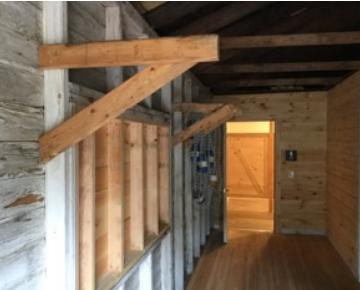
Obstructed by protruding objects	78"	Relocate wood beams above 80" min. aff. or provide a cane detectible barrier 27" max. aff.	1	Labor	\$0
9	Toilet Rooms	1		Interior Access Route	Interior

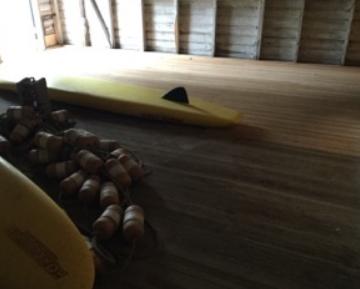
Accessible route not provided	-	Provide an accessible route. (Relocate paddle boards and netting to create a 36" wide min. accessible route.)	1	Labor	\$0

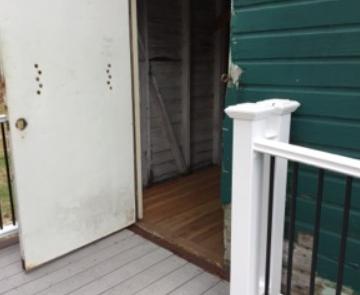
Maneuvering clearance(s) not provided Hardware not operable with a closed fist	12.5"	Ensure door remains open during public hours to provide maneuvering clearance. Provide hardware that can be operable with one hand and not require tight grasping, pinching, or twisting of the wrist.	1	242	\$242
Ramps												
11	Entrance to Toilet Rooms	Ext		Ramps	Exterior

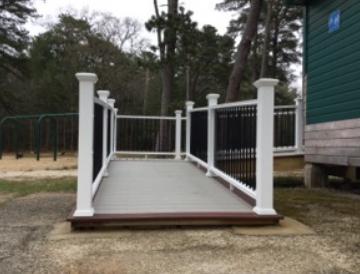
Handrails do not extend 12" past top & bottom No top or bottom landing provided Handrails not provided	- 3.5"	Alter handrails to extend horizontally above the bottom landing for 12" min. Provide landing at bottom of ramp. Provide lower handrails 18" min. and 24" max. aff. (Cost based on four (4) 12" extensions to wood end posts, including two lower handrails, and a ramp extension to correct change in level. See summary for link to purchase ramp extension.)	1	475	\$475

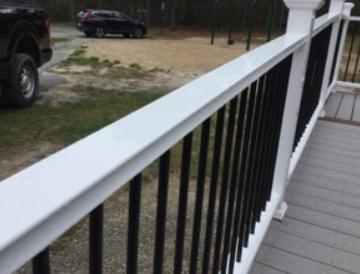
12	Entrance to Toilet Rooms	Ext		Ramps	Exterior

Handrails have non-compliant cross section Handrails not continuous where required Handrails not provided	-	Provide handrails with a 1 1/4" - 2" circular cross section. Provide continuous handrails for the length of ramp runs. Provide lower handrails 18" min., 24" max. aff. (Cost based on four (4) 30' long wood handrails, including two lower handrails, with a 1 1/4" - 2" circular cross section that are continuous for the length of the ramp runs.)	1	2640	\$2640
Picnic Tables												
13	Near Beach	Ext		Picnic Tables	N/A

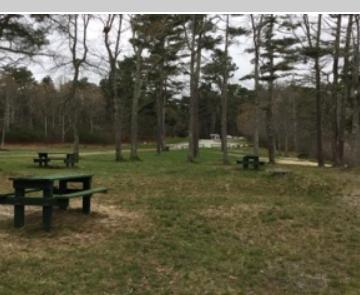
Number of seating spaces at picnic tables Number of accessible seating spaces Top of picnic table < 28" or > 34 Toe or knee clearance at table not provided Picnic table not on an accessible route	6 0 36"	Provide at least one picnic table with top between 28"- 34" above the ground and 27" clear height underneath and toe and knee clearance. Locate picnic table on an accessible route.	1	828	\$828

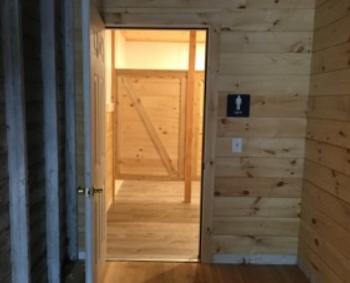
International Symbol of Acc. not provided		Provide a sign with the International Symbol of Accessibility.	1	116	\$116
15	Women's Toilet Room	1		Overall Access	Toilet Room

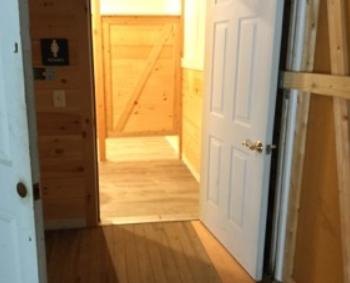
International Symbol of Acc. not provided		Provide a sign with the International Symbol of Accessibility.	1	116	\$116
Lavatory												
16	Women's Toilet Room	1		Lavatory	N/A

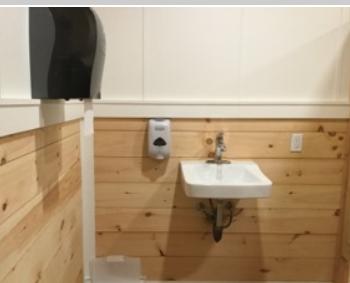
Lavatory rim or counter > 34" high Exposed plumbing underneath Dispensers not within reach range	35" - 52.5"	Provide at least one lavatory with the rim no higher than 34". Insulate or otherwise configure pipes to prevent contact, for at least one lavatory. Relocate paper towel dispenser to 48" max. above the floor. (Paper towel dispenser is too high and is also a protruding object.)	1	1946	\$1946

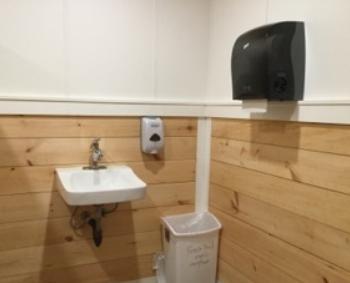
17	Men's Toilet Room	1		Lavatory	N/A

Exposed plumbing underneath Dispensers not within reach range	54.75"	Insulate or otherwise configure pipes to prevent contact, for at least one lavatory. Relocate paper towel dispenser to 48" max. above the floor. (Paper towel dispenser is too high and is also a protruding object.)	1	399	\$399
Toilet Compartment												
18	Men's Toilet Room	1		Toilet Compartment	Accessible Compartment

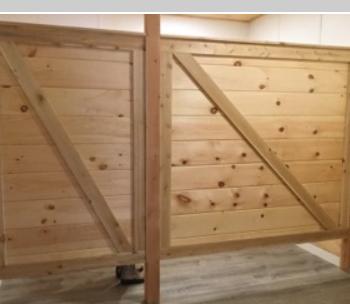
Door with non-compliant hardware		Provide hardware that can be operable with one hand and not require tight grasping, pinching, or twisting of the wrist.	1	Labor	\$0

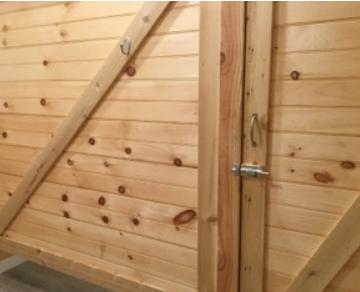
21	Men's Toilet Room	1		Toilet Compartment	Accessible Compartment

Coat hook > 48"	58"	Lower coat hook so that it is no higher than 48".	1	75	\$75

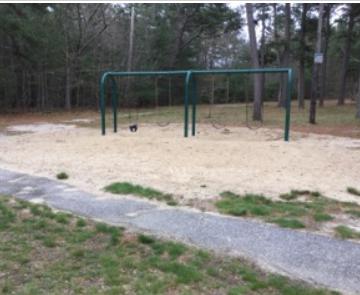
22	Playground	Ext		Play Areas	N/A

Accessible route not provided to play area Surface not stable, firm, and slip-resistant	15' -	Provide an accessible impact-attenuating surface around and under the play components. (Cost based on 60 square feet of poured in place rubber.)	1	840	\$840
----	------------	-----	--	------------	-----	--	--	----------	---	---	-----	-------

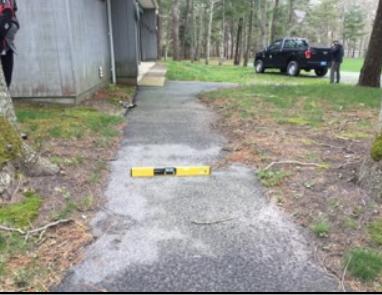
ID	Location	Floor	Room	Element	Type	Photo	Issues	Current Measure	Recommendations	Quantity	Price	Cost Estimation
Approach and Entrance												
Exterior Access Route												
1	Entrance to Toilet Rooms and Showers	Ext		Exterior Access Route	Walkway

Cross slope > 1:50 (2.00%) (MAAB)	3.1%	Reduce cross slope to be no steeper than 1:50 (2.00%). (Cost based on 36" wide min. 16' long of concrete to correct path cross slope to 2.00% (1:50) max.)	1	240	\$240
2	Route to Pond From Parking	Ext		Exterior Access Route	Walkway

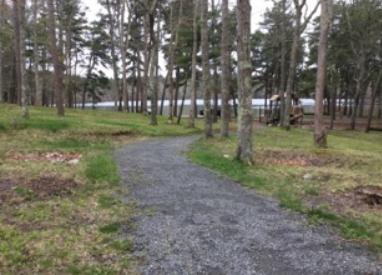
Cross slope > 1:50 (2.00%) (MAAB) Surface not stable, firm, and slip-resistant Running slope > 1:20 (5.00%)	7% 314' 8.3%	Reduce cross slope to be no steeper than 1:50 (2.00%). Repair surface. Reduce the running slope to be no steeper than 1:20 (5.00%). (Cost based on 36" wide min. 314' long stone dust path with running slope of 5.00% (1:20) max. and cross slope of 2.00% (1:50) max.)	1	3576	\$3576

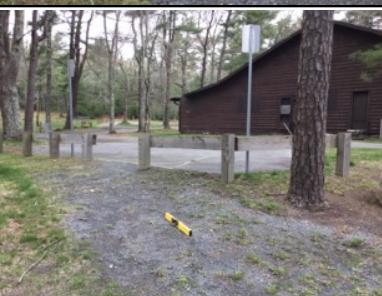
3	Parking	Ext		Exterior Access Route	Exterior

Cross slope > 1:50 (2.00%) (MAAB) Surface not stable, firm, and slip-resistant Running slope > 1:20 (5.00%)	2.4% - 8.9%	Reduce cross slope to be no steeper than 1:50 (2.00%). Repair surface. Reduce the running slope to be no steeper than 1:20 (5.00%). (Cost based on 36" wide min. 10' long stone dust path with running slope of 5.00% (1:20) max. and cross slope of 2.00% (1:50) max.)	1	114	\$114
4	Entrance to Toilet Rooms and Showers	Ext		Exterior Access Route	Walkway

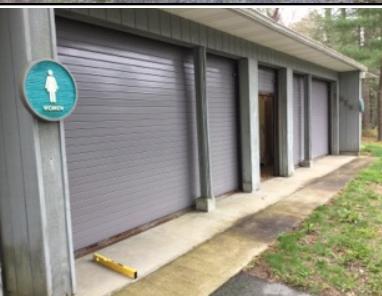
Cross slope > 1:50 (2.00%) (MAAB) Running slope > 1:20 (5.00%)	4.8% 7.3%	Reduce cross slope to be no steeper than 1:50 (2.00%). Reduce the running slope to be no steeper than 1:20 (5.00%). (Cost based on 36" wide min. 6' long of concrete to correct path running slope to 5.00% (1:20) max. and cross slope to 2.00% (1:50) max.)	1	90	\$90
5	Horseshoes	Ext		Exterior Access Route	Exterior

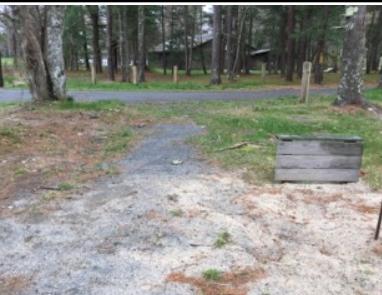
Surface not stable, firm, and slip-resistant	-	Repair surface. (Cost based on 36" wide min. 40' long stone dust path with running slope of 5.00% (1:20) max. and cross slope of 2.00% (1:50) max.)	1	456	\$456

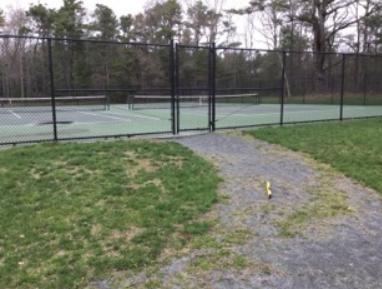
ID	Location	Floor	Room	Element	Type	Photo	Issues	Current Measure	Recommendations	Quantity	Price	Cost Estimation
6	Tennis Courts	Ext		Exterior Access Route	Walkway

Not maintained in an operable working condition	-	Ensure the accessible route is maintained in operable working condition. (Cost estimate for 25' long stone dust route.)	1	300	\$300
7	Tennis Courts	Ext		Exterior Access Route	Walkway

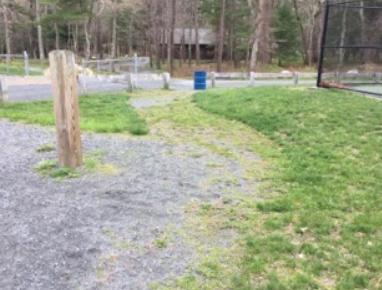
Not maintained in an operable working condition	-	Ensure the accessible route is maintained in operable working condition. (Cost estimate for 54' long stone dust route.)	1	648	\$648
8	Route to Pond From Parking	Ext		Exterior Access Route	Exterior

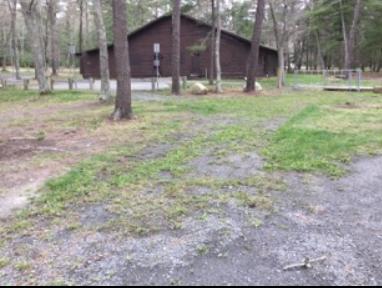
Not maintained in an operable working condition	52'	Ensure the accessible route is maintained in operable working condition. (Cost estimate for 52' long stone dust route.)	1	624	\$624
9	Walkway to Recreation Area	Ext		Exterior Access Route	Walkway

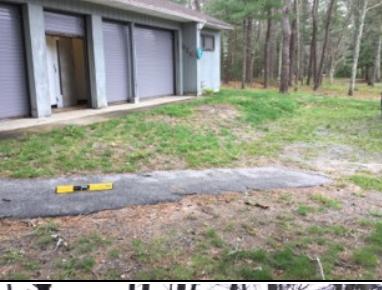
Not maintained in an operable working condition Running slope > 1:20 (5.00%)	56' 12.6%	Ensure the accessible route is maintained in operable working condition. Reduce the running slope to be no steeper than 1:20 (5.00%). (Cost based on 36" wide min. 66' long concrete path with a running slope of 5.00% (1:20) max. and cross slope of 2.00% (1:50) max.)	1	1288	\$1288

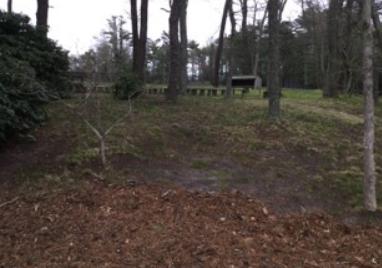
10	Assembly Area	Ext		Exterior Access Route	Exterior

Accessible route not provided	143'	Ensure an accessible route is provided. (Cost based on 36" wide min. 143' long stone dust path with a running slope of 5.00% (1:20) max. and cross slope of 2.00% (1:50) max.)	1	1629	\$1629

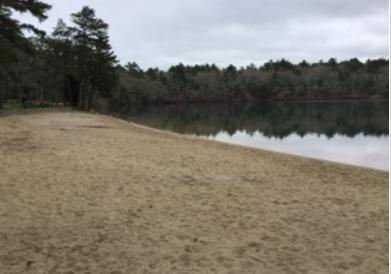
Beach route not provided	-	Provide an accessible route that is firm and stable. Ensure the accessible route extends to the recreation water level. (Cost based on 60" wide 50' long accessible beach mat.)	1	1925	\$1925
13	Boat Launch	Ext		Beach Access Routes	Permanent

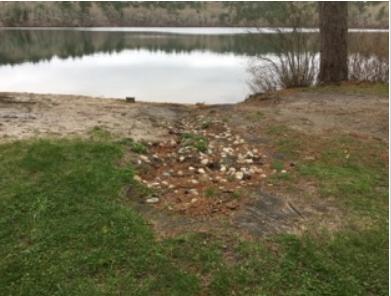
Not connected to accessible route	56'	Ensure boat launch is connected to an accessible route. (Cost based on 36" wide min. 56' long stone dust path with running slope of 5.00% (1:20) max. and cross slope of 2.00% (1:50) max.)	1	638	\$638

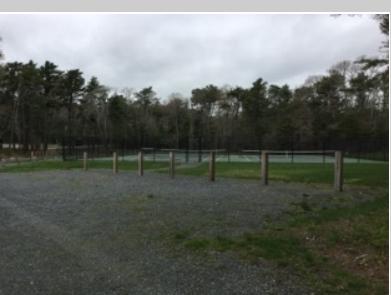
Total # of parking Total # of designated accessible parking spaces Total # of designated van accessible spaces Sign not provided	7 0 0 -	Provide a van accessible space 132" wide min. with an adjoining access aisle 60" wide min. Provide a sign with the bottom of the sign 60" min. above the ground and the top 96" max. above the ground. Add the designation "Van Accessible" to the sign.	1	400	\$400
15	Parking	Ext		Off-Street Parking Lot or Garage	N/A

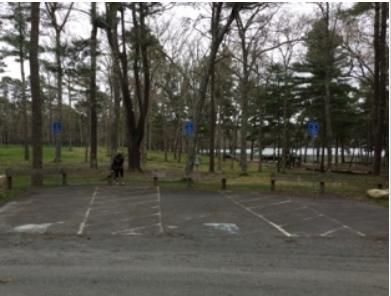
Total # of parking Total # of designated accessible parking spaces Total # of designated van accessible spaces Vehicle space < 96" wide at car space Access aisle < 90" wide at van space Sign does not have the designation "Van Accessible"	3 3 0 92" 85"	Provide a van accessible space that is 96" wide min. with an adjoining access aisle that is 96" wide min. Ensure accessible spaces are at least 96" wide. Provide an additional 9" width of asphalt to parking area to ensure all parking spaces and access aisles are compliant. Add the designation "Van Accessible" to the sign located at the van accessible space.	1	1175	\$1175

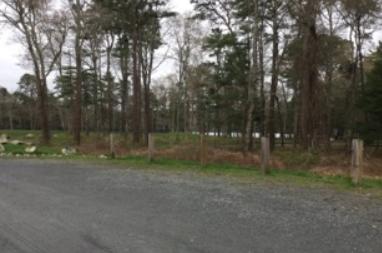
ID	Location	Floor	Room	Element	Type	Photo	Issues	Current Measure	Recommendations	Quantity	Price	Cost Estimation
16	Parking for Basketball Court	Ext		Off-Street Parking Lot or Garage	N/A

Total # of parking Total # of designated accessible parking spaces Total # of designated van accessible spaces	4 0 0	Provide a van accessible space that is 132" wide min. with an adjoining access aisle 60" wide min.	1	925	\$925
17	Parking for Basketball Court	Ext		Off-Street Parking Lot or Garage	N/A

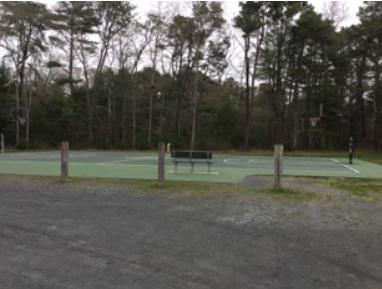
Total # of parking Total # of designated accessible parking spaces Total # of designated van accessible spaces	8 0 0	Provide a van accessible space that is 132" wide min. with an adjoining access aisle 60" wide min.	1	925	\$925
18	Trailhead	Ext		Off-Street Parking Lot or Garage	N/A

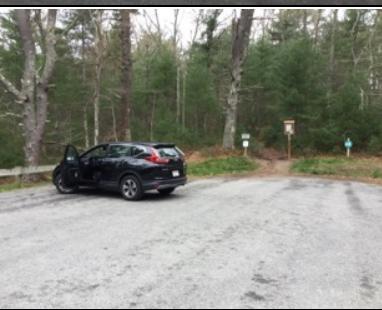
Total # of parking Total # of designated accessible parking spaces Total # of designated van accessible spaces	20 0 0	Provide a van accessible space that is 132" wide min. with an adjoining access aisle 60" wide min.	1	925	\$925

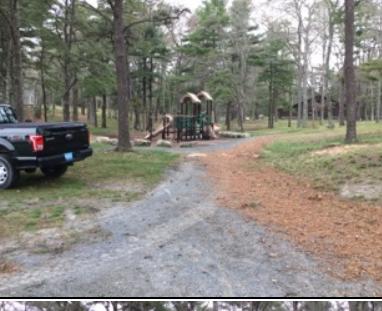
19	Playground Near Pond	Ext		Off-Street Parking Lot or Garage	Visitor

Total # of designated accessible parking spaces	0	Provide a van accessible space that is 132" wide min. with an adjoining access aisle 60" wide min.	1	925	\$925
20	Accessible Parking to Toilet Rooms and Showers	Ext		Off-Street Parking Lot or Garage	Visitor

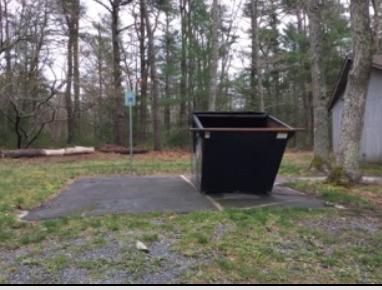
Vehicle space < 132" wide at van space Sign does not have the designation "Van Accessible"	117"	Provide a van accessible space that is at least 132" wide. Add the designation "Van Accessible" to the sign located at the van accessible space. Relocate the dumpster from the access aisle. (Cost for repainting stripes and adding "Van Accessible" designation to the sign.)	1	400 Labor \$400

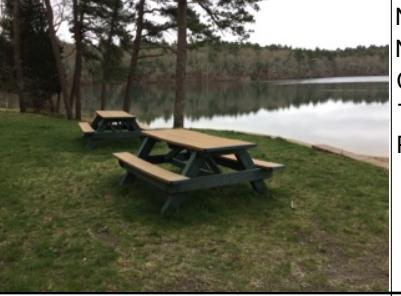
Number of seating spaces at picnic tables Number of accessible seating spaces Clear floor space not provided Toe or knee clearance at table not provided Picnic table not on an accessible route	6 0 - - -	Ensure that at a 30" by 48" clear floor space positioned for a forward approach is provided at the picnic table. Ensure there is a minimum 48" clear floor space at seating and around table. Provide at least one picnic table with toe and knee clearance. Locate picnic table on an accessible route. (Cost based on accessible picnic table, 16' x 17' stone dust area, and a 36" wide min. 6' long stone dust path.)	2	1801	\$3602

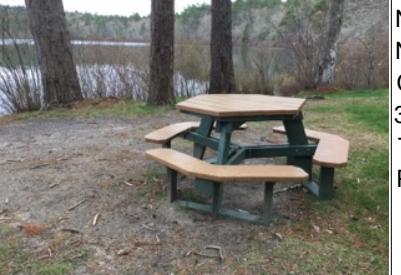
28	Pond	Ext		Picnic Tables	N/A

Number of seating spaces at picnic tables Number of accessible seating spaces Clear floor space not provided 30" clear width not provided Toe or knee clearance at table not provided Picnic table not on an accessible route	6 0 - - - -	Provide at least one accessible picnic table that is 30" wide. Locate accessible picnic table on an accessible route.	1	700 Labor	\$700
29	Playground	Ext		Picnic Tables	N/A

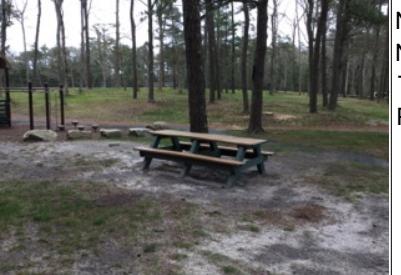
Number of seating spaces at picnic tables Number of accessible seating spaces Toe or knee clearance at table not provided Picnic table not on an accessible route	8 0 - -	Provide at least one picnic table with toe and knee clearance. Locate picnic table on an accessible route.	1	700 Labor	\$700
Benches												
30	Assembly Area	Ext		Benches	N/A

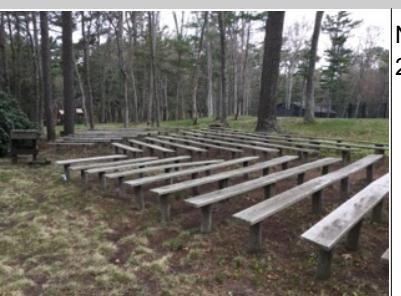
No accessible route to 20% of benches 20% of benches have clear space < 36" x 48"	- -	Provide an accessible route to 20% of benches in this area. Ensure that 20% of benches have a clear floor space of 36" wide min. by 48" deep min. (Cost for six (6) 36" x 48" stone dust area alongside benches. See ID number 10 for accessible route cost.)	1	264	\$264

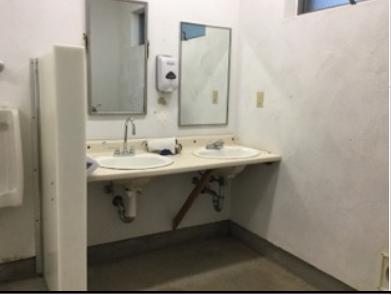
Exposed plumbing underneath Mirror above lavatory w/reflective surface > 40" Dispensers not within reach range	- 42" 49"	Insulate or otherwise configure pipes to prevent contact, for at least one lavatory. Lower mirror so that the bottom surface is at 40" max. above finish floor. Relocate soap dispenser to 42" max. above the floor.	1	527	\$527
33	Women's Toilet Room	1	2	Lavatory	N/A

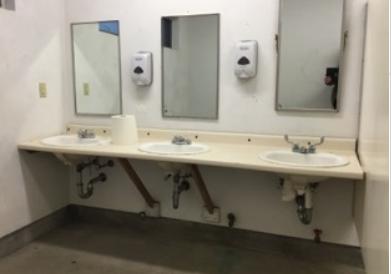
Exposed plumbing underneath Mirror above lavatory w/reflective surface > 40" Dispensers not within reach range	- 42.75" 51.5"	Insulate or otherwise configure pipes to prevent contact, for at least one lavatory. Lower mirror so that the bottom surface is at 40" max. above finish floor. Relocate dispenser to 42" max. above the floor.	1	527	\$527

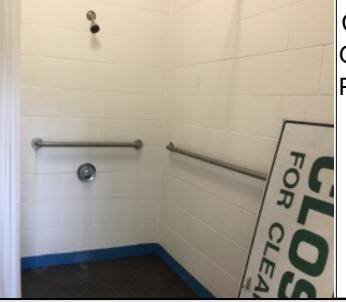
ID	Location	Floor	Room	Element	Type	Photo	Issues	Current Measure	Recommendations	Quantity	Price	Cost Estimation
Shower Compartment												
36	Between Men's and Women's Toilet Rooms	1	Shower Compartment	Shower Compartment	Roll-In Type

Controls height < 38" or > 48" Grab bar on control wall <42" Padded shower seat not provided	29" 31" -	Install a 42" long grab bar on the control wall. Relocate shower control to be 38" to 48" above the finished floor and over the grab bar. Install a padded transfer seat.	1	3744	\$3744
Play and Sport Areas												
37	Playground	Ext		Play Areas	N/A

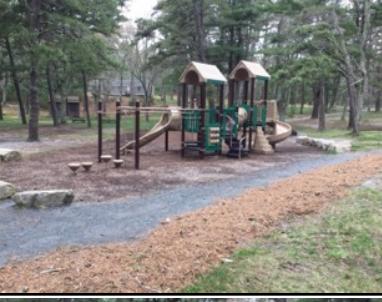
Accessible route not provided to ground level play components Surface not stable, firm, and slip-resistant	- -	Provide an accessible impact-attenuating surface around the play components. (Cost based on 430 square feet of poured in place rubber.)	1	6020	\$6020
38	Playground	Ext		Play Areas	N/A

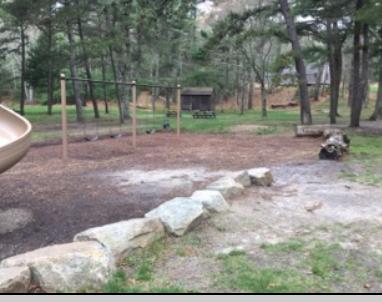
Surface not stable, firm, and slip-resistant	-	Provide an accessible impact-attenuating surface around the play components. (Cost based on 130 square feet of poured in place rubber.)	1	1820	\$1820

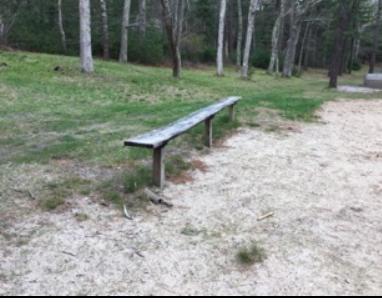
Court												
39	Volleyball Court	Ext		Court	Volleyball

Accessible space is not provided at team seating	-	Provide a 36" x 48" clear floor space at team seating.	2	45	\$90

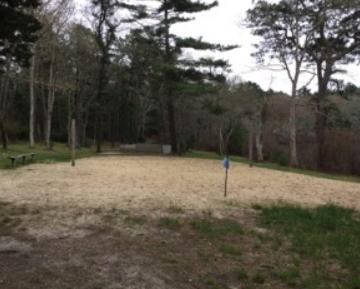
ID	Location	Floor	Room	Element	Type	Photo	Issues	Current Measure	Recommendations	Quantity	Price	Cost Estimation
40	Volleyball Court	Ext		Court	Volleyball

Not connected to accessible route	174'	Ensure volleyball court is connected to an accessible route. (Cost based on 36" wide min. 174' long stone dust path with running slope of 5.00% (1:20) max. and cross slope of 2.00% (1:50) max.)	1	1982	\$1982
41	Gaga Ball Court Behind Volleyball Court	Ext		Court	Gaga Ball

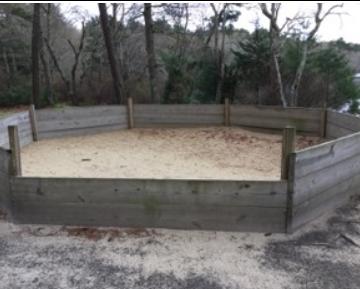
Not connected to accessible route	115'	Ensure gaga ball court is connected to an accessible route. Provide an accessible entrance into the sport area. (Cost based on 36" wide min. 115' long stone dust path with running slope of 5.00% (1:20) max. and cross slope of 2.00% (1:50) max.)	1	1310	\$1310
42	Basketball Court	Ext		Court	Basketball

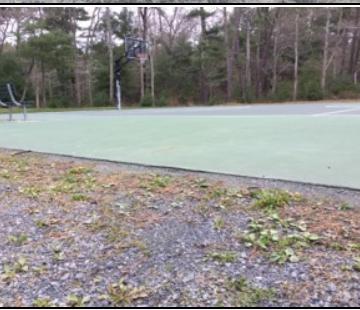
Not connected to accessible route	12'	Ensure basketball court is connected to an accessible route. (Cost based on 36" wide min. 12' long stone dust path with running slope of 5.00% (1:20) max. and cross slope of 2.00% (1:50) max.)	1	137	\$137

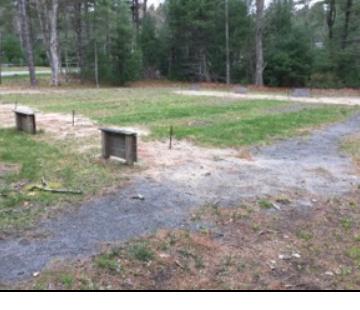
43	Horseshoes	Ext		Court	Horseshoes

Not connected to accessible route	70'	Ensure horseshoes court is connected to an accessible route. (Cost based on 36" wide min. 70' long stone dust path with running slope of 5.00% (1:20) max. and cross slope of 2.00% (1:50) max.)	1	797	\$797

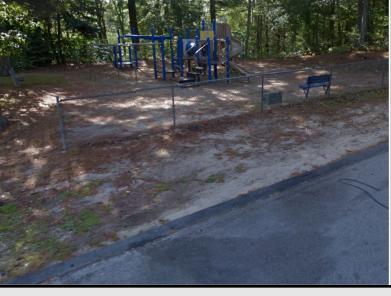
Curb ramp not provided		Provide a curb ramp with a detectable warning by the entrance to the park.	1	998	\$998
Access to Goods and Services												
Benches												
3	Adjacent to Lake Dr.	Ext		Benches	N/A

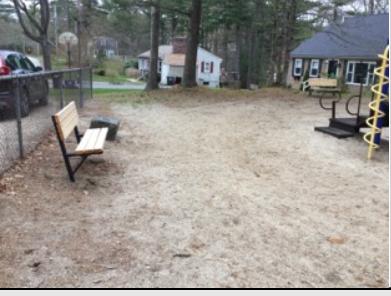
No accessible route to 20% of benches	35'	Provide an accessible route to 20% of benches in this area. (Cost based on 36" wide min. 35' long stone dust path with running slope of 5.00% (1:20) max. and cross slope of 2.00% (1:50) max.)	1	398	\$398

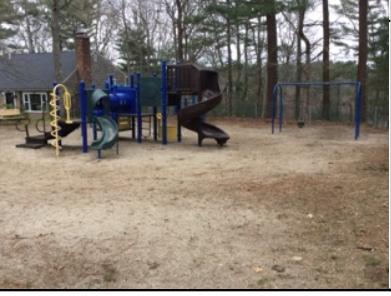
Play and Sport Areas												
Play Areas												
4	Play Structure	Ext		Play Areas	N/A

Surface not stable, firm, and slip-resistant	150'	Provide an accessible impact-attenuating surface around the play components. (Cost estimate based on a 150 sq. ft. poured-in place rubber surface.)	1	2100	\$2100

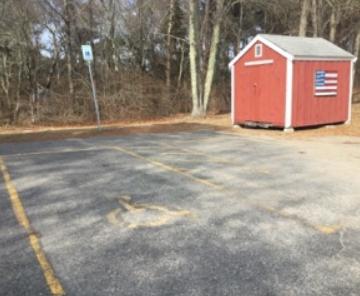
ID	Location	Floor	Room	Element	Type	Photo	Issues	Current Measure	Recommendations	Quantity	Price	Cost Estimation
Approach and Entrance												
Off-Street Parking Lot or Garage												
1	Parking Lot	Ext.		Off-Street Parking Lot or Garage	N/A

Access aisle < 96" wide at van space Sign does not have the designation "Van Accessible"	47" -	Provide a marked access aisle that is at least 96" wide at the van accessible space. (Re-stripe). Add the designation "Van Accessible" to the sign at the van accessible space. Position sign at van accessible space 60" min. and 96" max. above the ground. (Cost based on re-striping access aisle and a new "Van Accessible" sign.)	1	400	\$400
Entrance												
2	South Facing Entrance	1		Entrance	Secondary Entrance

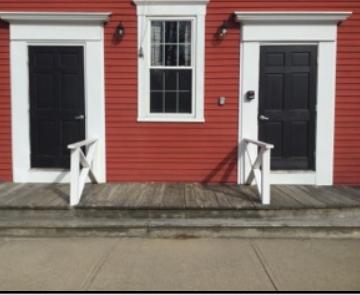
Entrance not on an accessible route	-	Provide a directional sign indicating the location of the nearest accessible entrance.	1	173	\$173

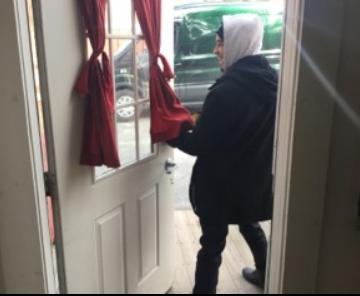
Access to Goods and Services												
Means of Egress												
3	All Egress Doors	1		Means of Egress	N/A

Tactile exit sign not provided	-	Ensure tactile exit signs with raised characters and braille are provided at exit doors. Mount signs between 48"- 60" above finished floor located on the latch side of the door.	3	116	\$348
Doors, Doorways, & Gates												
4	Accessible Toilet Room	1		Doors, Doorways, & Gates	Toilet Room

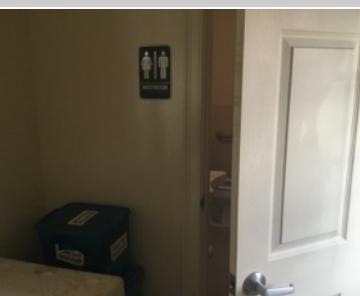
Maneuvering clearance(s) not provided International Symbol of Acc. not provided.	-	Remove clutter to provide 18" min. pull side maneuvering clearance at door and clear floor space at the designation sign. Replace sign with a sign containing the International Symbol of Accessibility (ISA) and the words "All Gender".	1	116	\$116

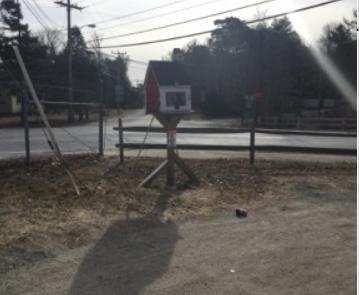
ID	Location	Floor	Room	Element	Type	Photo	Issues	Current Measure	Recommendations	Quantity	Price	Cost Estimation
Operable Parts												
5	Library Book Exchange	Ext.		Operable Parts	Other

Reach < 15" or > 48"(forward/side approach)	62"	Relocate free library book exchange box so that controls are between 15"- 48" above the ground.	1	Labor	\$0
Picnic Tables												
6	Picnic Table Area	Ext.		Picnic Tables	N/A

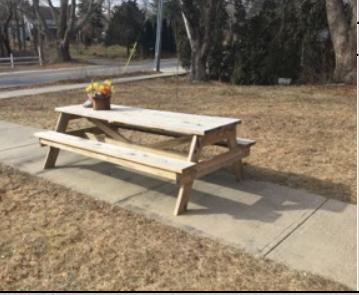
Toe or knee clearance at tables not provided Picnic table not on an accessible route	-	Provide at least 1 picnic table with toe and knee clearance. Ensure that the picnic table is connected to an accessible route and does not protrude into the general circulation path of the walkway. (Relocate existing picnic table out of walkway.) (Cost based on one accessible picnic table.)	1	700	\$700
Kitchens and Kitchenettes												
7	Kitchen	1		Kitchens and Kitchenettes	Other

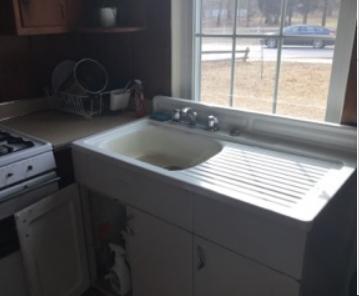
Knee/toe clearance not provided at sink Sink > 34" high	- 35.5"	Provide a sink with knee and toe clearance positioned for a forward approach. Ensure the sink work surface is no higher than 34" above the ground.	1	1547	\$1547

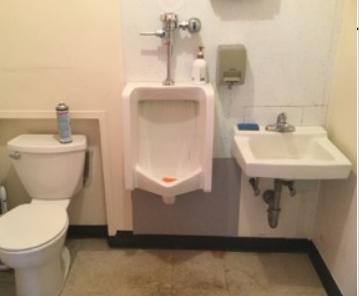
Toilet & Bathing Rooms												
Overall Access												
8	Inaccessible Toilet Room	1		Overall Access	Toilet Room

Accessible plumbing fixtures or stalls not provided	-	Provide signage with raised characters and braille directing users to the accessible toilet room. Locate sign on the exterior side of the door on the latch side.	1	116	\$116
Best Practice

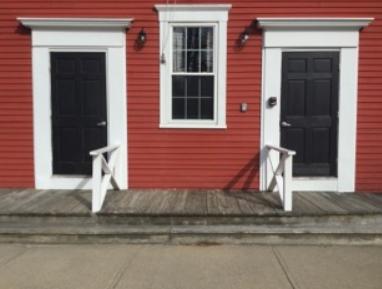
ID	Location	Floor	Room	Element	Type	Photo	Issues	Current Measure	Recommendations	Quantity	Price	Cost Estimation
N/A												
9	South Facing Entrance	1		N/A	N/A

-	Recommend providing handrails on both sides of the doorways at the south side entrance as well as ensuring that existing railings extend one tread length beyond the bottom stair riser.	1	0	\$0
10	Kitchen	1		N/A	N/A

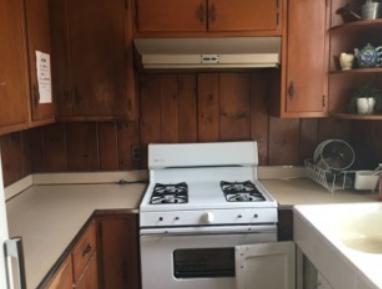
Recommend providing fume hood controls mounted no more than 48" above the finished floor.	1	0	\$0
Picnic Table												
11	Picnic Table Area	Ext.		Picnic Table	N/A

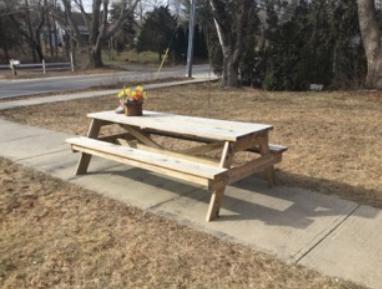
Surface at perimeter of table is not firm, stable & slip resistant.		Recommend that after the exiting picnic table is relocated to an accessible location that does not protrude into the walkway and an accessible picnic table is provided, a firm, stable and slip resistant surface extending 48" min. around all sides of the accessible picnic table be provided. Recommend cement, asphalt or stone dust surface.	1	0	\$0

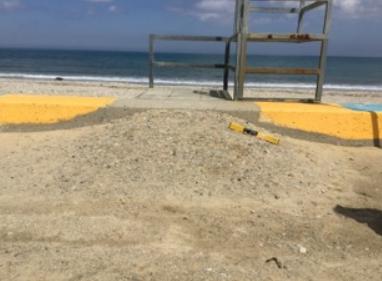
ID	Location	Floor	Room	Element	Type	Photo	Issues	Current Measure	Recommendations	Quantity	Price	Cost Estimation
Approach and Entrance												
Exterior Access Route												
1	Parking Near End of Public Beach	Ext.		Exterior Access Route	Exterior

Cross slope > 1:50 (2.00%) (MAAB) Surface not stable, firm, and slip-resistant Running slope > 1:20 (5.00%)	4% - 20%	Reduce cross slope to be no steeper than 1:50 (2.00%). Repair surface. Reduce the running slope to be no steeper than 1:20 (5.00%). (Cost based on reducing running slope to 5.00% (1:20) max. and cross slope to 2.00% (1:50) max.)	1	114	\$114
2	Accessible Beach Access	Ext.		Exterior Access Route	Exterior

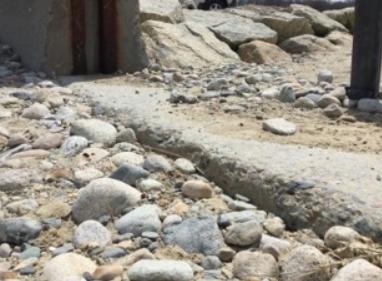
Level changes > 1/4" Surface not stable, firm, and slip-resistant	2"	Alter change in level to be 1/4" high max. Repair surface.	1	103	\$103
3	Route From Parking to Concession Stand	Ext.		Exterior Access Route	Exterior

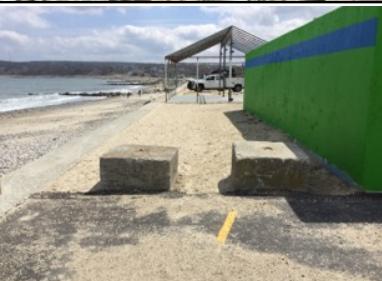
Surface not stable, firm, and slip-resistant Does not prevent accumulation of water Not maintained in an operable working condition	54'	Ensure the accessible route is maintained in operable working condition.	1	Labor	\$0

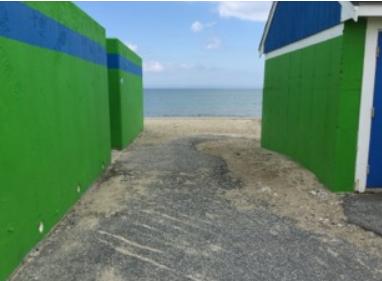
4	Between Toilet Rooms and Concession Stand	Ext.		Exterior Access Route	Exterior

Surface not stable, firm, and slip-resistant Does not prevent accumulation of water Not maintained in an operable working condition	40'	Repair surface. Ensure the accessible route is maintained in operable working condition. (Cost based on widening existing asphalt path to 36" wide min. 40' long path with running slope of 5.00% (1:20) max. and cross slope of 2.00% (1:50) max.)	1	200	\$200
5	Parking Along Beach	Ext.		Exterior Access Route	Exterior

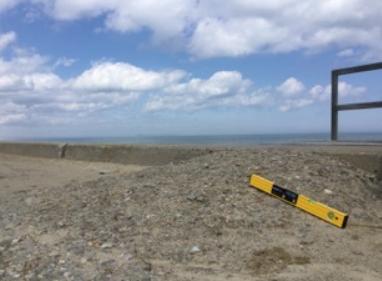
Surface not stable, firm, and slip-resistant Running slope > 1:20 (5.00%)	- 24.6%	Repair surface. Reduce the running slope to be no steeper than 1:20 (5.00%). (Cost based on reducing running slope to 5.00% (1:20) max.)	1	114	\$114

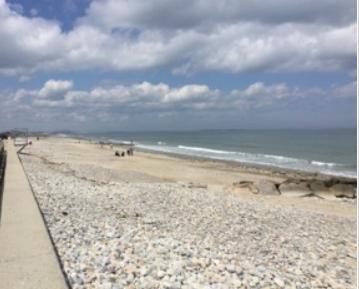
ID	Location	Floor	Room	Element	Type	Photo	Issues	Current Measure	Recommendations	Quantity	Price	Cost Estimation
Beach Access Routes												
6	Beach Near Parking by Toilet Rooms	Ext.		Beach Access Routes	Permanent

Beach route not provided	50'	Provide an accessible route that is firm and stable. Ensure the accessible route extends to the high tide level. (Cost based on 72" wide 50' long accessible beach mat.)	1	2,300	\$2300
7	Accessible Beach Access	Ext.		Beach Access Routes	Permanent

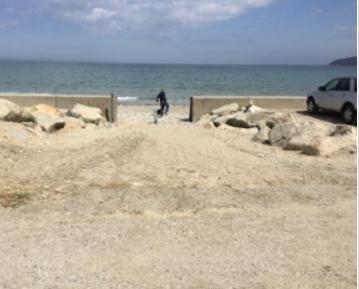
Surface is not firm and stable	43'	Ensure surface at the accessible route is firm and stable. (Cost based on 36" wide min. 43' long stone dust path with running slope of 5.00% (1:20) max. and cross slope of 2.00% (1:50) max.)	1	490	\$490
Off-Street Parking Lot or Garage												
8	Parking by Toilet Rooms	Ext.		Off-Street Parking Lot or Garage	N/A

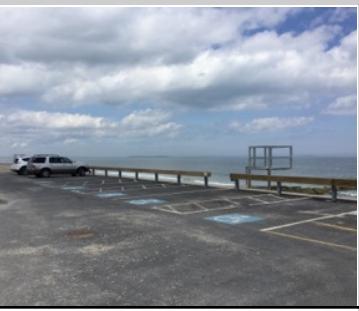
Total # of parking Total # of designated accessible parking spaces Total # of designated van accessible spaces Sign not provided	11 5 0	Convert a standard accessible space into a van accessible space. Provide a sign with the bottom of the sign 60" min. above the ground and the top 96" max. above the ground. (Cost based on five (5) signs and repainting surface for van accessible space.)	1	1400	\$1400

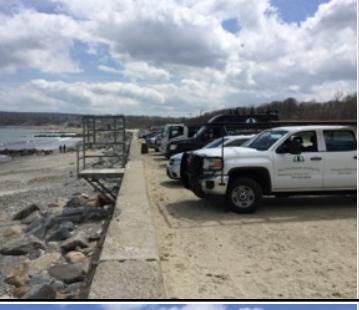
9	Parking Next to Sandy's	Ext.		Off-Street Parking Lot or Garage	N/A

Total # of designated accessible parking spaces	0	Provide a van accessible space with an adjacent access aisle.	1	925	\$925
10	Parking Near End of Public Beach	Ext.		Off-Street Parking Lot or Garage	N/A

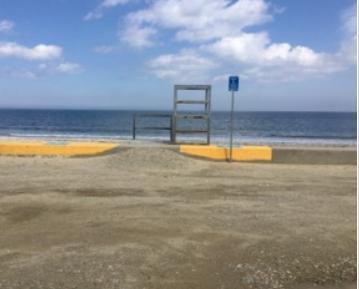
Total # of designated accessible parking spaces	1	Convert a standard accessible space into a van accessible space with an adjacent access aisle. (Cost based on repainting surface for van accessible space and access aisle.)	1	300	\$300

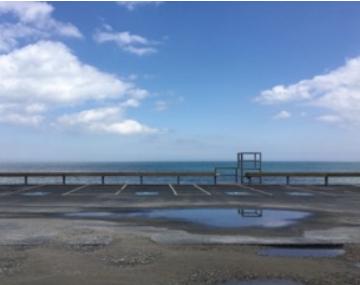
13	Parking by Toilet Rooms	Ext.		Off-Street Parking Lot or Garage	N/A

Access aisle does not adjoin an accessible route		Ensure the access aisle adjoins an accessible route. (Cost based on repairing existing 76' long asphalt area that adjoins access aisle to accessible route.)	1	988	\$988

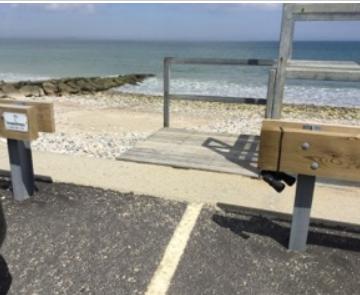
14	Parking by Toilet Rooms	Ext.		Ramps	Exterior

Ramps are provided in the summer but could not be surveyed since none were installed at the time of the survey.		Reduce running slope to be no steeper than 1:12 (8.33%). Ensure handrails are 34"- 38" high above the ramp surface and extend horizontally above the landing for 12" min. beyond the top and bottom of ramp runs. Provide handrails with a 1 1/4" - 2" circular cross section. Provide edge protection that prevents the	6	N/A	\$0
----	-------------------------	------	--	-------	----------	--	---	--	---	---	-----	-----
