Town of Plymouth

Part A – Executive Summary

October 2019

Prepared by the
**Institute for
Human
Centered
Design**

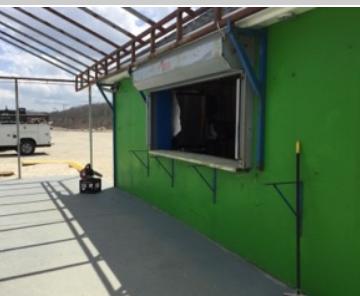
15	Concession Stand	Ext.		Service Counter	N/A

Counter > 36" high	38.5"	Provide a counter that is 36" max. above the ground.	1	440	\$440
----	------------------	------	--	-----------------	-----	--	--------------------	-------	--	---	-----	-------

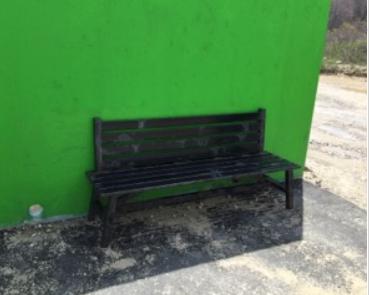
ID	Location	Floor	Room	Element	Type	Photo	Issues	Current Measure	Recommendations	Quantity	Price	Cost Estimation
Benches												
16	Outside of Men's Toilet Room	Ext.		Benches	N/A

Shoulder alignment not provided at bench - (12") back		Provide shoulder alignment with the adjacent wheelchair space. The shoulder alignment of the wheelchair space shall be measured 36" from the front of the wheelchair space.	1	Labor	\$0
Toilet & Bathing Rooms												
Overall Access												
17	Men's Toilet Room	Ext.		Overall Access	Toilet Room

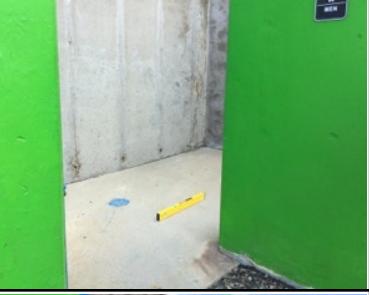
Cross slope > 1:50 (2.00%)	5.1%	Reduce cross slope to be no steeper than 1:50 (2.00%).	1	90	\$90
18	Women's Toilet Room	Ext.		Overall Access	Toilet Room

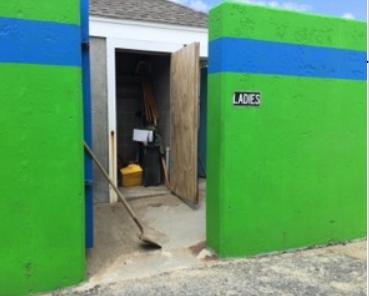
International Symbol of Acc. not provided Surface not stable, firm, and slip-resistant at entrance	-	Provide the International Symbol of Accessibility. Repair surface.	1	173 Labor	\$173
19	Men's Toilet Room	Ext.		Overall Access	Toilet Room

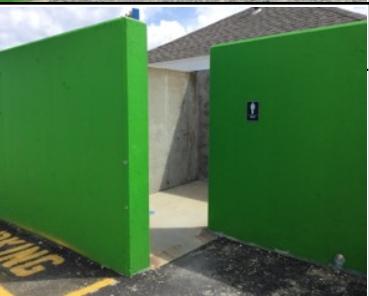
International Symbol of Acc. not provided Surface not stable, firm, and slip-resistant at entrance		Provide the International Symbol of Accessibility. Repair surface.	1	173 Labor	\$173

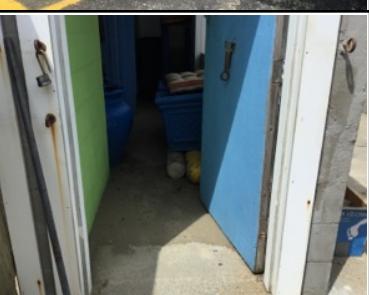
20	Women's Toilet Room	1		Overall Access	Toilet Room

International Symbol of Acc. not provided Audible and visible alarms not provided		Provide a sign with the International Symbol of Accessibility. When fire system is updated, ensure that a visible and audible fire alarm is installed.	1	462	\$462

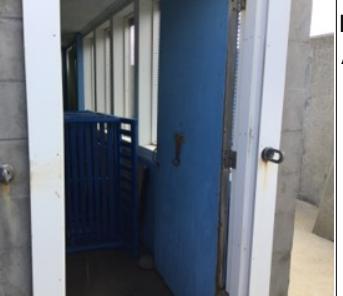
International Symbol of Acc. not provided Audible and visible alarms not provided		Provide a sign with the International Symbol of Accessibility. When fire system is updated, ensure that a visible and audible fire alarm is installed.	1	462	\$462
Lavatory												
22	Women's Toilet Room	1		Lavatory	N/A

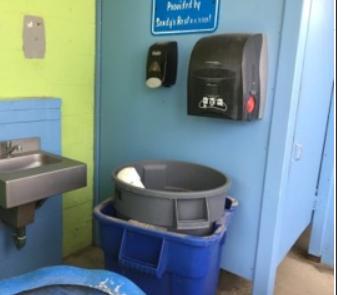
Dispensers not within reach range	50.75"	Relocate dispenser to 48" max. above the floor.	1	353	\$353
23	Men's Toilet Room	1		Lavatory	N/A

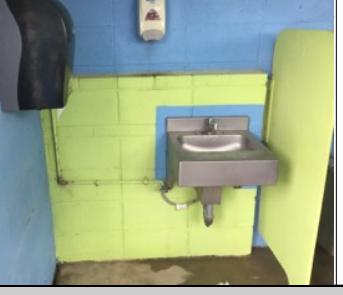
Dispensers not within reach range	54.75"	Relocate dispenser to 48" max. above the floor.	1	353	\$353
Toilet Compartment												
24	Men's Toilet Room	1		Toilet Compartment	Accessible Compartment

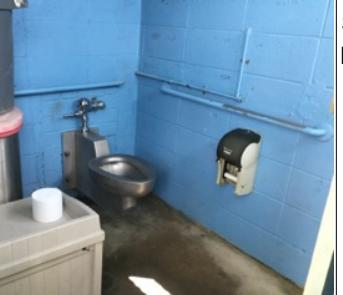
Side grab bar < 42" long Rear grab bar < 42" long	40" 40"	Provide a side wall grab bar that is 42" long min. located 12" max. from the rear wall. Provide a rear wall grab bar that is 42" long min. and extends from the toilet 12" min. on one side and 24" min. on the other side (open side).	1	898	\$898

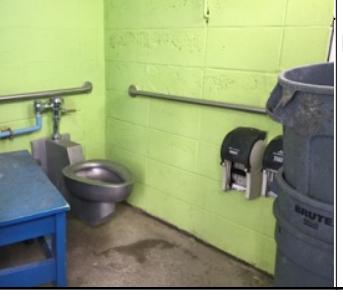
25	Women's Toilet Room	1		Toilet Compartment	Accessible Compartment

Flush control not on open side Non-compliant toilet paper dispenser		Provide the flush control on the open side of the toilet (transfer side). Relocate toilet paper so that it is between 15" and 48" above the finish floor and between 7" and 9" from the front of the toilet.	1	540	\$540

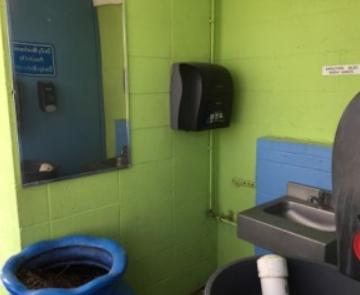
Controls > 42" (MAAB) Clear floor space not provided at accessory	45"	Relocate so the operable part is 42" max. above the finish floor. Provide a 30" min. by 48" min. clear floor space or relocate dispenser.	1	353	\$353
Outdoor Rinsing Showers												
27	Women's Toilet Room	Ext.		Outdoor Rinsing Showers	N/A

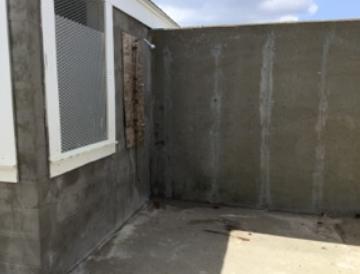
2 fixed showerheads not provided	-	Provide two showerheads located 48" and 72" min. above the ground.	1	319	\$319
28	Men's Toilet Room	Ext.		Outdoor Rinsing Showers	N/A

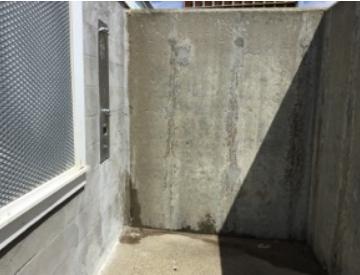
2 fixed showerheads not provided		Provide two showerheads located 48" and 72" min. above the ground.	1	319	\$319

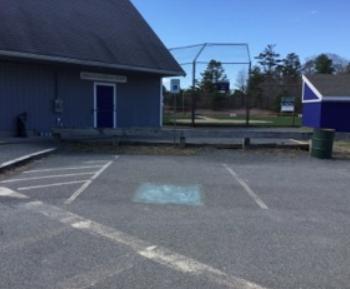
Total # of parking Total # of designated accessible parking spaces Total # of designated van accessible spaces	27 1 0	Provide an additional van accessible parking space in the lot in addition to the accessible space that is provided. (Cost estimate for leveling, striping and signage.)	1	925	\$925
6	Parking West of Concession Stand and Toilet Rooms	Ext		Off-Street Parking Lot or Garage	N/A

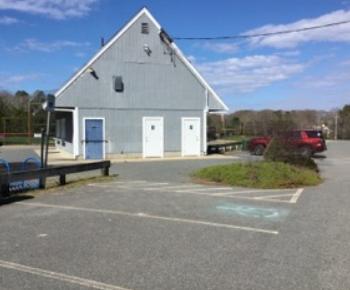
Total # of parking Total # of designated accessible parking spaces Total # of designated van accessible spaces	17 1 0	Provide 1 (one) van accessible space. Convert current accessible space into a van accessible space and provide signage that has the designation "Van Accessible."	1	400	\$400
7	Parking by Playground	Ext		Off-Street Parking Lot or Garage	N/A

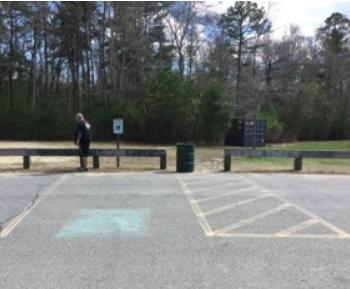
Access aisle does not adjoin an accessible route Sign < 60" above finished grade	- 44.25"	Relocate the trash can from the route adjoining the accessible parking space access aisle. Locate sign with the bottom of the sign 60" above the ground.	1	Labor	\$0

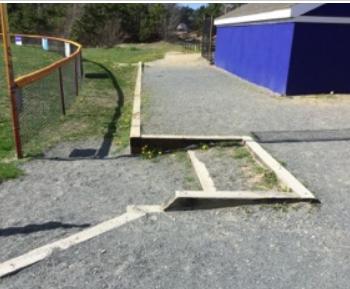
8	Concessions to Middle Baseball Field (Second From State Road)	Ext		Stairways	Exterior

Surface not stable, firm, and slip-resistant Not maintained in operable working condition Handrails not provided		Remove wood stairs and replace with a sloped walkway. Ensure running slope is no steeper than 1:20 (5.00%). (Cost estimate based on 6' long asphalt route.)	1	Labor 78	\$78
---	---	-----	--	-----------	----------	--	--	--	--	---	----------	------

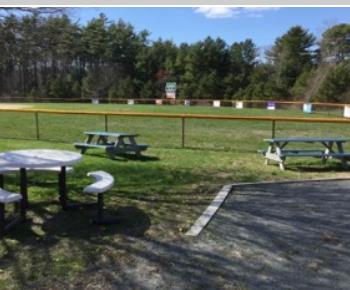
9	Concession Areas	Ext		Picnic Tables	N/A

Number of seating spaces at picnic tables Number of accessible seating spaces Toe or knee clearance at table not provided Picnic table not on an accessible route	6 0 - -	None of the picnic tables provided are accessible per ADA and 521 CMR. Provide at least one accessible picnic table with toe and knee clearance that is 27" high, 19" deep and 30" wide. Locate this picnic table on an accessible route.	1	1878	\$1878
---	------------------	-----	--	---------------	-----	--	--	------------------	---	---	------	--------

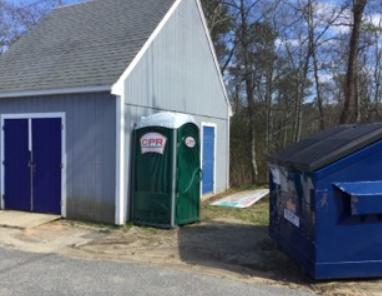
Not located on an accessible route Accessible portable toilets not provided		Ensure that at least 5% of portable toilets are accessible. Locate the accessible portable toilet on an accessible route.	1	Labor 2300	\$2300
11	Portable Toilet near Baseball Field on the West	Ext		Portable Toilet	N/A

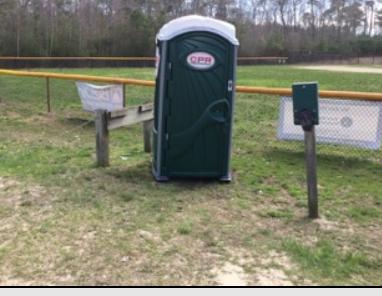
Not located on an accessible route Accessible portable toilets not provided	-	Ensure that at least 5% of portable toilets are accessible. Locate the accessible portable toilet on an accessible route.	1	Labor 2300	\$2300
Play and Sport Areas												
Play Areas												
12	Playground	Ext		Play Areas	N/A

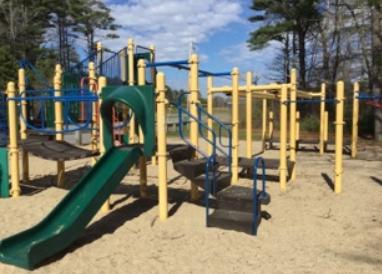
Surface not stable, firm, and slip-resistant	1000	Provide an accessible impact-attenuating surface around and underneath play components within the playground. (Cost estimate for a 1,000 sq. ft. of poured in place rubber surface.)	1	14000	\$14000

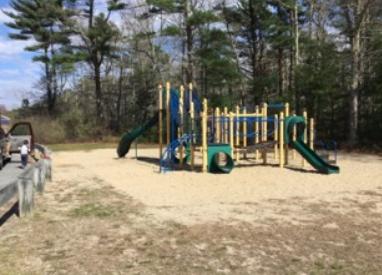
13	Playground	Ext		Play Areas	N/A

Accessible route not provided	30'	Ensure an accessible route to the playground is provided. (Cost estimate if for a 30' long route from the gate at the parking area by the accessible space to the playground.)	1	390	\$390

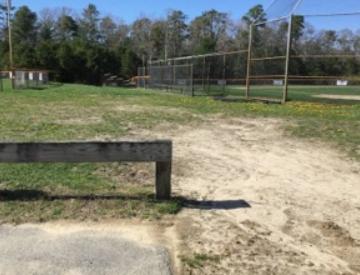
Accessible route to team seating is not provided	30'	Ensure baseball field is connected to an accessible route from the parking. (Cost estimate based on a 30' asphalt route.)	1	390	\$390
15	East Baseball Field Closest to State Road	Ext		Field	Baseball

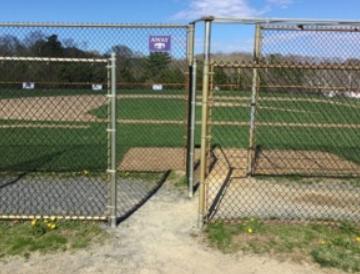
Accessible route to team seating is not provided		Ensure team seating is connected to an accessible route by relocating fence to expand depth of clear floor space in team seating area. (Cost estimate for relocating two fences.)	2	256	\$512
16	Far West Baseball Field by Playground	Ext		Field	Softball

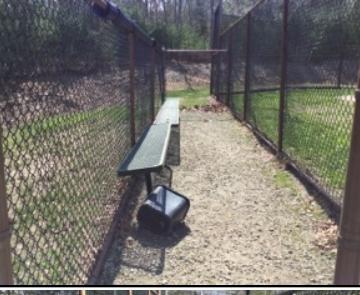
Accessible spaces are not provided at team seating		Provide a 36" x 48" clear level floor space at team seating. (Cost estimate for a 36" x 48" area of asphalt.)	2	52	\$104

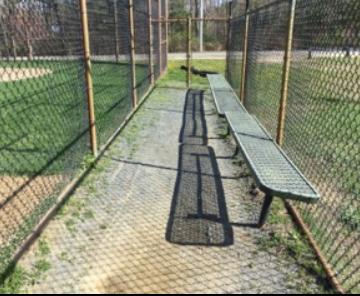
17	East Baseball Field Closest to State Road	Ext		Field	Baseball

Accessible spaces are not provided at team seating		Provide a 36" x 48" clear level floor space at team seating. (Cost estimate for a 36" x 48" area of asphalt.)	2	52	\$104
18	Baseball Field Directly West of the Concession Stand	Ext		Field	Baseball

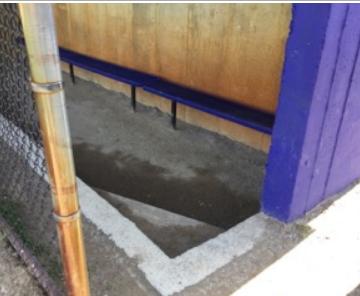
Accessible spaces are not provided at team seating Not connected to an accessible-route		Alteration of the dugout might be technically infeasible. Ensure that one of the 3 smaller fields is accessible for program access.	1		\$0

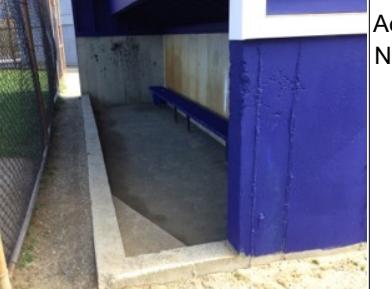
Accessible spaces are not provided at team seating Not connected to an accessible-route		Alteration of the dugout might be technically infeasible. Ensure that one of the 3 smaller fields is accessible for program access.	1		\$0
20	Baseball Field Directly West of the Concession Stand	Ext		Field	Baseball

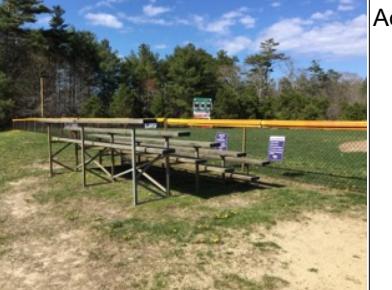
Accessible route not provided to sidelines seating	108'	Provide an accessible route to the each sidelines seating area. (Cost estimate for a 108' asphalt route).	1	1404	\$1404
21	Middle Baseball Field (Second From State Road)	Ext		Field	Baseball

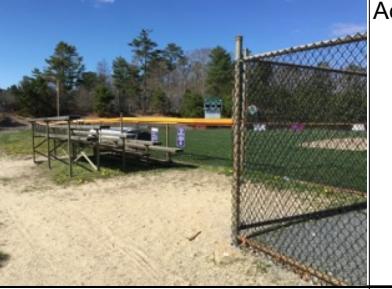
Accessible route not provided to sidelines seating	44'	Provide an accessible route to the each sidelines seating area. (Cost estimate for a 44' asphalt route to each bleacher.)	2	572	\$1144

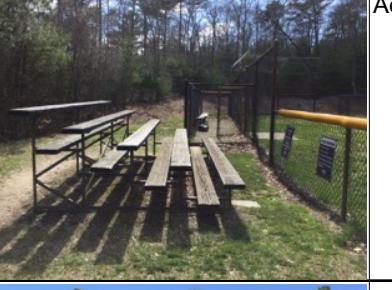
22	Baseball Fields (8 Bleachers Total)	Ext		Field	Baseball

Accessible spaces not provided at sidelines seating		Provide wheelchair spaces alongside each bleacher. Provide a level 36" by 60" clear floor space. along each side of each of the eight bleachers in the park. (Cost estimate for an asphalt accessible space beside the lowest seat on each side of each bleacher.)	16	65	\$1040
23	East Baseball Field Closest to State Road	Ext		Field	Baseball

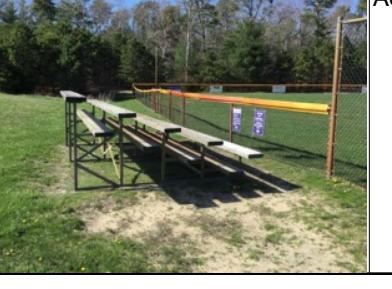
Accessible spaces not provided at sidelines seating	150'	Provide an accessible route to each of the the sideline seating areas. (Cost estimate based on a 150' asphalt route.)	1	1950	\$1950

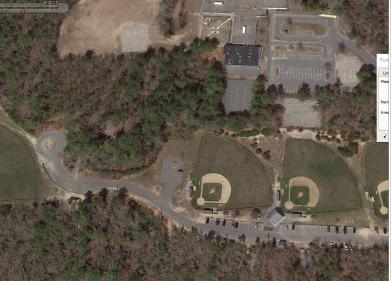
Not connected to an accessible-route	757'	Provide an accessible route between all areas of sports activity within the park. (Cost estimate for a 757' asphalt route.)	1	9841	\$9841
25	East Baseball Field Closest to State Road	Ext		Field	Baseball

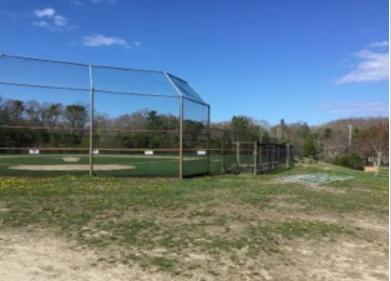
Not connected to an accessible-route	50'	Ensure both team seating areas are connected to an accessible route. (Cost estimate based on a 50' asphalt route.)	1	650	\$650
26	Far West Baseball Field by Playground	Ext		Field	Softball

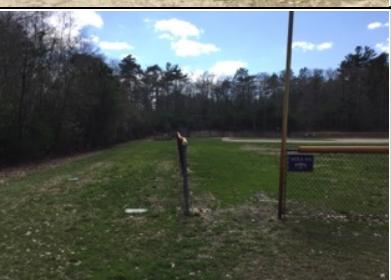
Not connected to an accessible-route	362'	Ensure the team and spectator areas are connected to an accessible route. (Cost estimate for a 362' asphalt walkway.)	1	4706	\$4706
27	Two Central Baseball Fields (Second and Third From State Road)	Ext		Field	Baseball

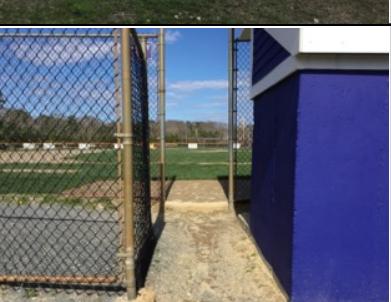
Not connected to an accessible-route	10'	Ensure baseball field is connected to an accessible route. (Cost estimate for 10' asphalt route each.)	2	130	\$260

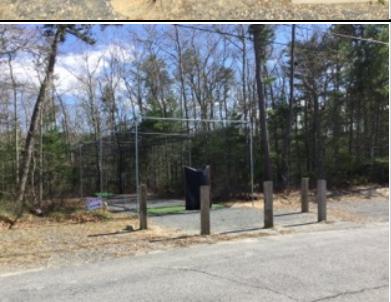
28	Batting Cages	Ext		Field	Baseball

Practice areas are not on an accessible route	25'	Provide an accessible route to at least one of the two practice areas. (Cost estimate for a 25' long asphalt route.)	1	325	\$325

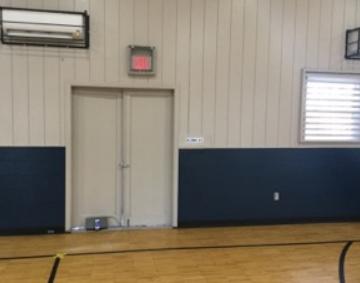
Emergency exit not on an accessible route Directional sign to accessible emergency exit not provided	- -	Provide a directional sign indicating the location of the nearest accessible emergency exit.	1	116	\$116
6	Exit to Stairs	1		Emergency Exit	N/A

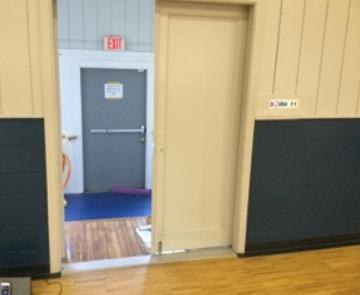
Emergency exit not on an accessible route Directional sign to accessible emergency exit not provided	- -	Provide a directional sign indicating the location of the nearest accessible emergency exit.	1	116	\$116
7	Emergency Egress	1		Emergency Exit	N/A

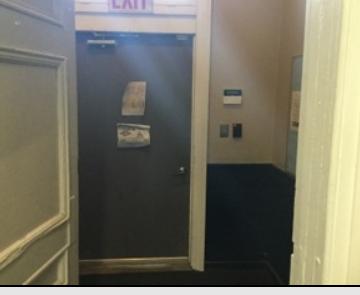
Directional sign to accessible emergency exit not provided Hardware not operable with a closed fist	- -	Provide a directional sign indicating the location of the nearest emergency exit. Provide hardware that can be operable with one hand and not require tight grasping, pinching, or twisting of the wrist.	1	358	\$358

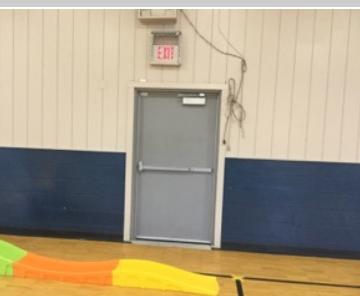
Access to Goods and Services												
Means of Egress												
8	Gym Accessible Egress to Ramp	1		Means of Egress	N/A

Tactile exit sign not provided	-	Ensure tactile exit signs with raised characters and braille are provided at exit doors. Mount signs between 48"- 60" above finish floor located on the latch side of the door.	1	116	\$116
9	Game Room Egress to Lower Ramp	B		Means of Egress	N/A

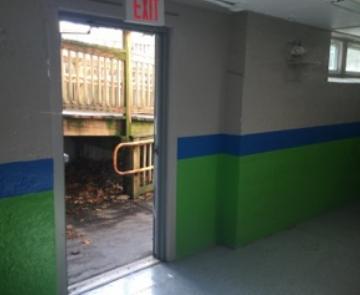
Tactile exit sign not provided	-	Ensure tactile exit signs with raised characters and braille are provided at exit doors. Mount signs between 48"- 60" above finish floor located on the latch side of the door.	1	116	\$116

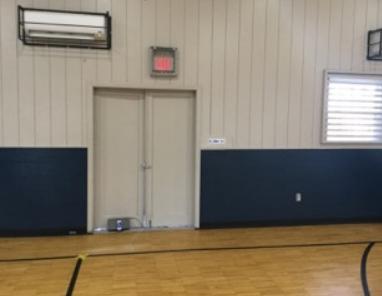
ID	Location	Floor	Room	Element	Type	Photo	Issues	Current Measure	Recommendations	Quantity	Price	Cost Estimation
10	Gym Egress to Stairs / Locked Door	1		Means of Egress	N/A

Tactile exit sign not provided	-	Ensure tactile exit signs with raised characters and braille are provided at exit doors. Mount signs between 48"- 60" above finish floor located on the latch side of the door.	1	116	\$116
11	Gym Exit to Stairs	1		Means of Egress	N/A

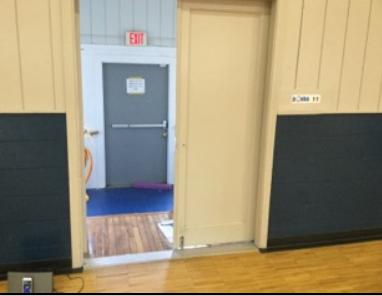
Tactile exit sign not provided	-	Ensure tactile exit signs with raised characters and braille are provided at exit doors. Mount signs between 48"- 60" above finish floor located on the latch side of the door.	1	116	\$116
Interior Access Route												
12	Office	1		Interior Access Route	N/A

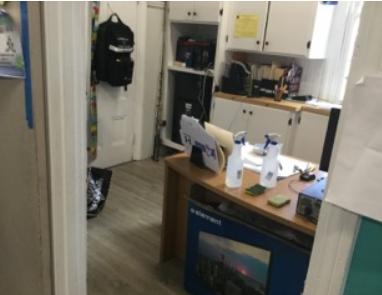
Route < 36" wide	29"	Reposition desk to ensure that a clear width of 36" min. is maintained at the accessible route.	1	Labor	\$0
Doors, Doorways, & Gates

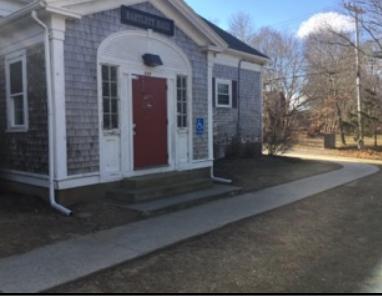
13	Egress Near Main Entrance	Ext.		Doors, Doorways, & Gates	Emergency Egress

Maneuvering clearance(s) not provided	-	Provide a landing that is 60" min. long. (Cost base on a 3' wide min. by 5' deep min. landing at the egress door.)	1	115	\$115
14	Main Entrance	Ext.		Doors, Doorways, & Gates	N/A

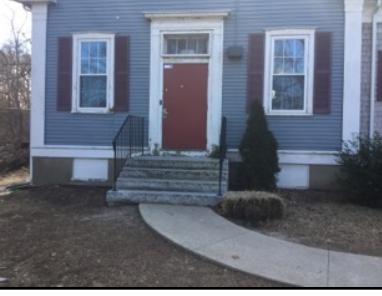
Maneuvering clearance(s) not provided	-	Provide a landing that is 60" min. long. (Cost base on a 3' wide min. by 5' deep min. landing at the egress door.)	1	115	\$115

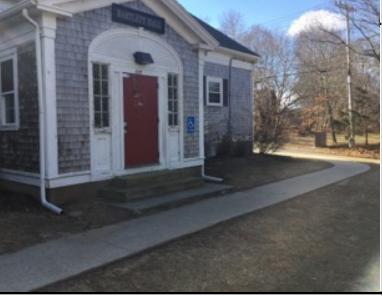
Handrail not provided on both sides	-	Provide handrails on both sides. (cost based on two 4' metal handrails at \$37 a foot.)	1	148	\$148
17	One of Two Stairways to Basement	1		Stairways	Interior

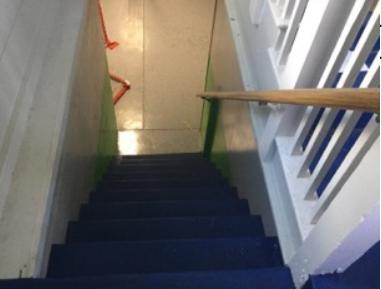
Handrail not provided on both sides Handrails do not extend 12" from stairs	-	At each staircase, provide handrail on one side. Top: Ensure handrails extend horizontally above the landing for 12" min. beginning above the first riser nosing. Bottom: Ensure handrails extend to one tread depth beyond the last riser. (Cost based on a 12' wood handrail plus 2 1' rail extensions for the existing handrail at each staircase.)	2	596	\$1192

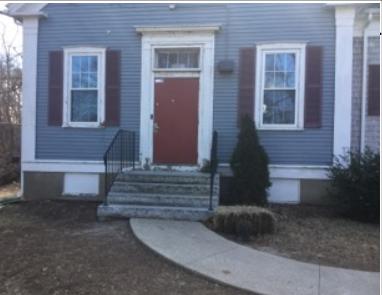
18	Main Entrance	Ext.		Stairways	Exterior

Handrails do not extend 12" from stairs	-	Bottom: Ensure handrails extend to one tread depth beyond the last riser. (Cost based on welding extensions on existing metal railings.)	1	142	\$142
Operable Parts												
19	By exit craft room	1		Operable Parts	Clothes Rod/Hooks

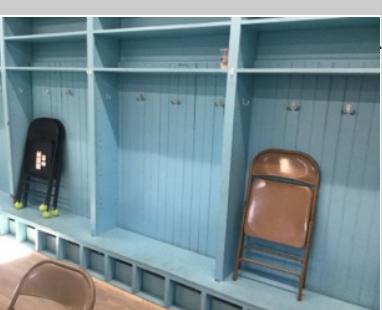
Side reach > 54"	-	Relocate so that a min. of 5% of coat hooks (at least 4) are between 15" - 48" above finish floor.	4	Labor	\$0
Toilet & Bathing Rooms

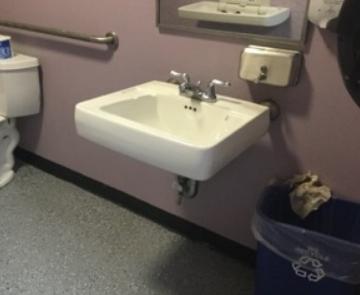
ID	Location	Floor	Room	Element	Type	Photo	Issues	Current Measure	Recommendations	Quantity	Price	Cost Estimation
Lavatory												
20	Women's	B		Lavatory	N/A

Plumbing underneath is exposed	-	Insulate or otherwise configure pipes to prevent contact, for at least one lavatory.	1	46	\$46
Single-User Toilet												
21	Women's	B		Single-User Toilet	N/A

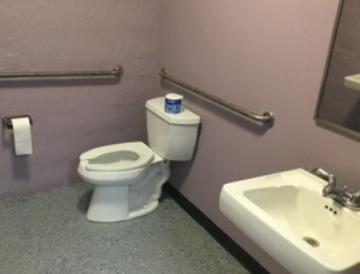
Flush control not on open side	-	Relocate the flush control to the open side.	1	187	\$187
Additional Access												
Drinking Fountains												
22	Near Toilet Rooms	B		Drinking Fountains	Low

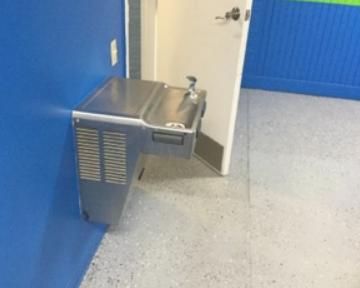
No drinking fountain provided for standing users	-	Provide an additional drinking fountain for standing users or install a hi-lo drinking fountain.	1	2014	\$2014

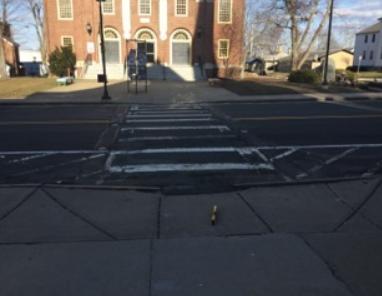
ID	Location	Floor	Room	Element	Type	Photo	Issues	Current Measure	Recommendations	Quantity	Price	Cost Estimation
Approach and Entrance												
Curb Ramp												
1	Court Street Cross at Shuttle Stop	Ext.		Curb Ramp	N/A

Running slope > 1:12 (8.33%) Landing not provided at top of curb ramp Detectable warning not provided	13.7% - -	Reduce running slope to be no steeper than 1:12 (8.33%). Provide landing at top of curb ramp or reconfigure ramp so landing cross slope is 1:50 (2.00%) max. in all directions. Provide a detectable warning on the curb ramp. (Cost based on a new curb ramp.)	2	1225	\$2450
Off-Street Parking Lot or Garage												
2	Memorial Drive East Side of Hall	Ext.		Off-Street Parking Lot or Garage	N/A

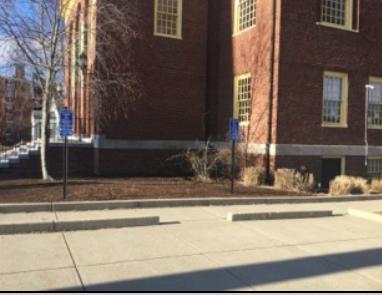
Total # of parking Total # of designated accessible parking spaces Total # of designated van accessible spaces Access aisle not provided Sign does not have the designation "Van Accessible"	2 2 - - -	Provide a marked access aisle that is at least 96" wide. (Re-stripe.) Add the designation "Van Accessible" to the sign located at the van accessible space. Mount the sign 60" min. and 96" max. above the ground.	1	400	\$400

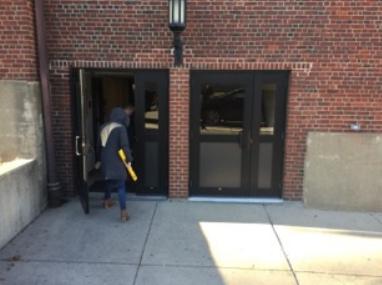
Entrance												
3	Staff Entrance and Egress Doors on Memorial Drive Near Municipal Parking Lot	Ext.		Entrance	Other

Directional sign to accessible entrance not provided	-	Provide a directional sign indicating the location of the nearest accessible entrance.	1	173	\$173
4	Main Entrance on Court Street	Ext.		Entrance	Main Entrance

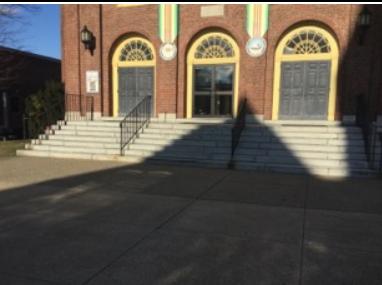
Directional sign to accessible entrance not provided	-	Provide a directional sign indicating the location of the nearest accessible entrance.	1	173	\$173
Access to Goods and Services

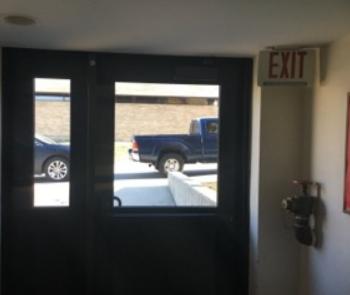
ID	Location	Floor	Room	Element	Type	Photo	Issues	Current Measure	Recommendations	Quantity	Price	Cost Estimation
Means of Egress												
5	Staff Entrance and Egress at Memorial Drive	B		Means of Egress	N/A

Tactile exit sign not provided	-	Ensure tactile exit signs with raised characters and braille are provided at exit doors. Mount signs between 48"- 60" above finish floor located on the latch side of the door.	1	116	\$116
6	Egress on Memorial Drive	B		Means of Egress	N/A

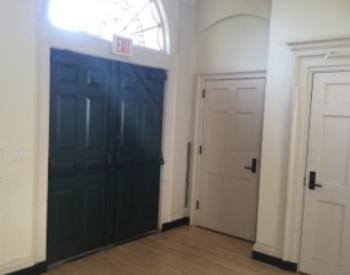
Tactile exit sign not provided	-	Ensure tactile exit signs with raised characters and braille are provided at exit doors. Mount signs between 48"- 60" above finish floor located on the latch side of the door.	2	116	\$232

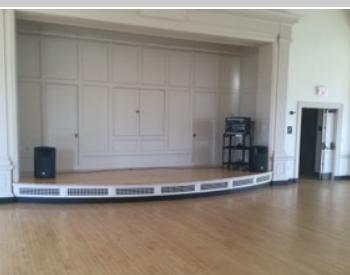
Interior Access Route												
8	Blue Room	2		Interior Access Route	N/A

Accessible route not provided to stage.	-	Provide an accessible route. (Cost based on a 15' long x 48" wide pressure treated wood ramp.)	1	1961	\$1961
Stairways												
9	Main Entrance on Court Street	Ext.		Stairways	Exterior

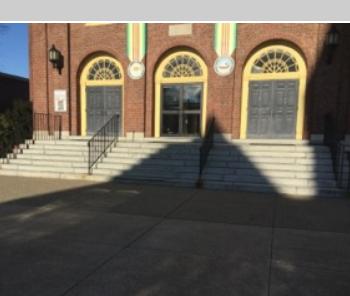
Handrails do not extend 12" from stairs	-	Bottom: Ensure handrails extend to one tread depth beyond the last riser. (Cost based on welding extensions on to existing railings.)	4	71	\$284

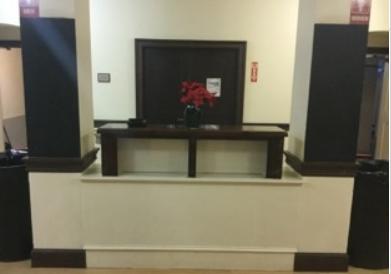
ID	Location	Floor	Room	Element	Type	Photo	Issues	Current Measure	Recommendations	Quantity	Price	Cost Estimation
Service Counter												
10	Bar Near Accessible Entrance	B		Service Counter	N/A

Counter > 36" high	45"	Provide a counter that is 36" max. above the ground or finish floor. Note: IHCD was told that lower accessible service tables are provided when the bar is used.	1	Labor	\$0
11	Box Office	1		Service Counter	N/A

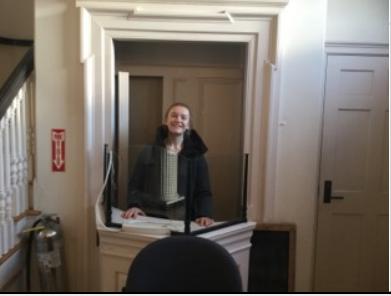
Counter > 36" high	-	Provide a counter that is 36" max. above the ground or finish floor. (Note: IHCD was told a new accessible box office counter is being built.)	1	440	\$440
Toilet & Bathing Rooms												
Lavatory												
12	Single-User Toilet Room	2		Lavatory	N/A

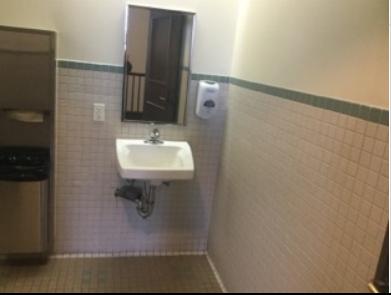
Plumbing underneath is exposed	-	Insulate or otherwise configure pipes to prevent contact, for at least one lavatory.	1	46	\$46
Toilet Compartment												
13	Men's Accessible Compartment	B		Toilet Compartment	Accessible Compartment

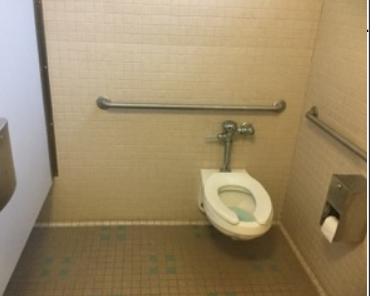
ID	Location	Floor	Room	Element	Type	Photo	Issues	Current Measure	Recommendations	Quantity	Price	Cost Estimation
14	Women's Accessible Compartment	B		Toilet Compartment	Accessible Compartment

Door has malfunctioning self-closing hinge	-	Repair hinge.	1	Labor	\$0
Dispensers												
15	Women's Multi-User Toilet Room	B		Dispensers	Hand Dryer

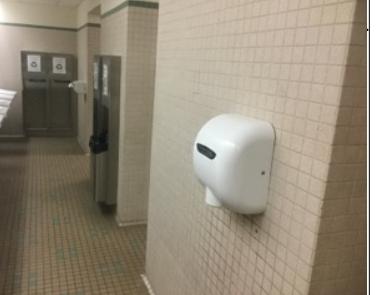
Dispenser acts as a protruding object	41"	Relocate dispenser out of the circulation path.	2	353	\$706
Additional Access												
Drinking Fountains												
16	Near Multi-User Toilet Rooms	B		Drinking Fountains	Low

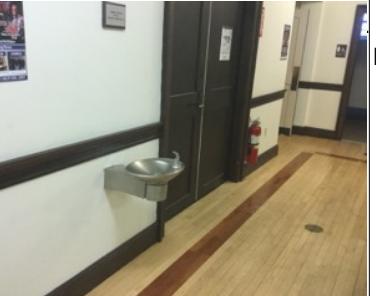
No drinking fountain provided for standing users Knee or toe clearance not provided	- 25"	Provide an additional drinking fountain for standing users or install a hi-lo drinking fountain. Provide knee and toe clearance, 27" min. high at drinking fountain for seated users. (Cost for a new hi-lo fountain.)	1	2108	\$2108
17	Near Single-User Toilet Room	2		Drinking Fountains	Low

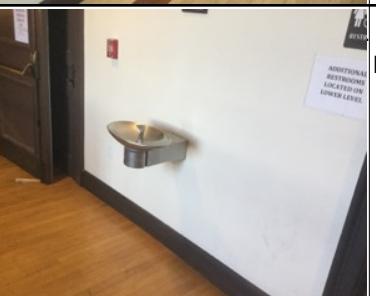
No drinking fountain provided for standing users Knee or toe clearance not provided	- 26"	Provide an additional drinking fountain for standing users or install a hi-lo drinking fountain. Provide knee and toe clearance, 27" min. high at drinking fountain for seated users. (Cost for a new hi-lo fountain.)	1	2108	\$2108

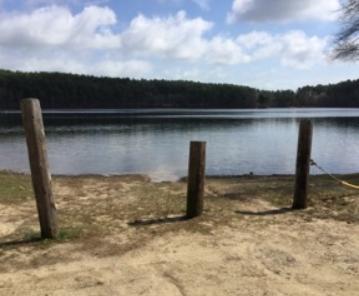
ID	Location	Floor	Room	Element	Type	Photo	Issues	Current Measure	Recommendations	Quantity	Price	Cost Estimation
Approach and Entrance												
Exterior Access Route												
1	Small Boat Launch at Red Springs Beach	Ext.		Exterior Access Route	Exterior

Cross slope > 1:50 (2.00%) (MAAB) Surface not stable, firm, and slip-resistant Running slope > 1:20 (5.00%) Accessible route not provided	8.3% - 12% -	Reduce cross slope to be no steeper than 1:50 (2.00%). Repair surface. Reduce the running slope to be no steeper than 1:20 (5.00%). Ensure an accessible route is provided. (Cost based on 36" wide min. 50' long stone dust path.)	1	570	\$570
2	Parking at Red Springs Beach	Ext.		Exterior Access Route	Exterior

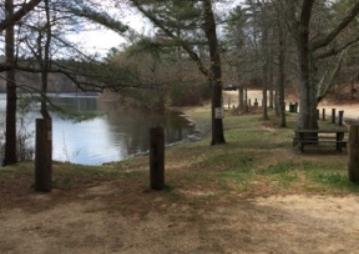
Cross slope > 1:50 (2.00%) (MAAB) Surface not stable, firm, and slip-resistant Running slope > 1:20 (5.00%) Accessible route not provided	4.4% - 15.9% -	Reduce cross slope to be no steeper than 1:50 (2.00%). Reduce the running slope to be no steeper than 1:20 (5.00%). Ensure an accessible route is provided. (Cost based on 36" wide min. 58' long stone dust path.)	1	661	\$661

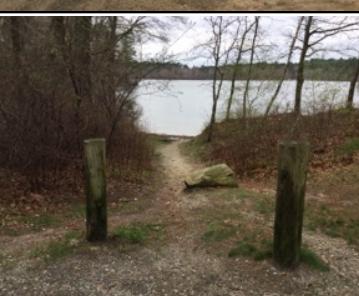
3	Girl's Swimming Area	Ext.		Exterior Access Route	Exterior

Cross slope > 1:50 (2.00%) (MAAB) Surface not stable, firm, and slip-resistant Running slope > 1:20 (5.00%)	7.8% - 21.4%	Reduce cross slope to be no steeper than 1:50 (2.00%). Repair surface. Reduce the running slope to be no steeper than 1:20 (5.00%). (Cost based on 36" wide min. 82' long stone dust path.)	1	934	\$934
4	Parking at The Grove	Ext.		Exterior Access Route	Exterior

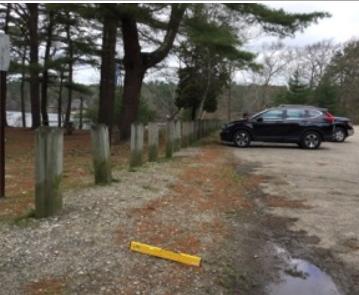
Cross slope > 1:50 (2.00%) (MAAB) Running slope > 1:20 (5.00%)	2.4% 11.6%	Reduce cross slope to be no steeper than 1:50 (2.00%). Reduce the running slope to be no steeper than 1:20 (5.00%). See ID #5 for cost.	1	0	\$0
5	From Parking at The Grove to Concession	Ext.		Exterior Access Route	Exterior

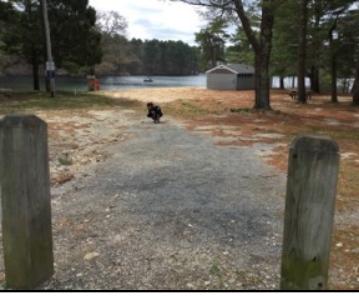
Cross slope > 1:50 (2.00%) (MAAB) Running slope > 1:20 (5.00%)	3.8% 11%	Reduce cross slope to be no steeper than 1:50 (2.00%). Reduce the running slope to be no steeper than 1:20 (5.00%). (Cost based on 36" wide min. 206' long of concrete.)	1	2346	\$2346

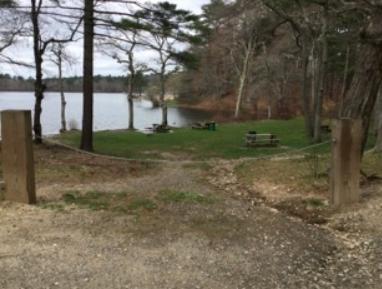
ID	Location	Floor	Room	Element	Type	Photo	Issues	Current Measure	Recommendations	Quantity	Price	Cost Estimation
6	Picnic Area at Girl's Swimming Area	Ext.		Exterior Access Route	Exterior

Surface not stable, firm, and slip-resistant Running slope > 1:20 (5.00%) Accessible route not provided	- 15.2% 60'	Repair surface. Reduce the running slope to be no steeper than 1:20 (5.00%). Ensure an accessible route is provided. (Cost based on 36" wide min. 60' long stone dust path.)	1	684	\$684
7	Red Springs Beach	Ext.		Exterior Access Route	Exterior

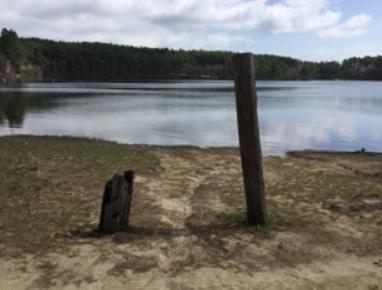
Surface not stable, firm, and slip-resistant Accessible route not provided	- 15'	Repair surface. Ensure an accessible route is provided. (Cost based on 36" wide min. 15' long stone dust path.)	1	171	\$171
Beach Access Routes												
8	The Grove	Ext.		Beach Access Routes	Permanent

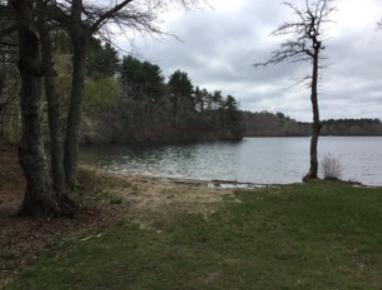
9	Girl's Swimming Area (From Picnic Area)	Ext.		Beach Access Routes	Permanent

Beach route not provided	-	Provide an accessible route that is firm and stable. Ensure the accessible route extends to the recreation water level. (Cost based on 36" wide min. 40' long stone dust path.)	1	456	\$456
Off-Street Parking Lot or Garage												
10	Parking at The Grove	Ext.		Off-Street Parking Lot or Garage	N/A

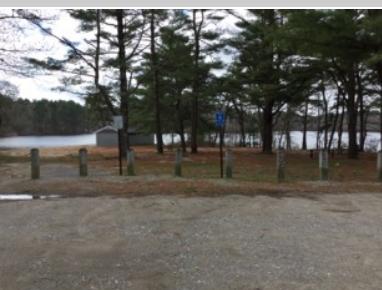
Total # of parking Total # of designated accessible parking spaces Total # of designated van accessible spaces Vehicle space < 96" wide at car space Vehicle space < 132" wide at van space Access aisle not provided Sign does not have the designation "Van Accessible"	30 4 0 - - - -	Provide one (1) van accessible space that is at least 132" wide and one (1) standard accessible space that is at least 96" wide. Provide a marked access aisle that is at least 60" wide between accessible parking spaces. Add the designation "Van Accessible" to the sign located at the van accessible space. (Cost based on painting lines for two (2) parking	1	700	\$700

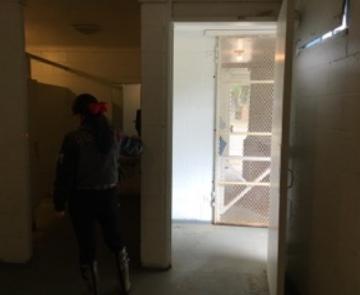
ID	Location	Floor	Room	Element	Type	Photo	Issues	Current Measure	Recommendations	Quantity	Price	Cost Estimation
Doors, Doorways, & Gates												
16	The Grove/Concession - Men's Toilet Room	Ext.		Doors, Doorways, & Gates	Toilet Room

Maneuvering clearance(s) not provided	41.5"	Alteration to provide a 48" min. maneuvering clearance may be technically infeasible.	1	0	\$0
17	The Grove/Concession - Women's Toilet Room	Ext.		Doors, Doorways, & Gates	Toilet Room

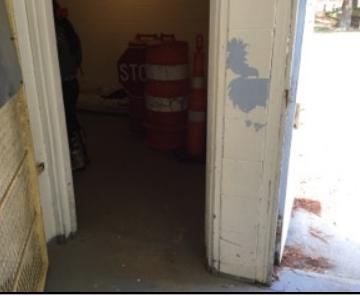
Maneuvering clearance(s) not provided	44.75"	Alteration to provide a 48" min. maneuvering clearance may be technically infeasible.	1	0	\$0
18	The Grove/Concession - Men's and Women's Toilet Rooms	Ext.		Doors, Doorways, & Gates	Toilet Room

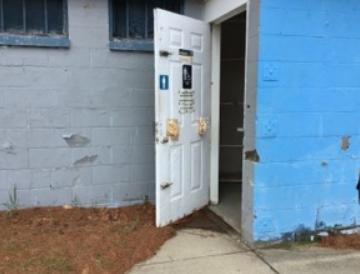
Threshold > 3/4" high	2"	Alter threshold to be 3/4" high max.	2	75	\$150
Signage												
19	The Grove/Concession - Men's and Women's Toilet Rooms	Ext.		Signage	Designation

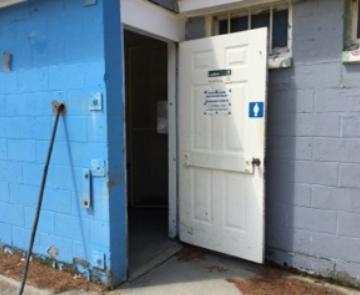
Raised characters not provided Braille not provided Sign not located on the latch side of the door	- - -	Provide text with raised characters duplicated in braille. Locate sign at permanent rooms alongside the door on the latch side.	2	173	\$346

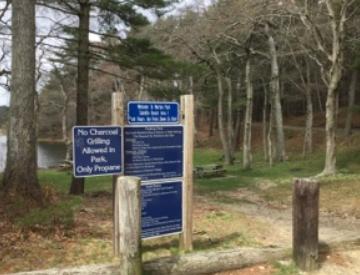
20	Girl's Swimming Area	Ext.		Signage	N/A

Text size non-compliant	-	Ensure that character size complies with the Character Height Table 703.5.5 in the ADA 2010 Standards.	1	400	\$400

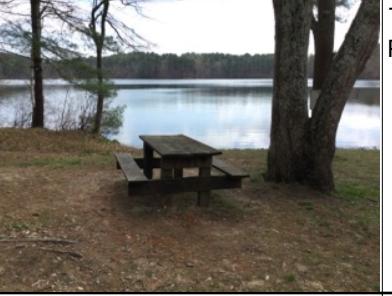
Toe or knee clearance at table not provided Picnic table not on an accessible route	- -	Provide at least one picnic table with toe and knee clearance. Locate picnic table on an accessible route.	1	700	\$700
23	The Grove (West)	Ext.		Picnic Tables	N/A

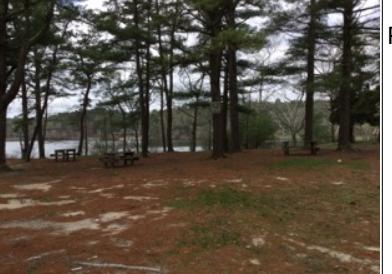
Toe or knee clearance at table not provided Picnic table not on an accessible route	- -	Provide at least one picnic table with toe and knee clearance. Locate picnic table on an accessible route.	1	700	\$700
24	The Grove (East)	Ext.		Picnic Tables	N/A

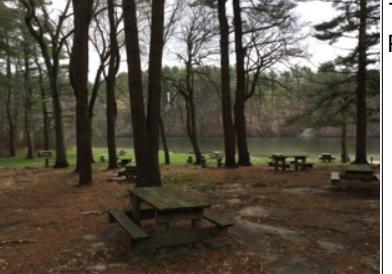
Toe or knee clearance at table not provided Picnic table not on an accessible route	- -	Provide at least one picnic table with toe and knee clearance. Locate picnic table on an accessible route.	1	700	\$700

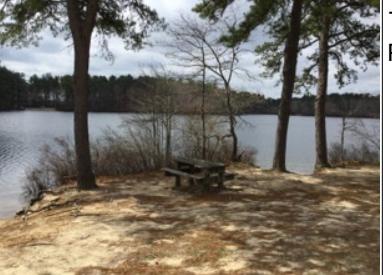
25	The Grove by Concessions	Ext.		Picnic Tables	N/A

Toe or knee clearance at table not provided Picnic table not on an accessible route	- -	Provide at least one picnic table with toe and knee clearance. Locate picnic table on an accessible route.	1	700	\$700

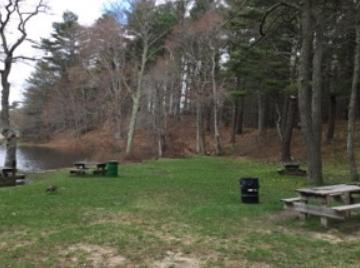
ID	Location	Floor	Room	Element	Type	Photo	Issues	Current Measure	Recommendations	Quantity	Price	Cost Estimation
26	Picnic Area at Girl's Swimming Area	Ext.		Picnic Tables	N/A

Toe or knee clearance at table not provided Picnic table not on an accessible route	- -	Provide at least one picnic table with toe and knee clearance. Locate picnic table on an accessible route.	1	700	\$700
27	Boy's Swimming Area	Ext.		Picnic Tables	N/A

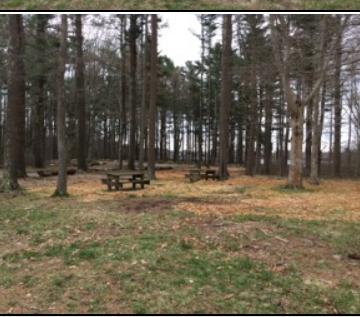
Toe or knee clearance at table not provided Picnic table not on an accessible route	- -	Provide at least one picnic table with toe and knee clearance. Locate picnic table on an accessible route.	1	700	\$700
Toilet & Bathing Rooms												
Toilet Compartment												
28	The Grove/Concession - Women's Toilet Room	Ext.		Toilet Compartment	Accessible Compartment

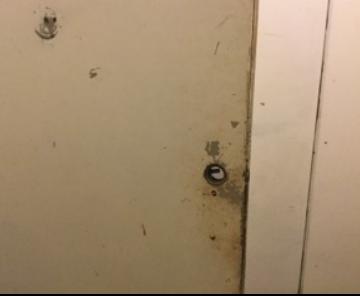
Door with non-compliant hardware	-	Provide hardware that can be operable with one hand and not require tight grasping, pinching, or twisting of the wrist.	1	12	\$12

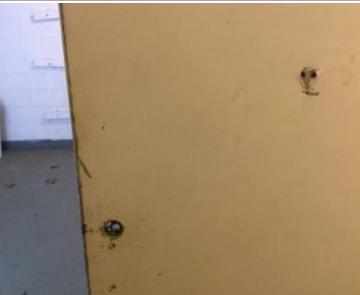
29	The Grove/Concession - Men's Toilet Room	Ext.		Toilet Compartment	Accessible Compartment

Door with non-compliant hardware	-	Provide hardware that can be operable with one hand and not require tight grasping, pinching, or twisting of the wrist.	1	12	\$12
30	The Grove/Concession - Women's Toilet Room	Ext.		Toilet Compartment	Accessible Compartment

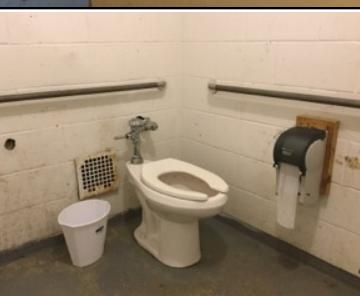
Side grab bar < 42" long	40.25"	Provide a side wall grab bar that is 42" long min. located 12" max. from the rear wall.	1	449	\$449

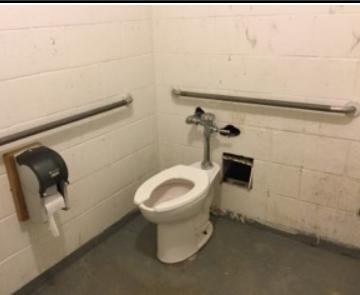
ID	Location	Floor	Room	Element	Type	Photo	Issues	Current Measure	Recommendations	Quantity	Price	Cost Estimation
31	The Grove/Concession - Men's Toilet Room	Ext.		Toilet Compartment	Accessible Compartment

Rear grab bar < 42" long	40"	Provide a rear wall grab bar that is 42" long min. and extends from the toilet 12" min. on one side and 24" min. on the other side (open side).	1	449	\$449
Dispensers												
32	The Grove/Concession - Women's Toilet Room	Ext.		Dispensers	N/A

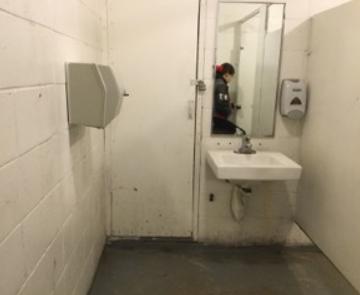
Controls > 42" (MAAB) Obstructed by protruding objects	50" -	Relocate paper towel dispenser so the operable part is 42" max. above the finish floor. Ensure paper towel dispenser does not protrude into the circulation path.	1	353	\$353
33	The Grove/Concession - Men's Toilet Room	Ext.		Dispensers	N/A

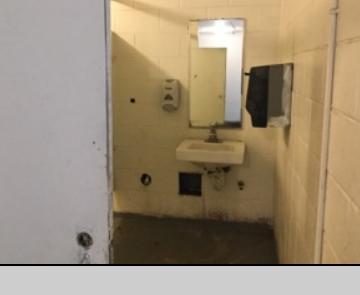
Controls > 42" (MAAB) Obstructed by protruding objects		Relocate so the operable part of the paper towel and soap dispensers are 42" max. above the finish floor. Ensure paper towel dispenser does not protrude into the circulation path.	2	353	\$706

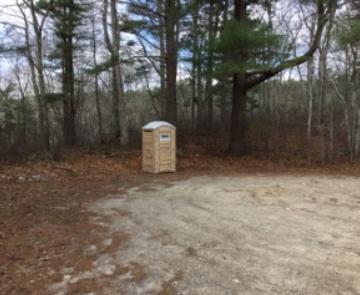
Portable Toilet												
34	Parking at Red Springs Beach, Boy's Swimming Area, Boat Launch to Billington Sea	Ext.		Portable Toilet	N/A

Accessible portable toilets not provided Not located on an accessible route	- -	Provide one portable toilets is accessible. Ensure the portable toilet is on an accessible route.	3	2300	\$6900

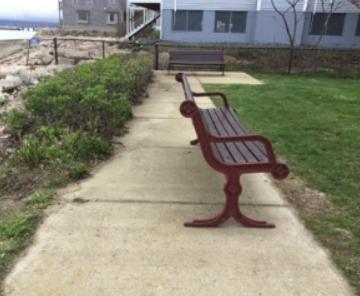
ID	Location	Floor	Room	Element	Type	Photo	Issues	Current Measure	Recommendations	Quantity	Price	Cost Estimation
Approach and Entrance												
Exterior Access Route												
1	Walkway Between Water and Play Area	Ext		Exterior Access Route	Exterior

Exterior route < 36" wide	33"	Ensure that a clear width of 36" min. is maintained at the accessible route. (Relocate bench to an accessible location that does not obstruct route.)		Labor	\$0
2	Walkway From Boat Launch Area	Ext		Exterior Access Route	Walkway

Best practice recommendation.		Recommend relocating bench that obstructs walkway to existing location with an accessible surface that does not obstruct walkway and has clear floor space next to bench. (See ID #1.)	1	Labor	\$0

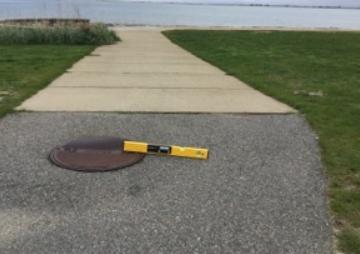
Cross slope > 1:50 (2.00%) (MAAB)	7.6%	Reduce cross slope to be no steeper than 1:50 (2.00%). (Cost based on 36" wide min. 3' long patch of asphalt to correct cross slope to 2.00% (1:50) max.)	1	45	\$45
3	End of Walkway by Boat Launch Area	Ext		Exterior Access Route	Walkway

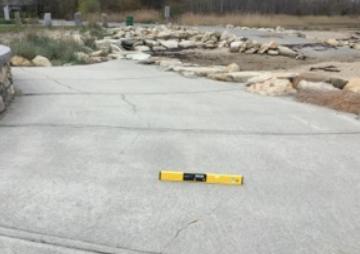
Cross slope > 1:50 (2.00%) (MAAB)	6.8%	Reduce cross slope to be no steeper than 1:50 (2.00%). (Cost based on 60" wide min. 30' long patch of concrete to correct cross slope to 2.00% (1:50) max.)	1	900	\$900

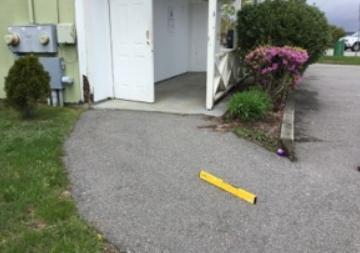
4	Toilet Rooms and Concessions	Ext		Exterior Access Route	Walkway

Cross slope > 1:50 (2.00%) (MAAB) Running slope > 1:20 (5.00%)	3.4% 7.7%	Reduce cross slope to be no steeper than 1:50 (2.00%). Reduce the running slope to be no steeper than 1:20 (5.00%). (Cost based on 36" wide min. 12' long of asphalt to correct path running slope to 5.00% (1:20) max. and cross slope to 2.00% (1:50) max.)	1	180	\$180
5	Path From Parking to Play Area	Ext		Exterior Access Route	Walkway

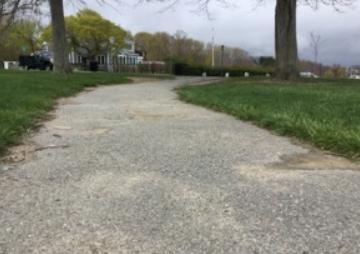
Not maintained in an operable working condition		Ensure the accessible route is maintained in operable working condition.	1	Labor	\$0

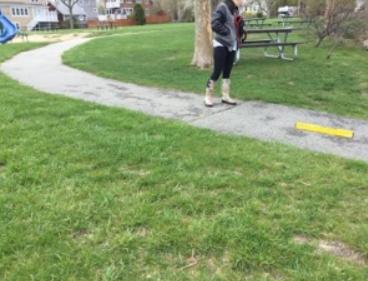
ID	Location	Floor	Room	Element	Type	Photo	Issues	Current Measure	Recommendations	Quantity	Price	Cost Estimation
6	Between Splash Pad and Playground	Ext		Exterior Access Route	Walkway

Running slope > 1:20 (5.00%)	7.4%	Reduce the running slope to be no steeper than 1:20 (5.00%). (Cost based on 36" wide min. 40' long of asphalt to correct path running slope to 5.00% (1:20) max.)	1	600	\$600
7	Walkway Between Water and Play Area	Ext		Exterior Access Route	Walkway

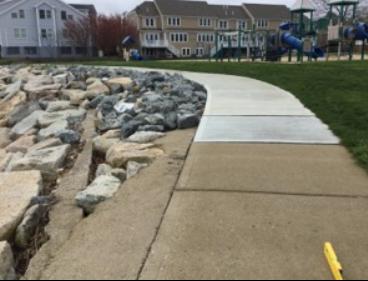
Running slope > 1:20 (5.00%)	6.3%	Reduce the running slope to be no steeper than 1:20 (5.00%). (Cost based on 60" wide min. 50' long of concrete to correct path running slope to 5.00% (1:20) max.)	1	1500	\$1500
Off-Street Parking Lot or Garage												
8	Parking Lot	Ext		Off-Street Parking Lot or Garage	N/A

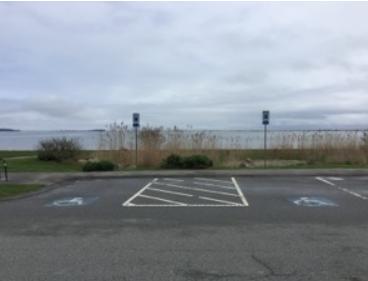
Total # of parking Total # of designated accessible parking spaces Total # of designated van accessible spaces Vehicle space < 132" wide at van space Sign does not have the designation "Van Accessible"	38 2 0 122" -	Provide a van accessible space that is at least 132" wide with an access aisle that is 60" wide min. Add the designation "Van Accessible" to the sign located at the van accessible space. (Cost based on re-painting stripes for van accessible parking space and adding van accessible sign to van accessible space.)	1	400	\$400

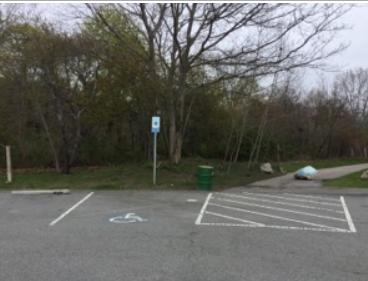
9	Parking Lot Near Trailhead	Ext		Off-Street Parking Lot or Garage	N/A

Total # of parking Total # of designated accessible parking spaces Total # of designated van accessible spaces	8 1 0	Provide a van accessible parking space that is 96" wide min. with adjoining access aisle that is 96" wide min. Add the designation "Van Accessible" to the sign located at the van accessible space. (Cost based on re-painting stripes for van accessible parking space and adding van accessible sign to van accessible space.)	1	400	\$400
10	Parking Lot	Ext		Off-Street Parking Lot or Garage	Visitor

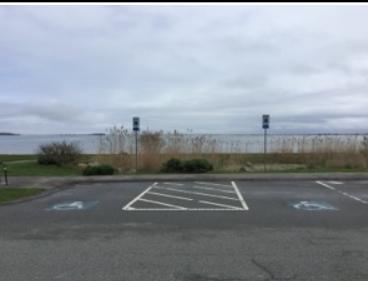
Access aisle does not adjoin an accessible route	17.9%	Ensure the access aisle adjoins an accessible route. (Install compliant curb ramp where access aisle joins walkway.) (Cost based on a new curb ramp at a concrete sidewalk.)	1	1225	\$1225
Access to Goods and Services

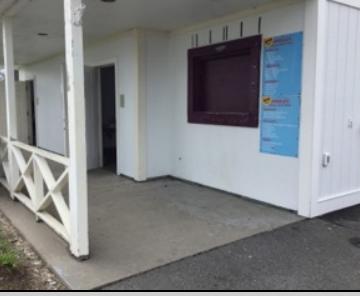
ID	Location	Floor	Room	Element	Type	Photo	Issues	Current Measure	Recommendations	Quantity	Price	Cost Estimation
Service Counter												
11	Toilet Rooms and Concessions	Ext		Service Counter

Counter > 36" high	46.25"	Provide a counter that is 36" max. above the ground. (Cost for lowering a 36" wide section of counter to 36" high max.)	1	440	\$440
Picnic Tables												
12	Between Splash Pad and Parking	Ext		Picnic Tables	N/A

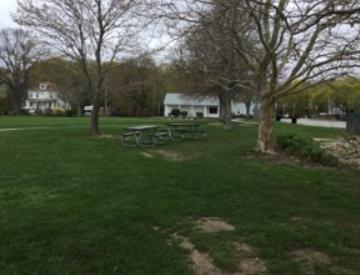
Number of seating spaces at picnic tables Number of accessible seating spaces Clear floor space not provided Toe or knee clearance at table not provided Picnic table not on an accessible route	60- - - - -	Provide at least one accessible picnic table. Ensure that at a 30" by 48" clear floor space positioned for a forward approach is provided at the picnic table. Ensure there is a minimum 48" clear floor space at seating and around table. Locate picnic table on an accessible route. (Cost based on accessible table and 16'x17' asphalt patch at and around picnic seating.)	1	1878	\$1878

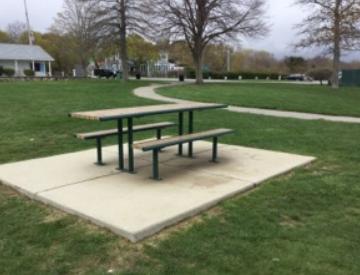
13	Play Area	Ext		Picnic Tables	N/A

Number of seating spaces at picnic tables Number of accessible seating spaces Clear floor space not provided	62- - - - -	Ensure that at a 30" by 48" clear floor space positioned for a forward approach is provided at the picnic table. Ensure there is a minimum 48" clear floor space at seating and around table. (Currently concrete is 10' x 12'. Cost based on expanding existing concrete patch to be 16' x 17').	1	260	\$260
14	Play Area	Ext		Picnic Tables	N/A

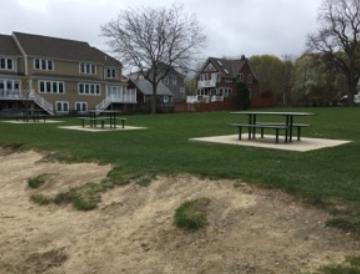
Picnic table not on an accessible route		Locate 20% of picnic tables on an accessible route. (Cost based on 36" wide min. 15' long asphalt path with running slope 5.00% (1:20) max. and cross slope 2.00% (1:50) max.)	1	195	\$195
Trash / Recycling												
15	Trailhead	Ext		Trash / Recycling	N/A

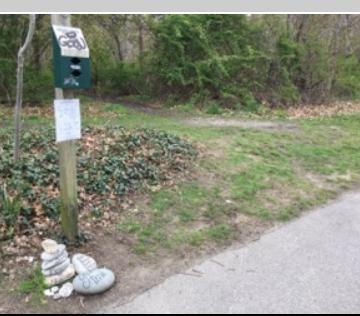
Dog waste bags container opening not within reach range Dog waste bags container not connected to an accessible route	52" 25"	Ensure that operable parts are 48" max. above ground. Ensure dog waste bags container is located on an accessible route.	1	Labor	\$0

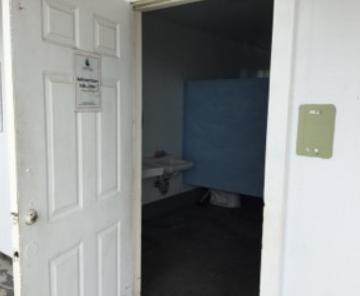
ID	Location	Floor	Room	Element	Type	Photo	Issues	Current Measure	Recommendations	Quantity	Price	Cost Estimation
Toilet & Bathing Rooms												
Overall Access												
16	Toilet Rooms and Concessions	1		Overall Access	Toilet Room

International Symbol of Acc. not provided		Provide a sign with the International Symbol of Accessibility for Men's and Women's Toilet Rooms.	2	116	\$232
Lavatory												
17	Women's Toilet Room	1		Lavatory	N/A

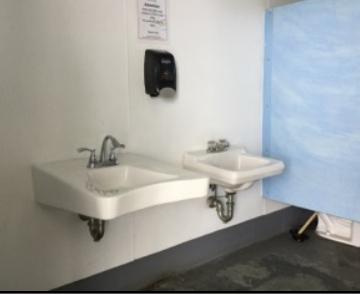
Exposed plumbing underneath Dispensers not within reach range	- 46.75"	Insulate or otherwise configure pipes to prevent contact, for at least one lavatory. Relocate soap dispenser to 48" max. above the floor.	1	399	\$399
18	Men's Toilet Room	1		Lavatory	N/A
