Town of Plymouth

Part A – Executive Summary

October 2019

Prepared by the
**Institute for
Human
Centered
Design**

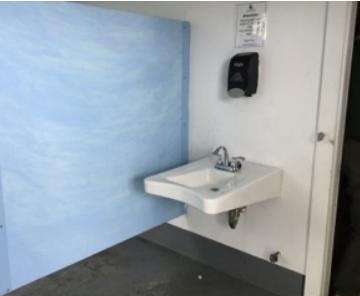
Exposed plumbing underneath Dispensers not within reach range	- 51"	Insulate or otherwise configure pipes to prevent contact, for at least one lavatory. Relocate soap dispenser to 48" max. above the floor.	1	399	\$399

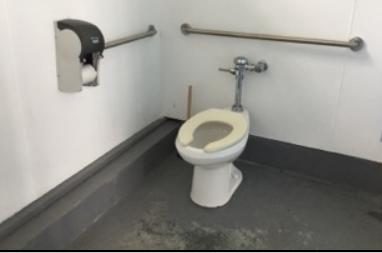
Side grab bar < 42" long Flush control not on open side Non-compliant toilet paper dispenser	25.75" - -	Provide a side wall grab bar that is 42" long min. located 12" max. from the rear wall. Provide the flush control on the open side of the toilet (transfer side). Relocate toilet paper so that it is between 15" and 48" above the finish floor and between 7" and 9" from the front of the toilet.	1	989	\$989

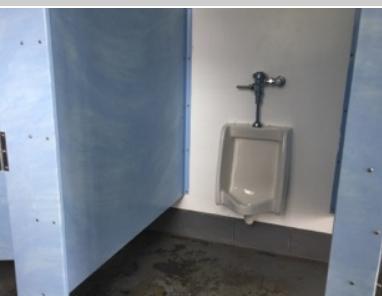
Urinal												
22	Men's Toilet Room	1		Urinal	N/A

Rim > 17" high Flush control too high or not properly located	18.75" 47.5"	Provide at least one urinal with the rim no higher than 17" above the finish floor. Mount flush control at 44" max. above the finish floor.	1	1811	\$1811
Dispensers												
23	Women's Toilet Room	1		Dispensers	N/A

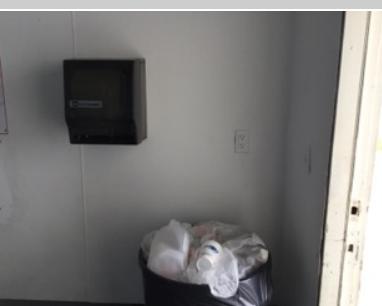
Controls > 42" (MAAB)	57"	Relocate so the operable part for paper towel dispenser is 42" max. above the finish floor.	1	353	\$353
24	Men's Toilet Room	1		Dispensers	N/A

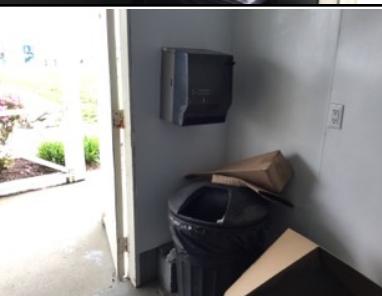
Controls > 48"	53"	Relocate so the operable part for paper towel dispenser is 48" max. above the finish floor.	1	353	\$353
Play and Sport Areas

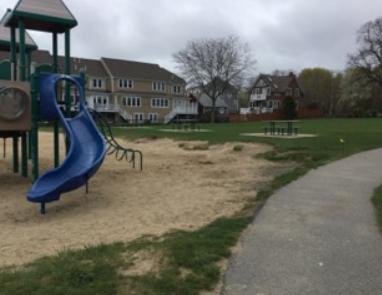
ID	Location	Floor	Room	Element	Type	Photo	Issues	Current Measure	Recommendations	Quantity	Price	Cost Estimation
Play Areas												
25	Play Area	Ext		Play Areas	N/A

Accessible route not provided to ground level play components		Ensure an accessible route is provided to one of each type of ground level play components. (Cost based on 36" wide min. 3' long asphalt path with running slope 5.00% (1:20) max. and cross slope 2.00% (1:50) max.)	1	39	\$39
26	Play Area	Ext		Play Areas	N/A

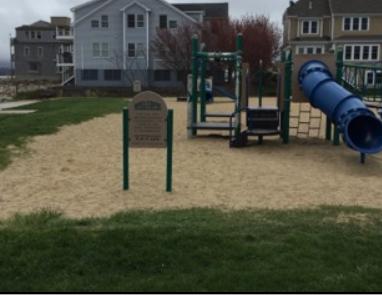
Surface not stable, firm, and slip-resistant		Provide an accessible impact-attenuating surface around and under the play components. (Cost based on 1935 square feet of poured in place rubber.)	1	27090	\$27090
27	Play Area	Ext		Play Areas	N/A

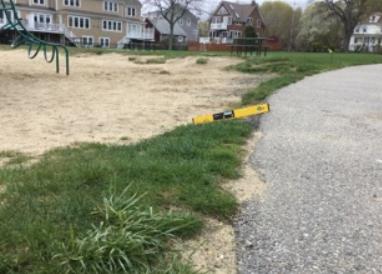
Running slope > 1:20 (5.00%)	30.3%	Reduce the running slope to be no steeper than 1:20 (5.00%). See ID #28 for cost.	1		\$0
Best Practice												
28	Walkway Between Water and Play Area	Ext			N/A

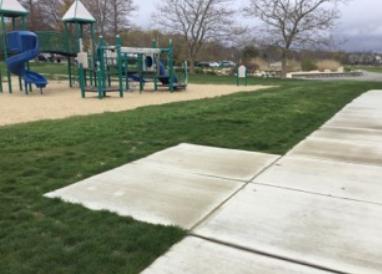
Best practice recommendation.		Recommend relocating bench that obstructs walkway to existing location with an accessible surface that does not obstruct walkway and has clear floor space next to bench. (See ID #1.)	1	Labor	\$0

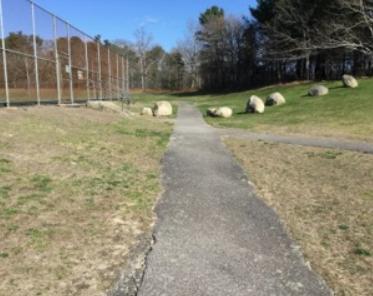
ID	Location	Floor	Room	Element	Type	Photo	Issues	Current Measure	Recommendations	Quantity	Price	Cost Estimation
Approach and Entrance												
Exterior Access Route												
1	Route to Playground and Tennis Courts	Ext		Exterior Access Route	Walkway

Cross slope > 1:50 (2.00%) (MAAB)	3.1%	Reduce cross slope to be no steeper than 1:50 (2.00%). (Cost based on 36" wide min. 88' long of concrete to correct path cross slope to 2.00% (1:50) max.)	1	1320	\$1320
2	Walkway by Circular Drive	Ext		Exterior Access Route	Walkway

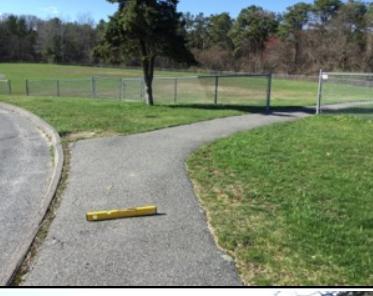
Cross slope > 1:50 (2.00%) (MAAB)	6.5%	Reduce cross slope to be no steeper than 1:50 (2.00%). (Cost based on 36" wide min. 130' long of stone dust to correct path cross slope to 2.00% (1:50) max.)	1	1950	\$1950
3	Walkway on Baseball Field Side of Parking Lot	Ext		Exterior Access Route	Walkway

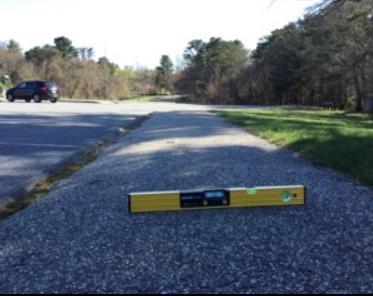
Cross slope > 1:50 (2.00%) (MAAB)	2.8%	Reduce cross slope to be no steeper than 1:50 (2.00%). (Cost based on 36" wide min. 45' long of concrete to correct path cross slope to 2.00% (1:50) max.)	1	675	\$675

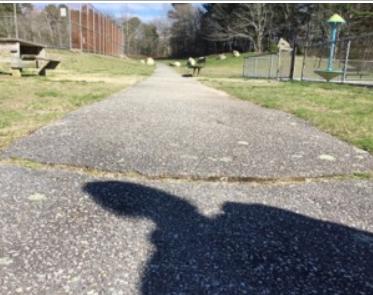
4	Route to Playground and Tennis Courts	Ext		Exterior Access Route	Walkway

Level changes > 1/4"	1"	Alter change in level to be 1/4" high max. (Cost for a 3'x3' concrete patch.)	1	103	\$103
5	Route Between Soccer Field and Baseball Field	Ext		Exterior Access Route	Walkway

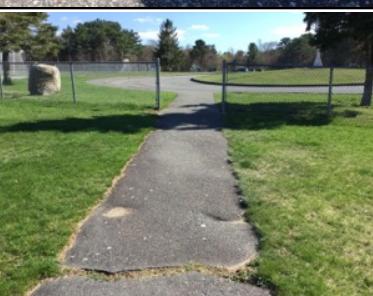
Level changes > 1/4"	2"	Alter change in level to be 1/4" high max. (Cost for a 3'x3' asphalt patch.)	1	18	\$18

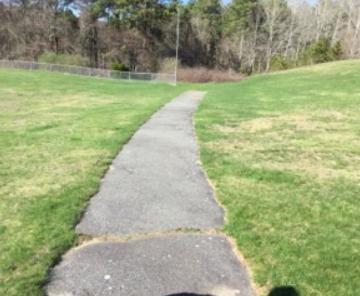
ID	Location	Floor	Room	Element	Type	Photo	Issues	Current Measure	Recommendations	Quantity	Price	Cost Estimation
6	Route Between Soccer Field and Baseball Field	Ext		Exterior Access Route	Walkway

Level changes > 1/4"	1"	Alter change in level to be 1/4" high max. (Cost for a 3'x3' asphalt patch.)	1	18	\$18
7	Walkway on Baseball Field Side of Parking Lot	Ext		Exterior Access Route	Walkway

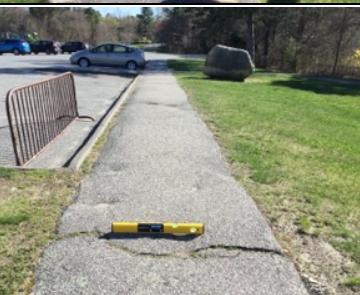
Level changes > 1/4"	1"	Alter change in level to be 1/4" high max. (Cost for a 3'x3' asphalt patch.)	1	18	\$18
8	Route to Playground and Tennis Courts	Ext		Exterior Access Route	Walkway

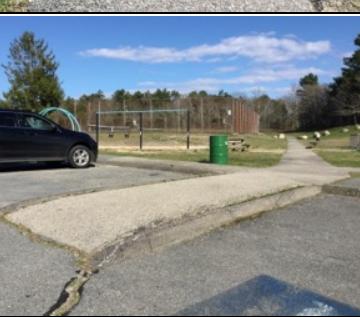
Running slope > 1:20 (5.00%)	18.8%	Reduce the running slope to be no steeper than 1:20 (5.00%). (Cost based on 36" wide min. 16' long concrete path with running slope of 5.00% (1:20) max. and a cross slope of 2.00% (1:50) max.)	1	240	\$240
9	Walkway on Baseball Field Side of Parking Lot	Ext		Exterior Access Route	Sidewalk

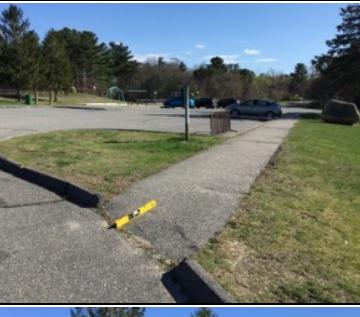
Running slope > 1:20 (5.00%)	18.8%	Reduce the running slope to be no steeper than 1:20 (5.00%). (Cost based on 36" wide min. 12' long stone dust path with running slope of 5.00% (1:20) max. and a cross slope of 2.00% (1:50) max.)	1	180	\$180

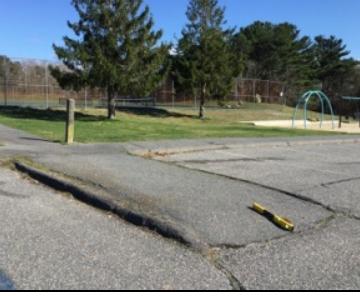
10	Parking Lot by Tennis Court and Soccer Field	Ext		Exterior Access Route	Walkway

Running slope > 1:20 (5.00%)	18.5%	Reduce the running slope to be no steeper than 1:20 (5.00%). (Cost based on 36" wide min. 16' long of concrete to correct running slope to 5.00% (1:20) max.)	1	240	\$240

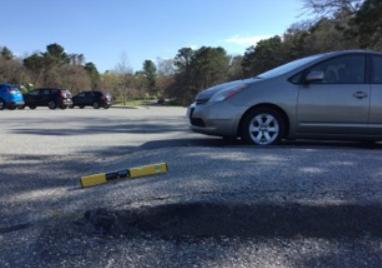
ID	Location	Floor	Room	Element	Type	Photo	Issues	Current Measure	Recommendations	Quantity	Price	Cost Estimation
11	Parking Lot by Baseball Field	Ext		Exterior Access Route	Walkway

Running slope > 1:20 (5.00%)	15.4%	Reduce the running slope to be no steeper than 1:20 (5.00%). (Cost based on 36" wide min. 16' long of concrete to correct running slope to 5.00% (1:20) max.)	1	240	\$240
12	Route to Baseball Field	Ext		Exterior Access Route	Walkway

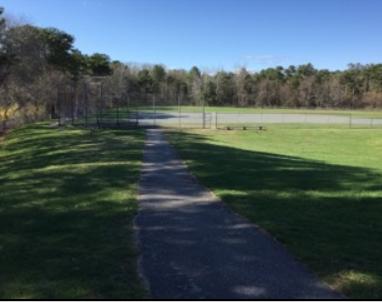
Running slope > 1:20 (5.00%)	6.1%	Reduce the running slope to be no steeper than 1:20 (5.00%). (Cost based on 36" wide min. 100' long of concrete to correct running slope to 5.00% (1:20) max.)	1	1500	\$1500
Off-Street Parking Lot or Garage												
13	Playground Parking Lot	Ext		Off-Street Parking Lot or Garage	Visitor

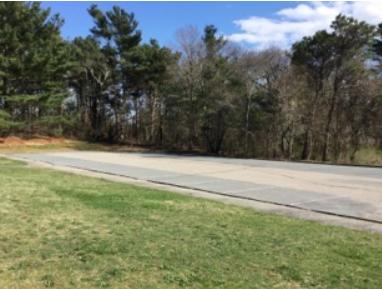
Total # of parking Total # of designated accessible parking spaces Total # of designated van accessible spaces Vehicle space < 132" wide at van space Sign not provided Sign does not have the designation "Van Accessible"	28 0 0 - - -	Provide a van accessible space that is at least 132" wide and a car accessible space that is 96: wide min. with an access aisle that is 60" wide min. Provide a sign with the ISA and the bottom of the sign 60" min. above the ground and the top 96" max. above the ground. Add the designation "Van Accessible" to the sign located at the van accessible space.	2	925	\$1850

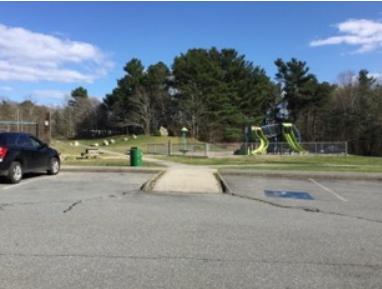
14	Parking Lot by Playground and Tennis Courts	Ext		Off-Street Parking Lot or Garage	Visitor

Total # of parking Total # of designated accessible parking spaces Total # of designated van accessible spaces Access aisle not provided Sign not provided	49 3 0 - -	Convert a standard accessible space into a van accessible space. Provide a marked access aisle that is at least 96" wide. Provide a sign with the ISA and bottom of the sign 60" min. above the ground and the top 96" max. above the ground. Add the designation "Van Accessible". (Cost based on re-painting accessible space and access aisle, and providing 3 signs.)	1	1050	\$1050
15	Parking Lot by Tennis Court and Soccer Field	Ext		Off-Street Parking Lot or Garage	Visitor

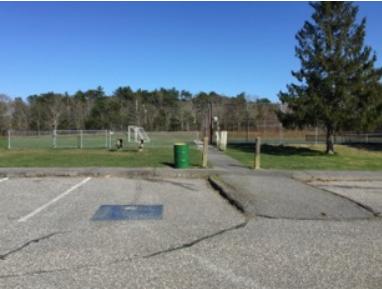
Access aisle not provided Sign not provided		Provide a marked access aisle that is at least 60" wide. Provide a sign with the International Symbol of Accessibility and the bottom of the sign 60" min. above the ground and the top 96" max. above the ground.	1	400	\$400

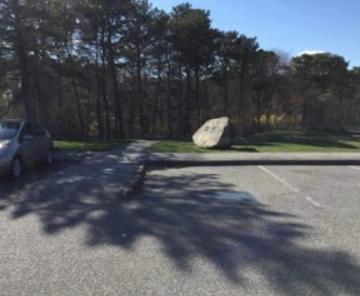
ID	Location	Floor	Room	Element	Type	Photo	Issues	Current Measure	Recommendations	Quantity	Price	Cost Estimation
16	Parking Lot by Baseball Field	Ext		Off-Street Parking Lot or Garage	Visitor

Access aisle not provided Sign not provided		Provide a marked access aisle that is at least 60" wide. Provide a sign with the International Symbol of Accessibility and the bottom of the sign 60" min. above the ground and the top 96" max. above the ground.	1	400	\$400
Access to Goods and Services												
Picnic Tables												
17	Walkway on Baseball Field Side of Parking Lot	Ext		Picnic Tables	N/A

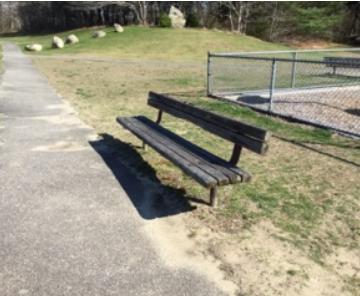
18	Route to Playground and Tennis Courts	Ext		Benches	N/A

20% of benches have clear space < 36" x 48"		Ensure that 20% of benches have a clear floor space of 36" wide min. by 48" deep min. (Cost is for a level - 2.00% (1:50) max. in all directions - asphalt patch alongside bench.)	1	52	\$52
Play and Sport Areas												
Play Areas												
19	Playground	Ext		Play Areas	N/A

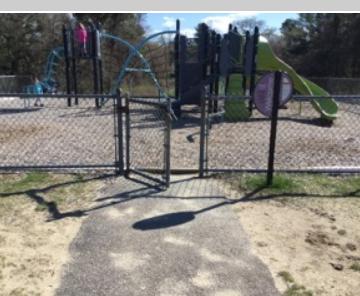
Level changes > 1/4"	2"	Alter change in level to be 1/4" high max.	1	18	\$18

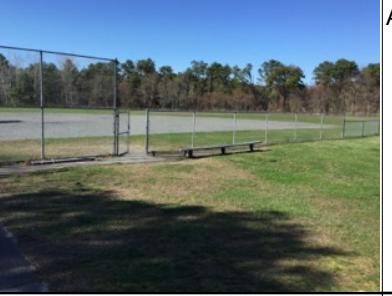
Accessible spaces are not provided at team seating		Provide a 36" x 48" clear floor space at team seating. (Cost based on 36" x 48" stone dust patch.)	2	45	\$90
22	Soccer Field	Ext		Field	Soccer

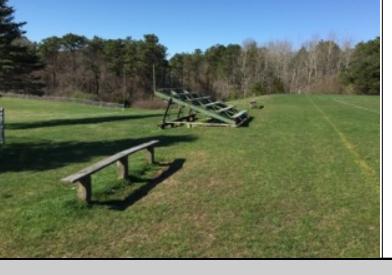
Not connected to an accessible-route		Ensure soccer field is connected to an accessible route. (Cost based on 36" wide min. 240' long stone dust path with running slope of 5.00% (1:20) max. and a cross slope of 2.00% (1:50) max.)	1	2734	\$2734

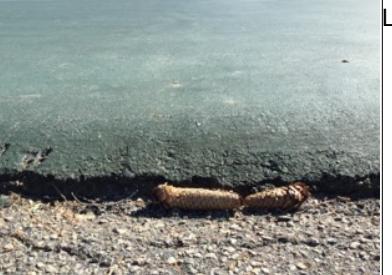
Court												
23	Entrance to Tennis Courts by Soccer Field	Ext		Court	Tennis

Level changes > 1/4"	1"	Alter change in level to be 1/4" high max.	1	18	\$18
24	Entrance to Tennis Courts by Soccer Field	Ext		Court	Tennis

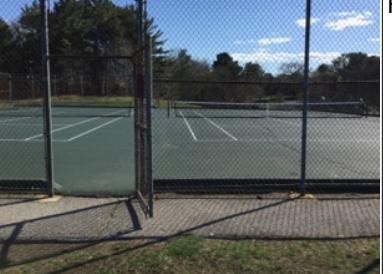
Hardware not operable with a closed fist		Provide hardware that can be operable with one hand and not require tight grasping, pinching, or twisting of the wrist.	1	242	\$242

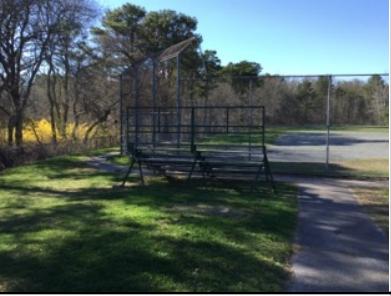
Total number of seats in the facility Min. # of designated wheelchair spaces not provided	50 0	Provide a 36" x 48" clear floor space at sidelines seating. Provide an accessible route to the seating area. (Cost for a 3'x4' stone dust patch.)	1	45	\$45
27	Soccer Field	Ext		Bleachers	N/A

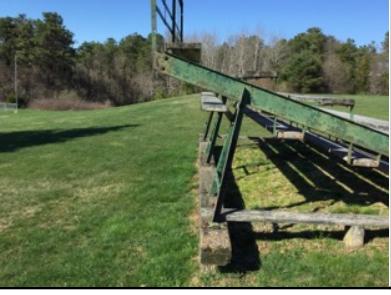
28	Soccer Field	Ext		Bleachers	N/A

Obstructed by protruding objects	55"	Provide a cane detectable barrier alongside the backside of each bleacher. (Cost based on 12' long guardrail. placed at 27" max. aff.)	1	306	\$306

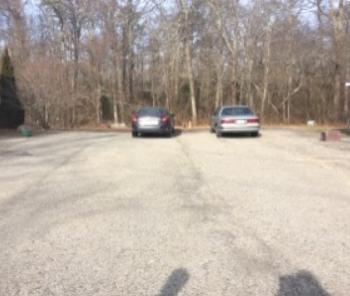
ID	Location	Floor	Room	Element	Type	Photo	Issues	Current Measure	Recommendations	Quantity	Price	Cost Estimation
Approach and Entrance												
Off-Street Parking Lot or Garage												
1	Parking Lot	-	-	Off-Street Parking Lot or Garage	Visitor

Total # of parking Total # of designated accessible parking spaces Total # of designated van accessible spaces Access aisle not provided Sign not provided	7 - - - -	Provide a van accessible parking space and marked access aisle. Ensure the space is 132" wide min. and the aisle is 60" wide min. or that both the space and aisle are 96" wide min. Provide sign with the International Symbol of Accessibility (ISA) and the words "Van Accessible" mounted 60" min. and 96" max. above the ground.	1	925	\$925
Entrance												
2	Main Entrance	-	-	Entrance	Main Entrance

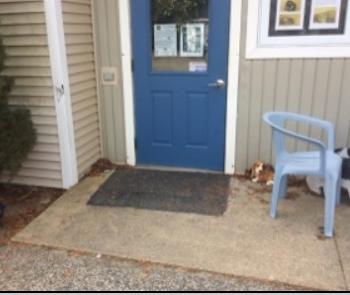
Entrance / emergency exit not on an accessible route Mat not securely attached	1.5" -	Provide an accessible route to this entrance/exit. Securely attach mat. (Cost based on 48" wide min. x 6' of asphalt to reduce change in level to 1/4" max.)	1	104	\$104

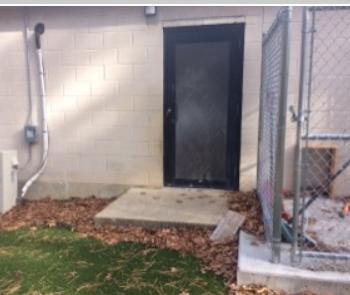
Emergency Exit												
3	West Side Exit	-	-	Emergency Exit	N/A

Emergency exit not on an accessible route	6"	Provide an accessible route to this exit. Ensure route is 48" wide min. with a max. running slope of 1:20 (5.00%) and a max. cross slope of 1:50 (2.00%). Ensure route has 1/4" max. change in level at landing. (Cost based on a 48" wide min. x 90' long asphalt path from parking lot to door landing.)	1	1560	\$1560
Access to Goods and Services												
Means of Egress												
4	Main Entrance and Exit, Interior Side	1	-	Means of Egress	N/A

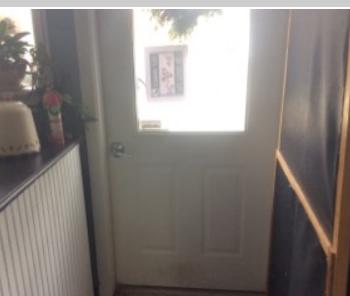
Illuminated International Symbol of Accessibility (ISA) not provided illuminated exit sign. Tactile exit sign not provided	- -	Ensure illuminated exit signs are provided at exits and exit doors. Ensure tactile exit signs with raised characters and braille are provided at exit doors. Mount signs between 48"- 60" above finished floor located on the latch side of the door. (Cost based on tactile egress sign and illuminated ISA sign.)	2	216	\$432

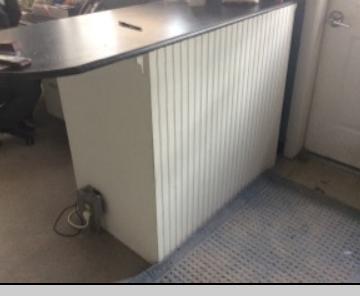
Counter > 36" high	39"	Provide a counter that is 36" max. above the finished floor.	1	440	\$440
Operable Parts												
7	Donation Bin	-	-	Operable Parts	Trash/Recycling

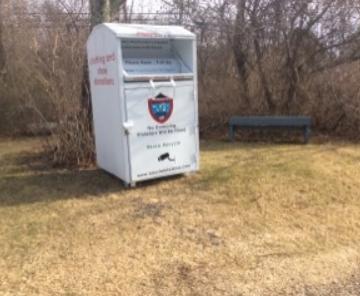
Element not on an accessible route Clear floor space is not provided	- 16.2%	Ensure donation bin is located on an accessible route that is firm, stable and slip resistant. Provide a 30" min. by 48" min. clear floor space with 2.00% max. slope in all directions at donation bin. (Relocate bin.)	1	Labor	\$0

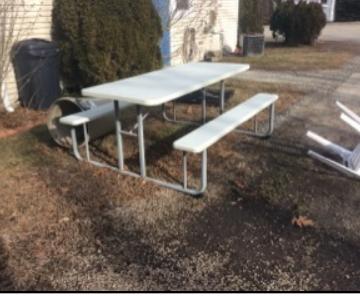
Picnic Tables												
8	Table Near Parking Lot	-	-	Picnic Tables	N/A

Toe or knee clearance at tables not provided	-	Provide a picnic table (5% min. and at least one (1)) with toe and knee clearance located on an accessible route. (Cost based on a new accessible picnic table.)	1	700	\$700

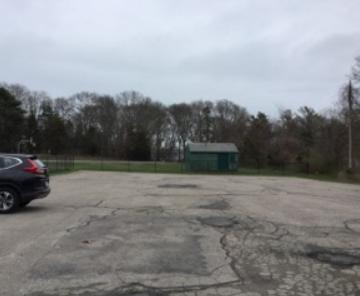
ID	Location	Floor	Room	Element	Type	Photo	Issues	Current Measure	Recommendations	Quantity	Price	Cost Estimation
Approach and Entrance												
Off-Street Parking Lot or Garage												
1	Parking Lot	Ext.		Off-Street Parking Lot or Garage	Visitor

Total # of parking Total # of designated accessible parking spaces Total # of designated van accessible spaces Access aisle not provided Sign not provided Sign does not have the designation "Van Accessible"	40 0 0 - - -	Provide one (1) van accessible parking space and one (1) car accessible parking space. Provide a shared marked access aisle that is at least 96" wide. Provide a sign with the International Symbol of Accessibility (ISA) at both spaces 60" min. and 96" max. above the ground. Add the designation "Van Accessible" to the sign at the van accessible parking space.	2	925	\$1850
Access to Goods and Services												
Doors, Doorways, & Gates

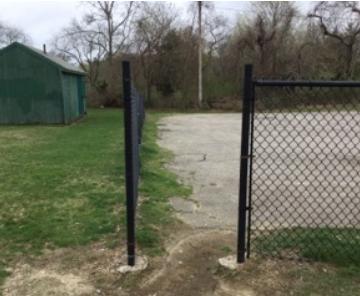
2	Entrance to Parking Lot From Field	Ext.		Doors, Doorways, & Gates	Other

Clear width at door < 32"	25"	Widen the gate so that there is 32" min. clear width.	1	128	\$128
Play and Sport Areas												
Play Areas												
3	Route to Playground Near State Road	Ext.		Play Areas	N/A

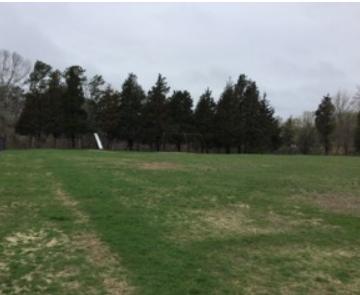
Not connected to a accessible route	-	Ensure the playground is connected to an accessible route. (Cost based on a 4' wide x 280' long asphalt path to and around the perimeter of the playground.)	1	4760	\$4760
4	Playground Near State Road	Ext.		Play Areas	N/A

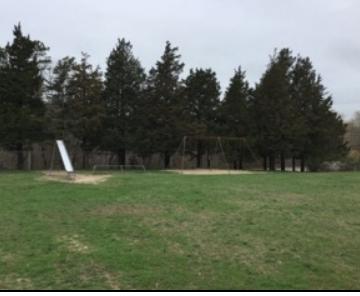
Accessible route not provided to ground level play components	-	Ensure an accessible route is provided to ground level play components. (Provide an accessible route that is 60" min. wide to each play component in the playground.) (Cost based on 60" wide x 45' long poured-in-place rubber route inside the playground to each play component.)	1	3150	\$3150

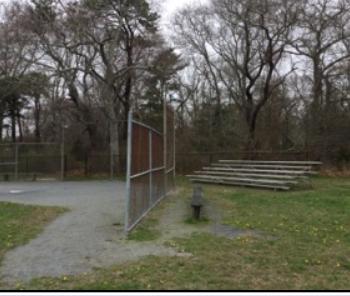
ID	Location	Floor	Room	Element	Type	Photo	Issues	Current Measure	Recommendations	Quantity	Price	Cost Estimation
Field												
5	Baseball Field Team and Bleacher Seating	Ext.		Field	Baseball

Accessible spaces are not provided at team seating Accessible spaces not provided at sidelines seating	- -	Provide a 36" x 48" clear floor space at both team seating areas. Provide a 36" x 48" clear floor space at bleacher sidelines seating. (Cost based on a 3' x 4' asphalt patch at each location.)	3	52	\$156
6	Baseball Field	Ext.		Field	Baseball

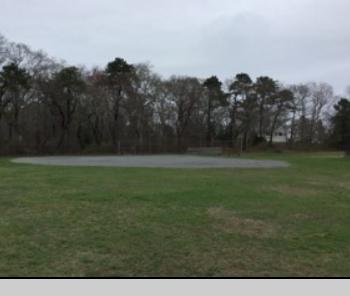
Not connected to an accessible-route	304'	Ensure baseball field is connected to an accessible route. (Cost based on a 3' wide x 304' asphalt route that connects the east entrance from the parking lot to each entrance of the tennis court, and to the baseball field and both team and bleacher seating areas at the baseball field.)	1	3,952	\$3952
Court

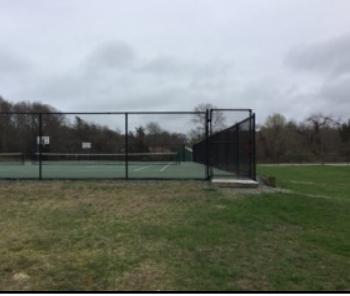
7	Tennis Court Entrance by Baseball Field	Ext.		Court	Tennis

Not connected to accessible route	35'	Ensure tennis court is connected to an accessible route. See ID #6 for cost.	1	-	\$0
8	Basketball Court	Ext.		Court	Basketball

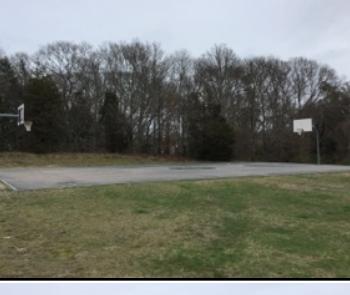
Not connected to accessible route	55'	Ensure basketball court is connected to an accessible route. (Cost based on a 3' wide x 50' asphalt route from new proposed accessible route described in ID #6 to edge of basketball court.)	1	650	\$650
9	Tennis Court Entrance by Parking	Ext.		Court	Tennis

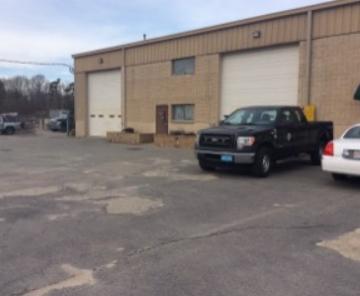
ID	Location	Floor	Room	Element	Type	Photo	Issues	Current Measure	Recommendations	Quantity	Price	Cost Estimation
Approach and Entrance												
Off-Street Parking Lot or Garage												
1	Parking Lot	Ext.		Off-Street Parking Lot or Garage	N/A

Total # of parking Total # of designated accessible parking spaces Total # of designated van accessible spaces Access aisle not provided Sign not provided Sign does not have the designation "Van Accessible"	15 - - - - -	Provide one van accessible space that is 96" wide min. with a marked access aisle that is 96" wide min. Provide a sign with the International Symbol of Accessibility (ISA) with the bottom of the sign 60" min. above the ground and the top 96" max. above the ground. Add the designation "Van Accessible" to the sign located at the van accessible space.	1	925	\$925
Entrance												
2	Main Entrance	Ext.		Entrance	Main Entrance

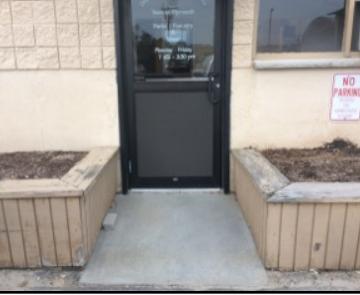
Maneuvering clearance is not provided	-	Provide an automatic door opener.	1	1530	\$1530

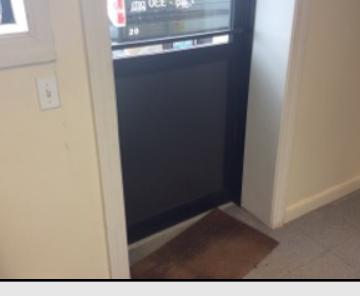
3	Main Entrance	1		Entrance	Main Entrance

Mat not securely attached	-	Securely attach mat.	1	Labor	\$0
Access to Goods and Services												
Means of Egress												
4	Main Entrance	1		Means of Egress	N/A

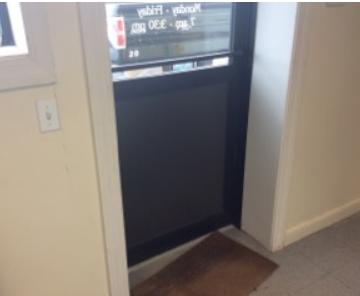
Tactile exit sign not provided	-	Ensure tactile exit signs with raised characters and braille are provided at exit doors. Mount signs between 48" - 60" above finished floor located on the latch side of the door.	1	116	\$116

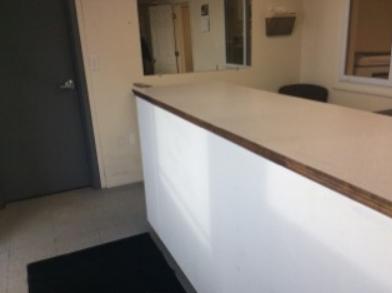
ID	Location	Floor	Room	Element	Type	Photo	Issues	Current Measure	Recommendations	Quantity	Price	Cost Estimation
Service Counter												
5	Main Office	1		Service Counter	N/A

Counter > 36" high	43"	Provide a counter that is 36" max. above the ground or finished floor.	1	440	\$440

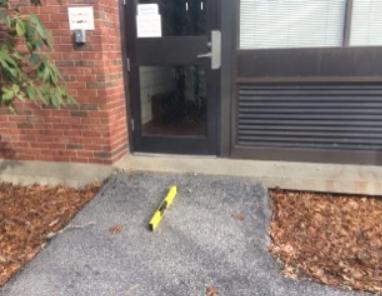
ID	Location	Floor	Room	Element	Type	Photo	Issues	Current Measure	Recommendations	Quantity	Price	Cost Estimation
Approach and Entrance												
Exterior Access Route												
1	Main Entrance	Ext.	-	Exterior Access Route	Exterior

Running slope > 1:20 (5%) Level changes > 1/4"	8.7% 1.25"	Reduce running slope to be no steeper than 1:20 (5%). Alter change in level to be 1/4" high max.	1	193	\$193
2	Route To Back Entrance	Ext.	-	Exterior Access Route	Walkway

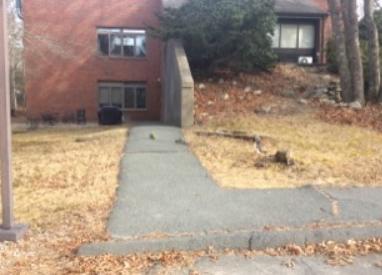
Running slope > 1:20 (5%) Surface is not stable, firm, and slip-resistant	10.3% -	Reduce running slope to be no steeper than 1:20 (5%). Repair surface.	1	1003	\$1003
3	Apparatus Bay	Ext.	-	Exterior Access Route	Walkway

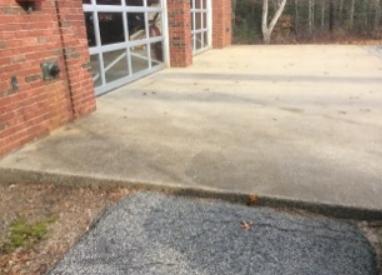
Level changes > 1/4"	3"	Alter change in level to be 1/4" high max.	1	103	\$103
4	Sidewalk on South Side	Ext.	-	Exterior Access Route	Walkway

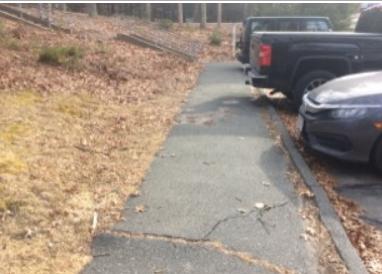
Surface is not stable, firm, and slip-resistant	-	Repair surface.	1	103	\$103

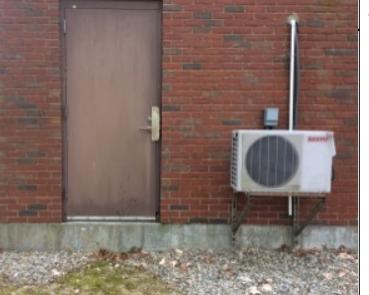
ID	Location	Floor	Room	Element	Type	Photo	Issues	Current Measure	Recommendations	Quantity	Price	Cost Estimation
Emergency Exit												
6	Emergency Exits on Northwest, West, and Southwest Sides of the Building	Ext.	-	Emergency Exit	N/A

Threshold > 3/4" high	11.5"	At doorways greater than 1/2", thresholds shall be ramped.	3	75	\$225
Access to Goods and Services												
Doors, Doorways, & Gates												
7	Back Entrance	Ext.	-	Doors, Doorways, & Gates	Emergency Egress

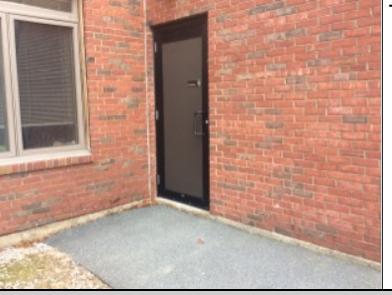
Threshold > 1/2" high	4"	At a doorway greater than 1/2", threshold shall be ramped.	1	75	\$75
Signage												
8	Toilet Room	B	-	Signage	Designation

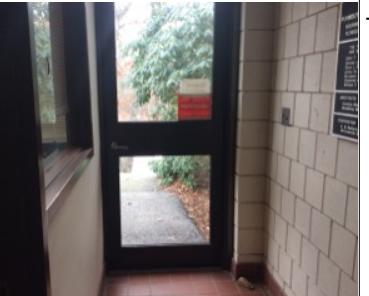
Tactile exit sign not provided	-	Ensure tactile exit signs with raised characters and braille are provided at exit doors. Mount signs between 48"- 60" above finish floor located on the latch side of the door or on nearest adjacent wall.	2	116	\$232

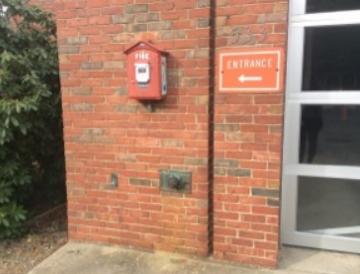
ID	Location	Floor	Room	Element	Type	Photo	Issues	Current Measure	Recommendations	Quantity	Price	Cost Estimation
Operable Parts												
10	Apparatus Bay	Ext.	-	Operable Parts	Emergency Telephone

Reach < 15" or > 48"(forward/side approach)	60.75"	Relocate emergency device so that controls are 48" max. above finish floor.	1	128	\$128
11	Main Entrance	Ext.	-	Operable Parts	Door Bell

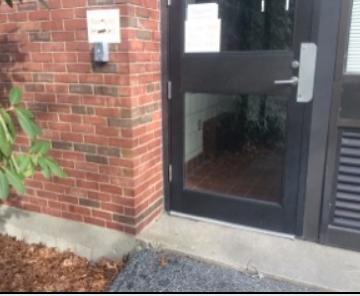
Reach < 15" or > 48"(forward/side approach) Element not on an accessible route	49.75"	Ensure emergency devices are located on an accessible route and make sure the controls are 48" max. above finish floor.	1	128	\$128
Toilet & Bathing Rooms												
Overall Access												
12	Toilet Room	B	-	Overall Access	Toilet Room

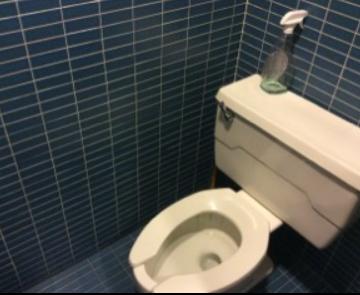
Accessible plumbing fixtures or stalls not provided	-	Add an accessible single-user toilet room.	1	12302	\$12302
Lavatory												
13	Toilet Room	B	-	Lavatory	N/A

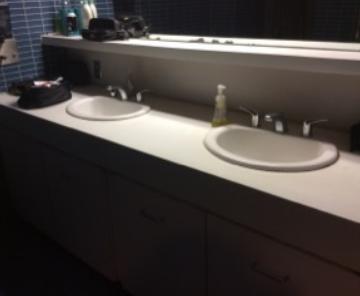
Toe or knee clearances not provided Mirror above lavatory w/reflective surface > 40"	- 46.25"	Provide at least one lavatory with knee and toe clearance positioned for a forward approach. Lower mirror so that the bottom surface is at 40" max. above finish floor.	1	971	\$971

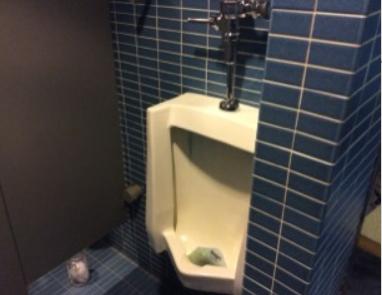
ID	Location	Floor	Room	Element	Type	Photo	Issues	Current Measure	Recommendations	Quantity	Price	Cost Estimation
Urinal												
14	Toilet Room	B	-	Urinal	N/A

Rim > 17" high Flush control is > 44" high or not properly located	22.5" 52"	Provide one urinal with the rim no higher than 17" above the finish floor. Mount flush control at 44" max. above the finish floor.	1	1811	\$1811
Best Practice												
Exit Sign												
15	Emergency Exits on Northwest, West and Southwest Sides of the Building	Ext.	-	Exit Sign	N/A

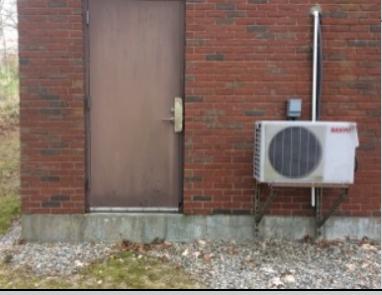
Directional sign to accessible emergency exit not provided	-	Recommend providing directional signs indicating the location of the nearest emergency exit on the interior of the door.	3	0	\$0
Stairs												
16	Stairs To Main	Ext.	-	Stairs	N/A

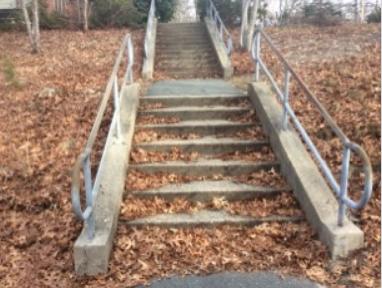
Handrail height < 34" or > 38"	32.75"	Alter so the handrails are 34"- 38" high above the floor.	1	0	\$0

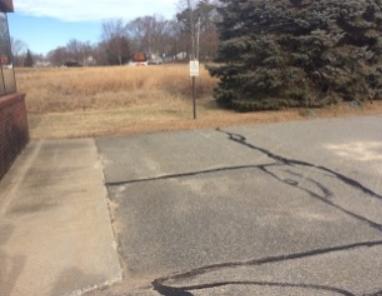
ID	Location	Floor	Room	Element	Type	Photo	Issues	Current Measure	Recommendations	Quantity	Price	Cost Estimation
Approach and Entrance												
Off-Street Parking Lot or Garage												
1	Parking Lot	-	-	Off-Street Parking Lot or Garage	Visitor

Total # of parking Total # of designated accessible parking spaces Total # of designated van accessible spaces Access aisle < 60" wide at car/van space Sign does not have the designation "Van Accessible" Sign bottom < 60" above finished grade	19 2 0 48" - 51"	Provide a marked access aisle that is at least 96" wide. Ensure accessible spaces are also at least 96" wide. Add the designation "Van Accessible" to the sign located at the van accessible space. Locate sign with the bottom of the sign 60" above the ground.	1	400	\$400
Emergency Exit												
2	Exterior Exit, South Side	-	-	Emergency Exit	N/A

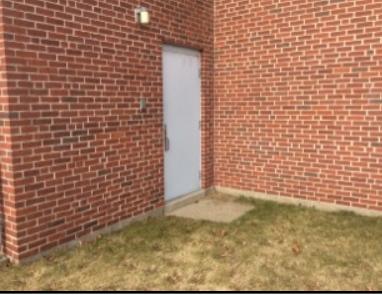
Emergency exit not on an accessible route Threshold > 3/4" high	- 5.5"	Provide a directional sign indicating the location of the nearest emergency exit on the interior of the door. Alter threshold to be 3/4" high max.	1	191	\$191

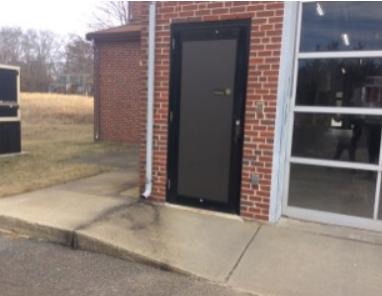
3	Exterior Exit, West Side	-	-	Emergency Exit	N/A

Maneuvering clearance at emergency door > 1:50 (2.00%)	4.9%	Alter so that the slope in all directions is no greater than 1:50 (2.00%).	1	90	\$90
4	Exterior Exit, South Side	-	-	Emergency Exit	N/A

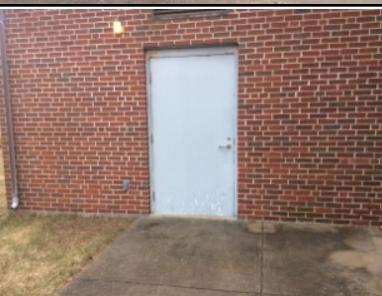
Threshold > 3/4" high	1"	Alter threshold to be 3/4" high max.	1	75	\$75
Access to Goods and Services

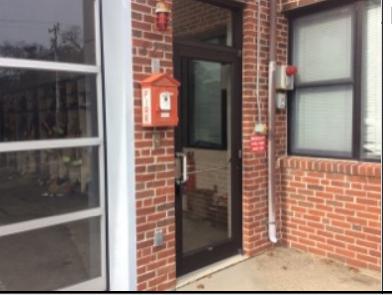
Reach < 15" or > 48"(forward/side approach)	67"	Relocate emergency controls so that controls are 48" max. above finish floor.	1	128	\$128
Toilet & Bathing Rooms												
Lavatory												
7	Toilet Room	1	-	Lavatory	N/A

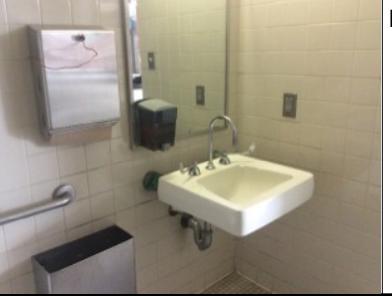
Plumbing underneath is exposed	-	Insulate or otherwise configure pipes to prevent contact.	1	46	\$46
Single-User Toilet												
8	Toilet Room	1	-	Single-User Toilet	N/A

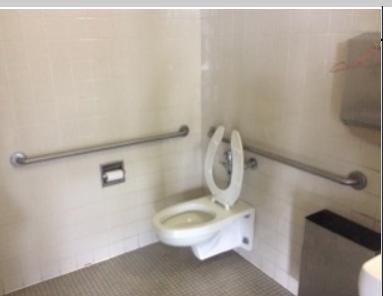
Side or rear grab bar < 33" or > 36" high	31.25"	Mount grab bars 33"- 36" above the floor.	2	128	\$256

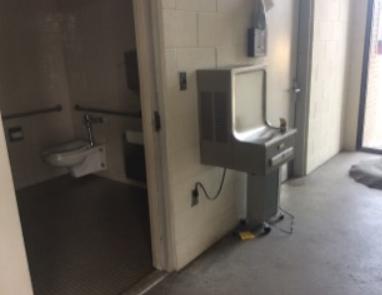
Knee or toe clearance not provided Spout > 36" high (wheelchair users) Inadequate water flow	36.5" - 26"	Lower drinking fountain for seated users so that the spout is 36" max. above the finish floor or ground. Provide knee and toe clearance, 27" min. high at drinking fountain for seated users. Repair drinking fountain to provide adequate water flow.	1	2014	\$2014

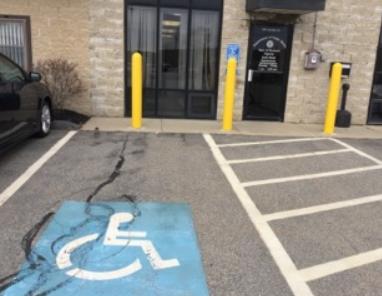
Total # of parking Total # of designated accessible parking spaces Total # of designated van accessible spaces Sign does not have the designation "Van Accessible"	67 1 1 -	Add the designation "Van Accessible" to the sign located at the van accessible space. Reposition existing sign so it is not blocked by the yellow pole. Provide an additional car accessible parking space that is 96" wide min. with a marked access aisle 60" wide min. and an ISA sign mounted 60" min. and 96" max. above the ground.	1	1175	\$1175
2	Parking Lot	Ext.		Off-Street Parking Lot or Garage	Visitor

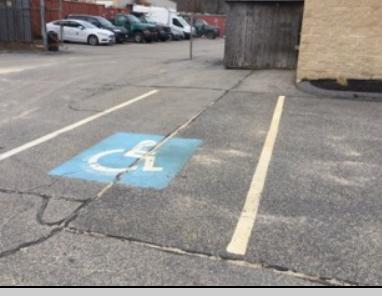
Access aisle not provided Sign not provided	- -	Provide a marked access aisle that is at least 60" wide. Provide a sign with the International Symbol of Accessibility (ISA) mounted with the bottom of the sign 60" min. above the ground and the top 96" max. above the ground. (Cost based on an ISA sign and striping the access aisle.)	1	400	\$400

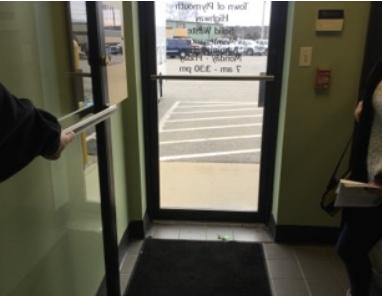
Mat not securely attached	-	Securely attach walk-off mat.	1	Labor	\$0
Emergency Exit												
4	Employee Only Exit to Garage From Lobby	1		Emergency Exit	N/A

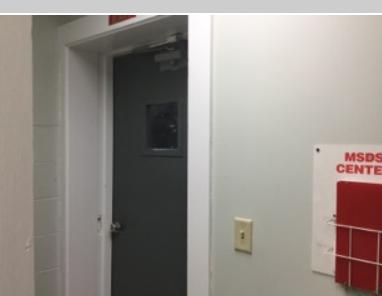
Directional sign to accessible emergency exit not provided	-	Provide a directional sign with raised characters and braille indicating the location of the nearest accessible emergency exit. Mount signs between 48"- 60" above finished floor located on the latch side of the door.	1	116	\$116
Access to Goods and Services

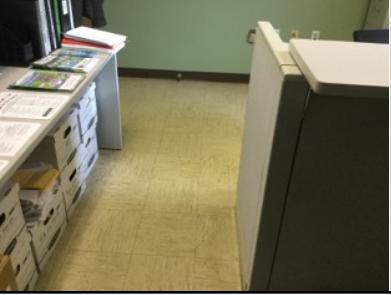
Route < 36" wide	31"	Ensure that a clear width of 36" min. is maintained in the circulation path by relocating office furniture.	1	Labor	\$0
7	Route to Rear Offices	1		Interior Access Route	N/A

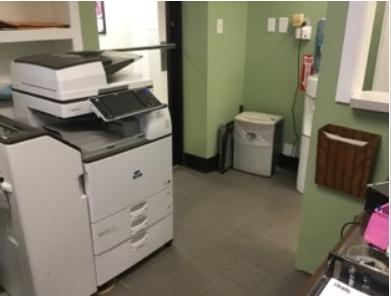
Route < 36" wide	29.5"	Ensure that a clear width of 36" min. is maintained in the circulation path by relocating the printer.	1	Labor	\$0
8	Near Toilet Room	1		Interior Access Route	N/A

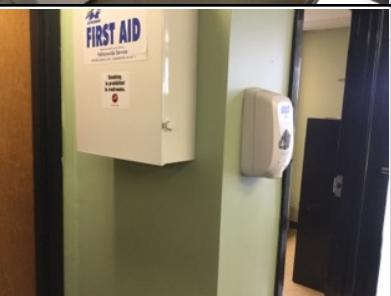
Obstructed by protruding objects	5"	Relocate first aid box so that it does not protrude into the circulation path or add a cane-detectable barrier mounted 27" max. above the ground. (Cost based on adding a cane-detectable barrier below each metal case mounted 27" max. above the finished floor.)	1	153	\$153

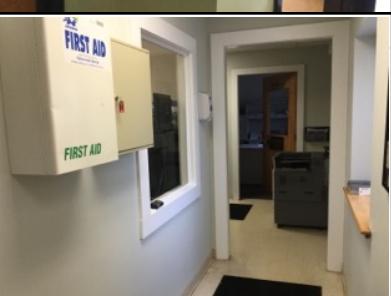
9	Route to Rear Offices	1		Interior Access Route	N/A

Obstructed by protruding objects	5"	Relocate first aid box and other cabinet so that they do not protrude into the circulation path or provide a cane-detectable barrier mounted 27" max. above the ground. (Cost based on adding a cane-detectable barrier below each metal case mounted 27" max. above the finished floor.)	2	153	\$306

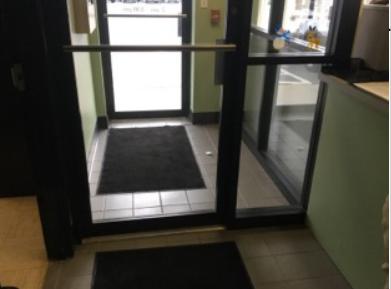
Mat not securely attached	-	Securely attach mat.	1	Labor	\$0
11	Rear Offices Area	1		Doors, Doorways, & Gates	Circulation

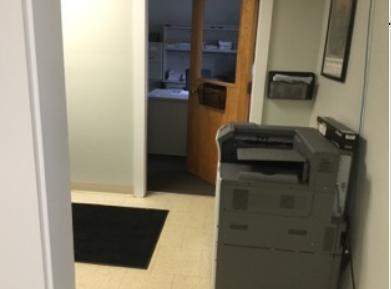
Mat not securely attached	-	Securely attach mat.	1	Labor	\$0
12	Exit to Garage	1		Doors, Doorways, & Gates	Circulation

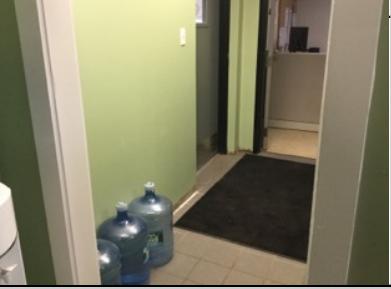
Mat not securely attached	-	Securely attach mat.	1	Labor	\$0
Service Counter												
13	Service Counter in Lobby/Main Office Area	1		Service Counter	N/A

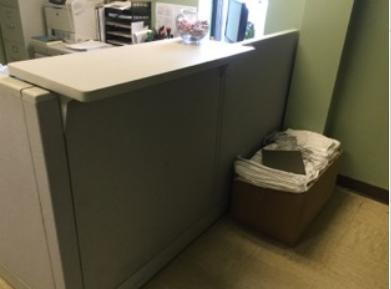
Counter > 36" high	41"	Provide a counter that is 36" max. above the finished floor.	1	440	\$440
Toilet & Bathing Rooms

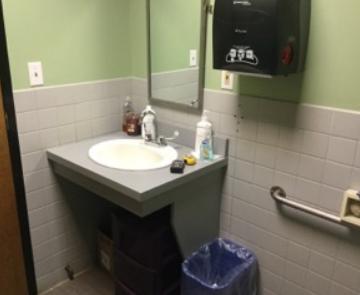
Toe or knee clearances not provided Plumbing underneath is exposed Mirror above lavatory w/reflective surface > 40"	- - 42"	Provide at least one lavatory with knee and toe clearance positioned for a forward approach. Insulate or otherwise configure pipes to prevent contact, for at least one lavatory. Lower mirror so that the bottom surface is at 40" max. above finished floor.	1	1117	\$1117
Single-User Toilet												
15	Toilet Room	1		Single-User Toilet	N/A

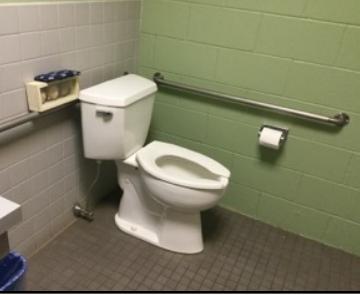
Dispenser positioned above grab bar.		Relocate dispenser below grab bar.	1	353	\$353
16	Toilet Room	1		Single-User Toilet	N/A

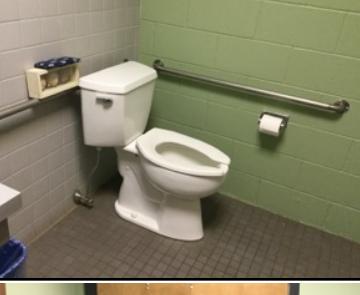
Side or rear grab bar < 33" or > 36" high	29.5"	Mount grab bars 33"- 36" above the floor.	2	198	\$396
17	Toilet Room	1		Single-User Toilet	N/A

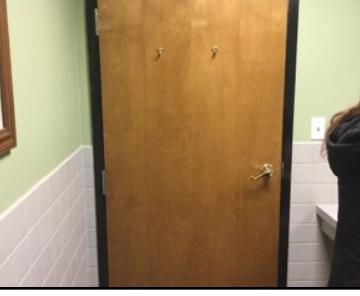
Hook located > 48" high	65"	Locate at least one hook no higher than 48" above the finished floor.	1	75	\$75

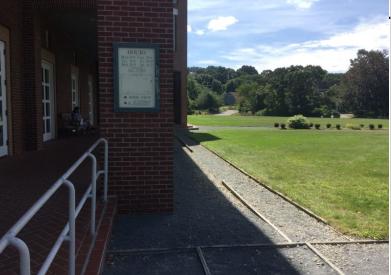
Accessible route not provided	-	Ensure an accessible route is provided to the community garden. (Cost based on 60' of asphalt to cover exposed wooden beams.)	1	780	\$780
Curb Ramp												
3	Curb Ramp at Main Entrance and Accessible Spaces	1		Curb Ramp	Diagonal

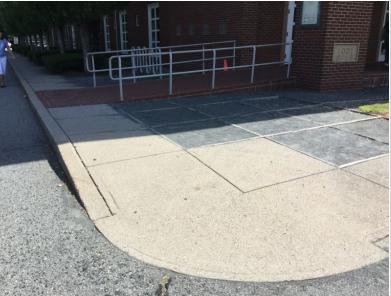
Cross slope > 1:50 (2%) (MAAB)	6.6%	Reduce cross slope at curb ramp to be no steeper than 1:50 (2%). (Cost based on a new curb ramp.)	1	1225	\$1225

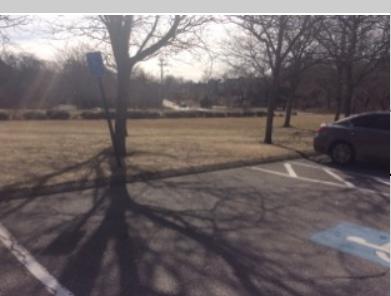
Off-Street Parking Lot or Garage												
4	Parking Lot	1		Off-Street Parking Lot or Garage	N/A

Total # of parking Total # of designated accessible parking spaces Total # of designated van accessible spaces Access aisle < 96" wide at van space Sign does not have the designation "Van Accessible"	128 5 1 65" -	Provide a marked access aisle that is at least 96" wide. Add the designation "Van Accessible" to the sign located at the van accessible space. (Cost based on re-striping and a new sign.)	1	400	\$400

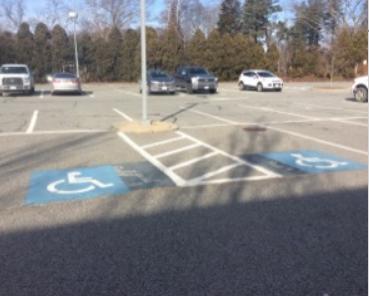
Sign not provided	-	Provide signs with the International Symbol of Accessibility (ISA) with the bottom of the signs 60" min. above the ground and the top 96" max. above the ground.	2	250	\$500
Access to Goods and Services												
Means of Egress												
6	Emergency Egress From Meeting Room	2		Means of Egress	N/A

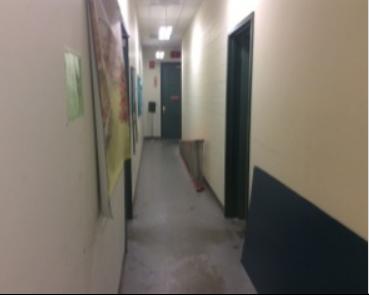
Tactile exit sign not provided	-	Ensure tactile exit signs with raised characters and braille are provided at exit doors. Mount signs between 48" - 60" above finished floor located on the latch side of the door.	1	116	\$116
7	Exit in Children's Room	1		Means of Egress	N/A

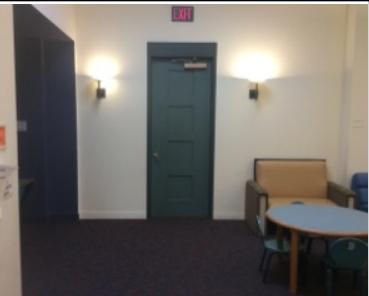
Tactile exit sign not provided	-	Ensure tactile exit signs with raised characters and braille are provided at exit doors. Mount signs between 48"- 60" above finished floor located on the latch side of the door.	1	116	\$116

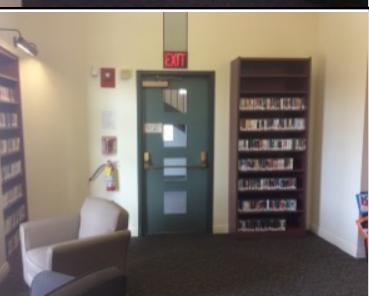
8	Emergency Exit to Parking Lot, Southwest Side	1		Means of Egress	N/A

Tactile exit sign not provided Illuminated International Symbol of Accessibility not provided.	-	Ensure tactile exit signs with raised characters and braille are provided at exit doors. Mount signs between 48"- 60" above finished floor located on the latch side of the door. (Cost for tactile sign and illuminated ISA at accessible means of egress.)	1	216	\$216
9	Exit to Courtyard on Southeast Side of Building	1		Means of Egress	N/A

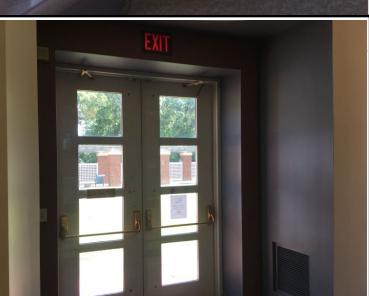
Tactile exit sign not provided Illuminated International Symbol of Accessibility not provided.	-	Ensure tactile exit signs with raised characters and braille are provided at exit doors. Mount signs between 48"- 60" above finished floor located on the latch side of the door. (Cost for tactile sign and illuminated ISA at accessible means of egress.)	1	216	\$216

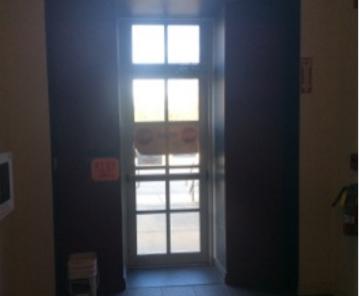
Tactile exit sign not provided Illuminated International Symbol of Accessibility not provided.	-	Ensure tactile exit signs with raised characters and braille are provided at exit doors. Mount signs between 48"- 60" above finished floor located on the latch side of the door. (Cost for tactile sign and illuminated ISA at accessible means of egress.)	1	216	\$216
11	Egress Door Near Plymouth Historical Society, Southeast Side	2		Means of Egress	N/A

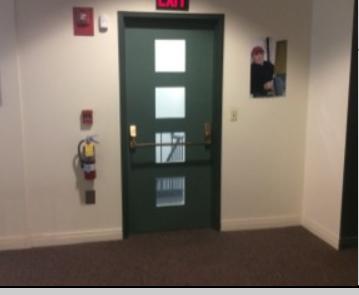
Tactile exit sign not provided Floor level designation not provided Stairway sign not compliant	- - -	Ensure tactile exit signs with raised characters and braille are provided at exit doors. Mount signs between 48"- 60" above finished floor located on the latch side of the door. Provide a sign on the interior of the stairway enclosure indicating the floor level. Ensure stairway signs meet tactile and visual requirements and are located 48"- 60" above the finished floor.	1	116	\$116

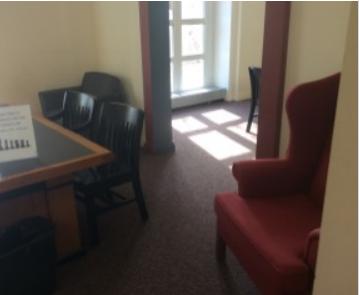
Interior Access Route												
12	Tables in East End of Nonfiction Wing	1		Interior Access Route	N/A

Route < 36" wide	26"	Ensure that a clear width of 36" min. is maintained at the accessible route.	1	Labor	\$0
13	Fiction Wing South Side	2		Interior Access Route	N/A

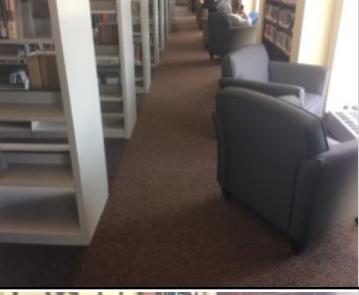
Route < 36" wide	28"	Ensure that a clear width of 36" min. is maintained at the accessible route.	1	Labor	\$0
14	Fire Extinguisher Near Central Stairs	1		Interior Access Route	N/A

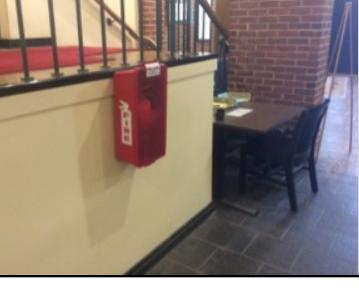
Obstructed by protruding objects	7"	Relocate fire extinguisher out of the circulation path.	1	353	\$353

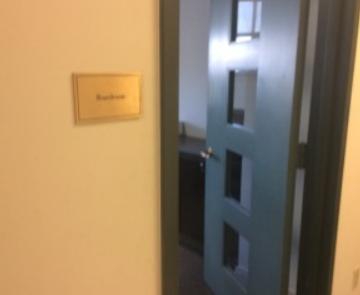
Raised characters not provided Braille not provided	- -	Provide text with raised characters duplicated in braille.	1	116	\$116
16	Children's Family Toilet Room	1		Signage	Designation		Raised characters not provided Braille not provided	- -	Provide text with raised characters duplicated in braille.	1	116	\$116
17	Men's and Women's Toilet Rooms, Second Floor	2		Signage	Designation		Raised characters not provided Braille not provided Sign not located on the latch side of the door International Symbol of Acc. not compliant	- - - -	Provide text with raised characters duplicated in braille. Locate sign at permanent rooms alongside the door on the latch side. Replace sign with a sign containing the International Symbol of Accessibility (ISA).	2	116	\$232

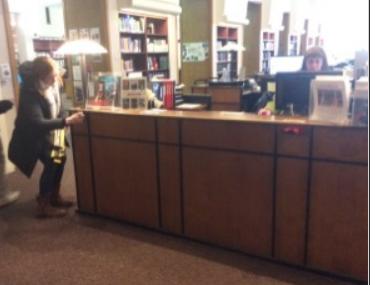
Counter > 36" high	40"	Provide a service counter with a section of counter at least 36 inches long and not more than 36 inches above the finished floor.	1	440	\$440
Dining or Work Surfaces												
21	Microfiche Machines	1		Dining or Work Surfaces	Work Surface

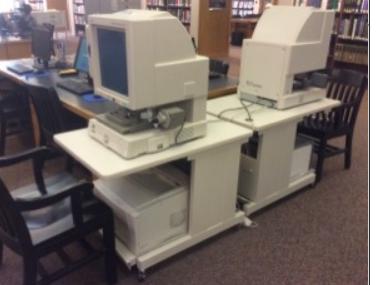
Knee or toe clearance not provided	-	Due to the age and complexity of this machine, providing knee and toe clearance may be technically infeasible.	1	-	\$0
22	Plymouth Historical Center	2		Dining or Work Surfaces	Work Surface

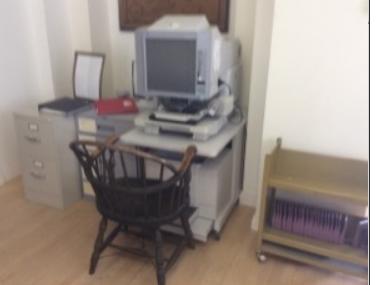
Knee or toe clearance not provided	-	Due to the age and complexity of this machine, knee and toe clearance may be technically infeasible.	1	-	\$0
23	Children's Room Library Computer	1		Dining or Work Surfaces	Work Surface

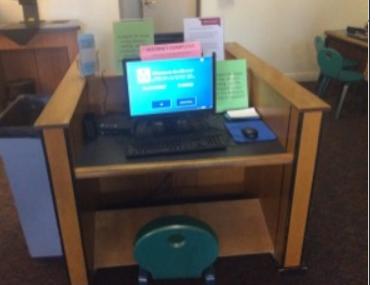
Knee or toe clearance not provided	-	Provide at least 1 work surface with 24" min. knee and toe clearance in the children's section.	1	350	\$350

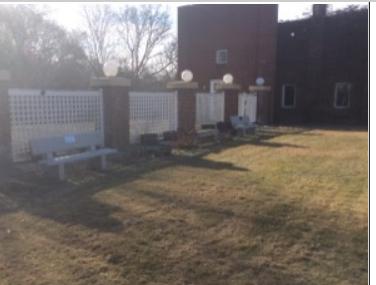
Benches												
24	Benches in Courtyard, Southeast Side	1		Benches	N/A

No accessible route to 20% of benches 20% of benches have clear space < 36" x 48"	-	Provide an accessible route to 20% of benches (1) in this area. Ensure that 20% of benches (1) have a clear floor space of 36" wide min. by 48" deep min. (Cost based on 20' of crushed stone dust path to one bench from northeast side of courtyard as well as a 3' by 4' crushed stone dust patch at the bench for clear floor space.)	1	264	\$264

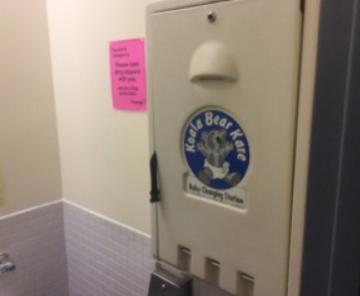
ID	Location	Floor	Room	Element	Type	Photo	Issues	Current Measure	Recommendations	Quantity	Price	Cost Estimation
Toilet & Bathing Rooms												
Overall Access												
25	Children's Family Toilet Room	1		Overall Access	Toilet Room

Clear floor space not provided	-	Provide a 30" min. by 48" min. clear floor space at baby changing station. (See ID #27 for cost.)	1	-	\$0
26	Children's Family Toilet Room	1		Overall Access	Toilet Room

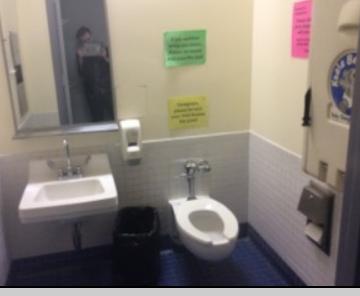
Turning space not provided Grab bars not provided	-	Renovate toilet room to allow for a compliant depth of at least 72" per MAAB. Ensure grab bars are provided at the toilet that are at least 42" long and are mounted between 33" and 36" above the finished floor. (Cost based on accessible single-user toilet room.)	1	12302	\$12302
Lavatory												
27	Children's Family Toilet Room	1		Lavatory	N/A
