Town of Plymouth

Part A – Executive Summary

October 2019

Prepared by the
**Institute for
Human
Centered
Design**

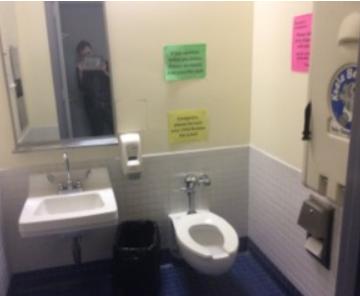
Turning space not provided Grab bars not provided	-	Renovate toilet room to allow for a compliant depth of at least 72" per MAAB. Ensure grab bars are provided at the toilet that are at least 42" long and are mounted between 33" and 36" above the finished floor. (Cost based on accessible single-user toilet room.)	1	12302	\$12302
Lavatory												
27	Children's Family Toilet Room	1		Lavatory	N/A

Toe or knee clearances not provided Plumbing underneath is exposed	26" -	Provide at least one lavatory with knee and toe clearance positioned for a forward approach. Insulate or otherwise configure pipes to prevent contact, for at least one lavatory. (Cost for accessible lavatory included in ID #26.)	1	0	\$0

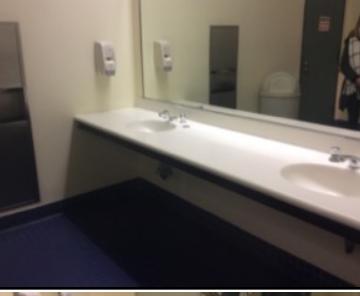
28	Men's and Women's Toilet Rooms, Second Floor	2		Lavatory	N/A

Plumbing underneath is exposed	-	Insulate or otherwise configure pipes to prevent contact, for at least one lavatory.	2	46	\$92
29	Men's and Women's Toilet Rooms, First Floor	1		Lavatory	N/A

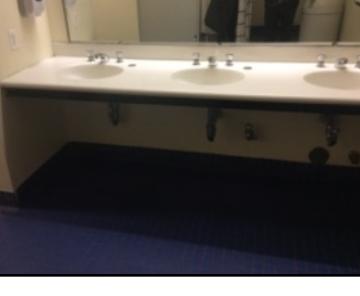
Plumbing underneath is exposed	-	Insulate or otherwise configure pipes to prevent contact, for at least one lavatory.	2	46	\$92

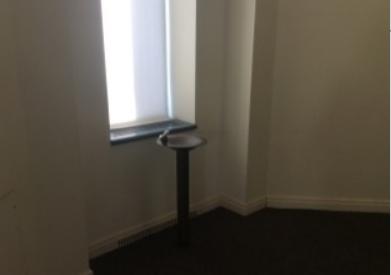
ID	Location	Floor	Room	Element	Type	Photo	Issues	Current Measure	Recommendations	Quantity	Price	Cost Estimation
35	Drinking Fountain in Nonfiction Wing	1		Drinking Fountains	Low

No drinking fountain provided for standing users	-	Provide an additional drinking fountain for standing users.	1	2014	\$2014
36	Near Elevator	2		Drinking Fountains	Low

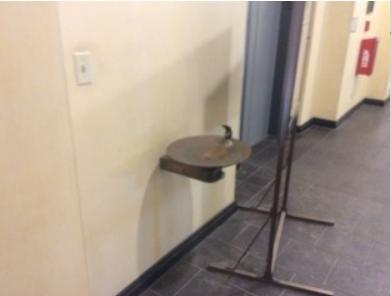
No drinking fountain provided for standing users	-	Provide an additional drinking fountain for standing users.	1	2014	\$2014
37	Drinking Fountain Near Children's Room	1		Drinking Fountains	Low

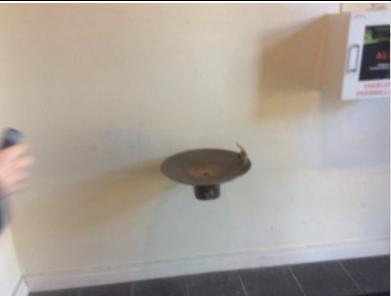
No drinking fountain provided for standing users	-	Provide an additional drinking fountain for standing users or install a Hi-Lo drinking fountain if current drinking fountains have historical value to the building. (Cost based on a new Hi-Lo drinking fountain.)	1	2108	\$2108
Best Practice												
N/A												
38	Near Elevator	2		N/A	N/A

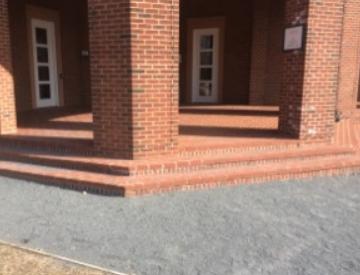
A photograph showing a bookshelf on the left and a wall with a sign that reads "PLEASE NOTE NEW PRICING PLYMOUTH PUBLIC LIBRARY CORPORATION BOOKSTORE PRICES".			Recommend providing signage that is more easily distinguishable from the other library posters.	1	0	\$0
41	Route to Community Garden, Southwest Side of Building	1		N/A	N/A

A photograph of a brick building with a set of steps leading up to a double door entrance.			Recommend providing handrails.	1	0	\$0
42	Parking Lot	1		N/A	N/A

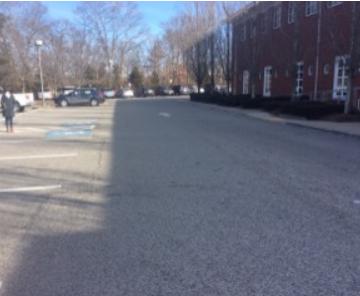
A photograph of a paved parking lot with several cars parked and a building visible in the background.			Recommend providing a crosswalk from the accessible spaces to the accessible entrance.	1	0	\$0

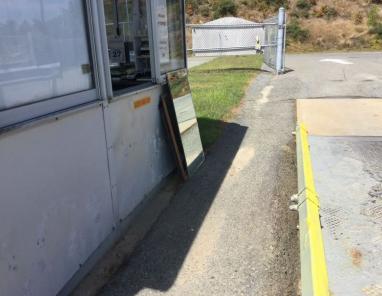
ID	Location	Floor	Room	Element	Type	Photo	Issues	Current Measure	Recommendations	Quantity	Price	Cost Estimation
Access to Goods and Services												
Service Counter												
1	Pay Station	Ext.		Service Counter	N/A

Surface is not stable, firm, and slip-resistant Counter > 36" high	39"	In order to provide program access, ensure a staff person is available to assist people who have difficulty accessing the service counter.	1	Labor	\$0
Best Practice												
N/A												
2	Transfer Station	Ext.		N/A	N/A

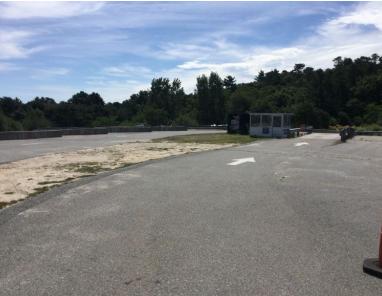
Recommend allowing a staff person to assist visitors who need help removing disposal items from their vehicle or in accessing the disposal bins. (During the survey, IHCD team was told that only one staff person is regularly at the transfer station, and that person does not help visitors who may need assistance with disposal items. Recommend providing additional staff person as needed.)	1	-	\$0

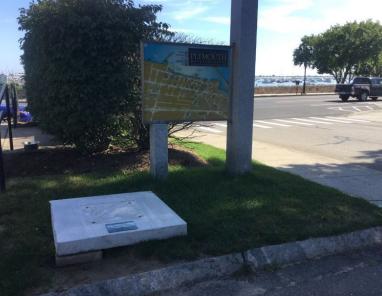
ID	Location	Floor	Room	Element	Type	Photo	Issues	Current Measure	Recommendations	Quantity	Price	Cost Estimation
Approach and Entrance												
Exterior Access Route												
1	Map Near Main Entrance	Ext.		Exterior Access Route	Exterior

Accessible route not provided	-	Ensure an accessible route is provided to the wayside. (Cost is based on cutting the curb to provide an accessible route to the wayside.)	1	1225	\$1225
2	Map and Info on South Side of Building	Ext.		Exterior Access Route	Exterior

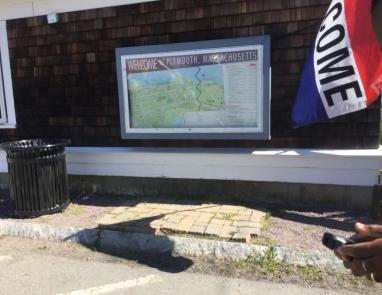
Accessible route not provided	-	Ensure an accessible route is provided to the waysides. (Cost is based on cutting the curb to provide an accessible route to the waysides.)	2	1225	\$2450
Curb Ramp												
3	Memorial Drive Crossing Parking Lot Entrance	Ext.		Curb Ramp	N/A

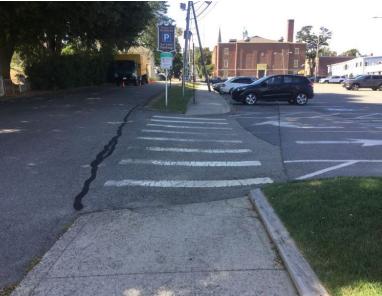
Cross slope > 1:50 (2%) (MAAB)	5.2%	Reduce cross slope at curb ramp to be no steeper than 1:50 (2%). (Cost based on a new curb ramp in an concrete sidewalk.)	1	1225	\$1225

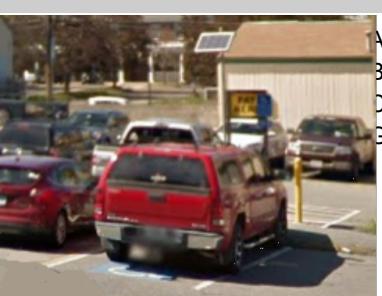
Off-Street Parking Lot or Garage												
4	Parking Lot	Ext.		Off-Street Parking Lot or Garage	Visitor

A. Total # of parking B. Total # of designated accessible parking spaces C. Total # of designated van accessible spaces D. Access aisle not provided	60 2 1 -	Provide a marked access aisle that is at least 60" wide at the designated car accessible parking space closest to the Visitor's Center.	1	150	\$150
Access to Goods and Services

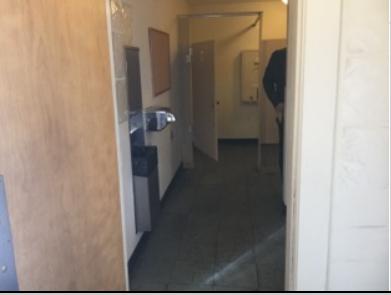
Tactile exit sign not provided Mat not securely attached Illuminated International Symbol of Acc. not provided	- - -	Ensure tactile exit signs with raised characters and braille are provided at exit doors. Mount signs between 48"- 60" above finished floor located on the latch side of the door. Securely attach mat. Provide the International Symbol of Accessibility (ISA) on the illuminated exit sign above the exit door.	1	216	\$216
Signage												
6	Men's and Women's Toilet Rooms	1		Signage	Designation

Not provided	-	Provide toilet room designation signs with raised characters and braille. Include the International Symbol of Accessibility (ISA). Locate signs alongside the door on the latch side.	2	116	\$232

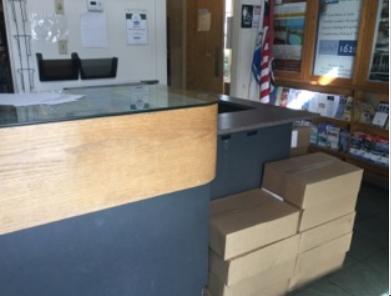
Service Counter												
7	Service Counter	1		Service Counter	N/A

Clear floor space not provided at accessible service counter.	-	Provide a 30" by 48" clear floor space positioned for a parallel approach at the accessible service counter by removing boxes.	1	Labor	\$0
Benches												
8	On Route to Main Entrance	Ext.		Benches	N/A

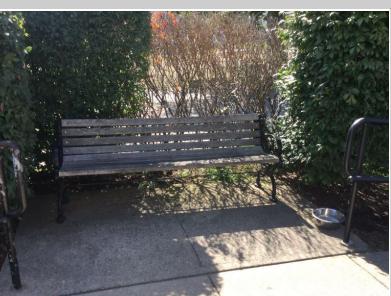
20% of benches have clear space < 36" x 48"	-	Ensure that 20% of benches (1) have a clear floor space of 36" wide min. by 48" deep min. (Cost based on a 3' by 4' concrete patch next to the bench.)	1	92	\$92
Toilet & Bathing Rooms

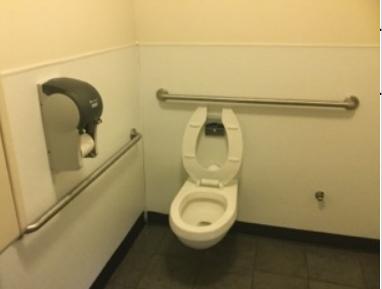
ID	Location	Floor	Room	Element	Type	Photo	Issues	Current Measure	Recommendations	Quantity	Price	Cost Estimation
Toilet Compartment												
9	Men's Toilet Room	1		Toilet Compartment	Accessible Compartment

Door has malfunctioning self-closing hinge Side or rear grab bar < 33" or >36" high Non-compliant toilet paper dispenser	- 27" -	Repair hinge. Locate rear grab bar between 33"- 36" above the finished floor. Relocate toilet paper dispenser so that it is 15" min. high, located below the grab bar, and between 7" and 9" from the front of the toilet.	1	481	\$481
10	Women's Toilet Room	1		Toilet Compartment	Accessible Compartment

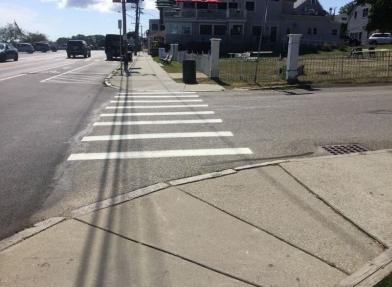
ID	Location	Floor	Room	Element	Type	Photo	Issues	Current Measure	Recommendations	Quantity	Price	Cost Estimation
Curb Ramp												
13	Water Street Crossing Memorial Drive	Ext.		Curb Ramp	N/A

Detectable warning not provided	-	Recommend providing detectable warnings at the curb ramps on both ends of the crosswalk.	2	0	\$0

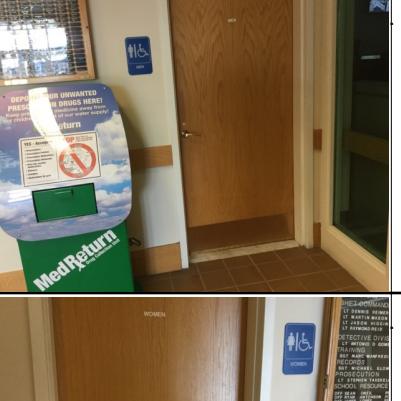
Level changes > 1/4"	-	Changes in level greater than 1/2" must be ramped. Consider providing a transition aluminum threshold ramp.	1	75	\$75
6	Men's Toilet Room	1		Doors, Doorways, & Gates	Toilet Room

Door requires > 5 lbs. of force to open	20 lbs	Adjust closers so doors do not require more than 5 pounds of force to open.	1	Labor	\$0
7	Women's Toilet Room	1		Doors, Doorways, & Gates	Toilet Room

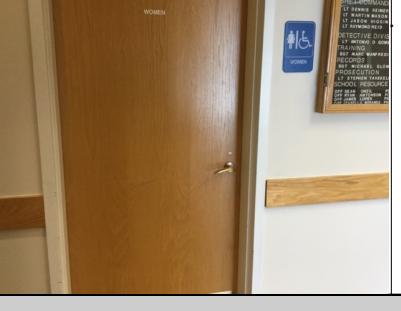
Door requires > 5 lbs. of force to open	25 lbs	Adjust closers so doors do not require more than 5 pounds of force to open.	1	Labor	\$0
Signage												
8	Interview Room	1		Signage	Designation

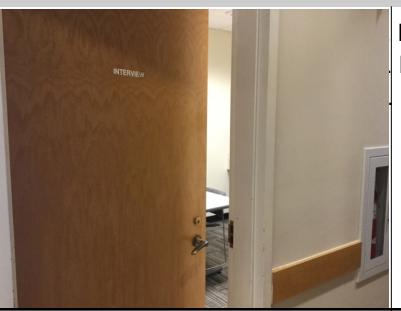
Raised characters not provided Braille not provided Sign not located on the latch side of the door	- - -	Provide a sign with raised characters duplicated in braille. Locate sign alongside the door on the latch side.	1	116	\$116

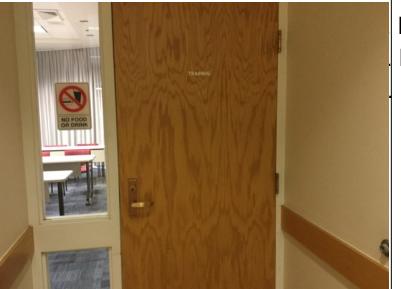
9	Training Room	1		Signage	Designation

Raised characters not provided Braille not provided Sign not located on the latch side of the door	- - -	Provide a sign with raised characters duplicated in braille. Locate sign alongside the door on the latch side.	1	116	\$116

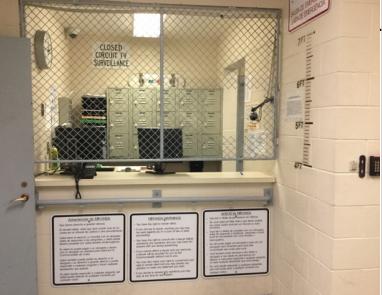
ID	Location	Floor	Room	Element	Type	Photo	Issues	Current Measure	Recommendations	Quantity	Price	Cost Estimation
Service Counter												
10	Booking Area	1		Service Counter	N/A

Parallel approach w/ part of counter surface < 36" long	42"	Provide a portion of the counter surface that is 36" long min. and 36" high max. above the finish floor.	1	440	\$440
11	Lobby	1		Service Counter	N/A

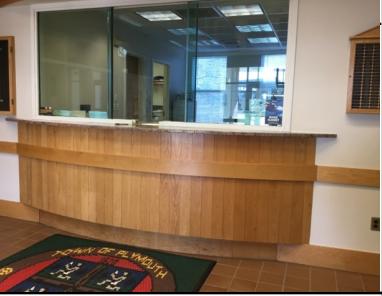
Parallel approach w/ part of counter surface < 36" long	48"	Provide a portion of the counter surface that is 36" long min. and 36" high max. above the finish floor.	1	440	\$440
12	Lobby	1		Service Counter	N/A

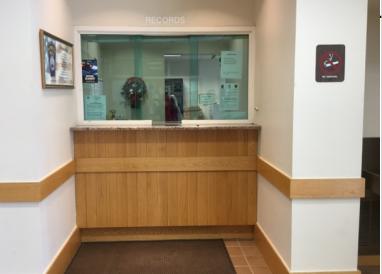
Parallel approach w/ part of counter surface < 36" long	48"	Provide a portion of the counter surface that is 36" long min. and 36" high max. above the finish floor.	1	440	\$440
Operable Parts												
13	Hallway	1		Operable Parts	Clothes Rod/Hooks

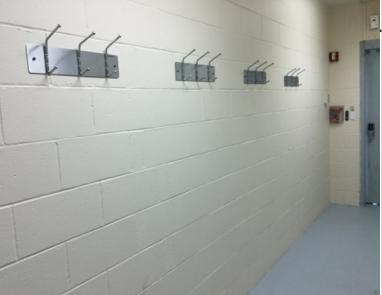
Reach < 15" or > 48"(forward/side approach)	-	Lower hooks so at least 5% are mounted 48" max. above finish floor.	1	Labor	\$0

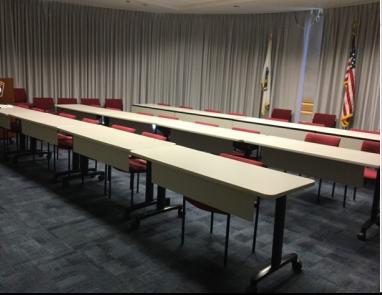
Assembly Area												
14	Training Room	1		Assembly Area	N/A

Assistive listening devices not provided	-	If audible communication is integral to the use of the space, provide an assistive listening system.	1	1214	\$1214

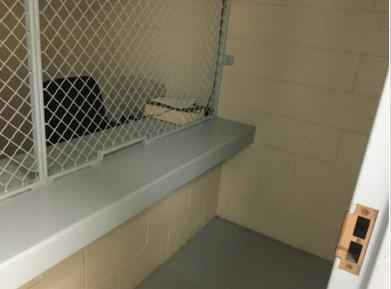
ID	Location	Floor	Room	Element	Type	Photo	Issues	Current Measure	Recommendations	Quantity	Price	Cost Estimation
Detention Facilities												
15	Alternate Booking	1		Detention Facilities	Other

Clear floor space is not provided		Providing a 30" min. by 48" min. clear floor space at the counter might be technically infeasible.	1	0	\$0
16	Holding Cell	1		Detention Facilities	Other

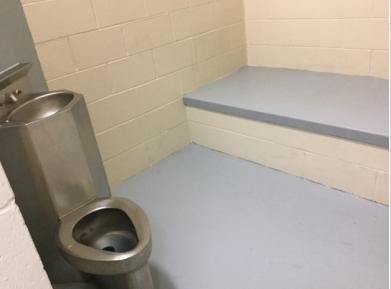
Mobility cell lacks access to accessible toilet/lavatory	-	Ensure an accessible lavatory and toilet are provided. See attachment: Department of Justice Design Guide for Accessible Cells.	1	0	\$0
Toilet & Bathing Rooms												
Overall Access												
17	Single-User Toilet Room (Near Booking Area)	1		Overall Access	Toilet Room

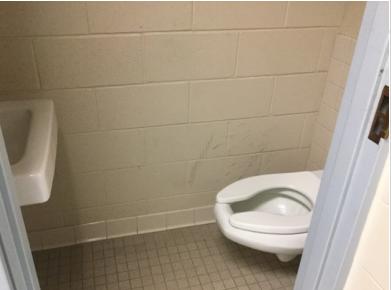
Turning space not provided	-	Provide an accessible single-user toilet room.	1	12302	\$12302
Lavatory												
18	Single-User Toilet Room (Near Booking Area)	1		Lavatory	N/A

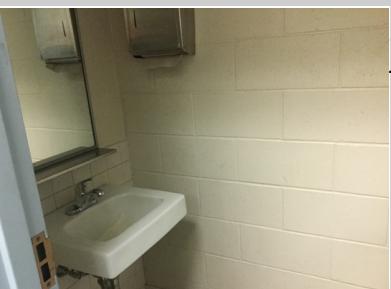
Plumbing underneath is exposed Dispensers not within reach range	-	Insulate or otherwise configure pipe at lavatory to prevent contact. Relocate dispenser to 42" max. above the floor. See ID #17	1	0	\$0

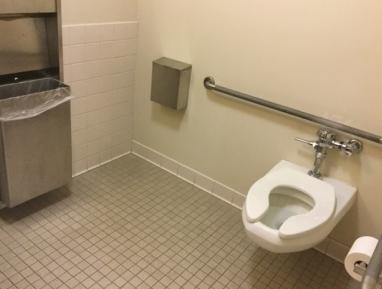
Side or rear grab bar < 33" or > 36" high	30"	Mount grab bars 33"- 36" above the floor.	2	128	\$256
Additional Access												
Drinking Fountains												
21	Lobby	1		Drinking Fountains	Low

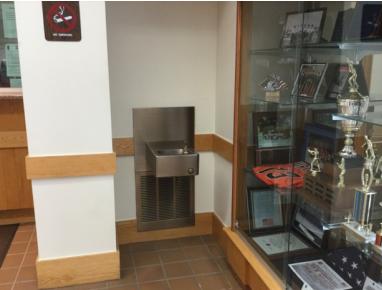
No drinking fountain provided for standing users	-	Provide an additional drinking fountain for standing users.	1	2014	\$2014

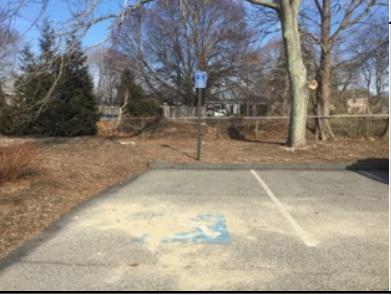
Access aisle not provided	-	Provide a marked access aisle that is at least 60" wide at the car accessible parking space. (Re-stripe).	1	150	\$150
3	Parking Lot	Ext.		Off-Street Parking Lot or Garage	Visitor

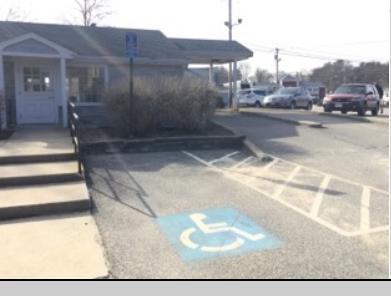
Access aisle < 96" wide at van space	66"	Provide a marked access aisle that is at least 96" wide at the van accessible parking space. (Re-stripe.)	1	150	\$150
Entrance												
4	Emergency Exit Northeast Side	Ext.		Entrance	N/A

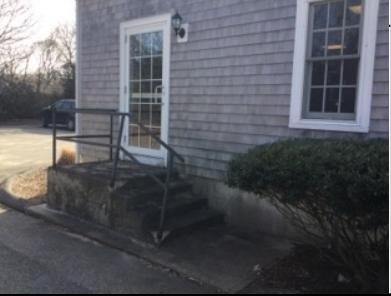
Directional sign to accessible entrance not provided	-	Provide a directional sign indicating the location of the nearest accessible entrance.	1	173	\$173

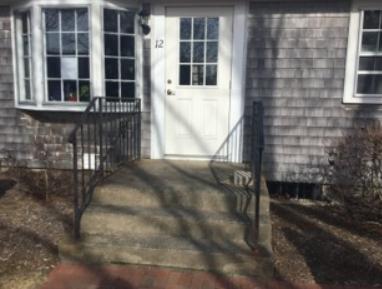
Directional sign to accessible entrance not provided	-	Provide a directional sign indicating the location of the nearest accessible entrance.	1	173	\$173
6	Secondary Entrance Southeast Side, Near Children's Section	Ext.		Entrance	N/A

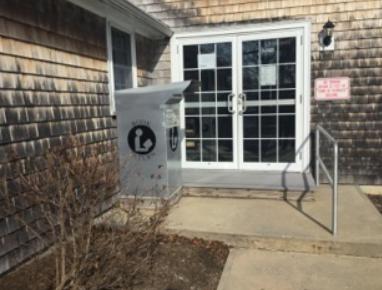
Directional sign to accessible entrance not provided	-	Provide a directional sign indicating the location of the nearest accessible entrance.	1	173	\$173
Emergency Exit												
7	Emergency Exit Southwest Side, Near Meeting Room	1		Emergency Exit	N/A

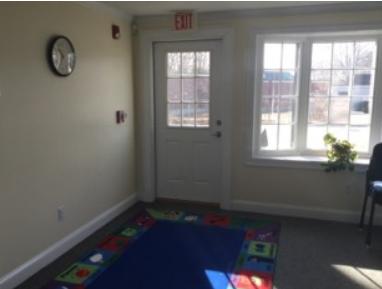
Tactile exit sign not provided Emergency exit not on an accessible route Directional sign to accessible emergency exit not provided Mat not securely attached	- - - -	Provide a directional sign indicating the location of the nearest emergency exit. Ensure tactile exit signs with raised characters and braille are provided at exit doors. Mount signs between 48"- 60" above finished floor located on the latch side of the door. Securely attach walk-off mat.	1	116	\$116

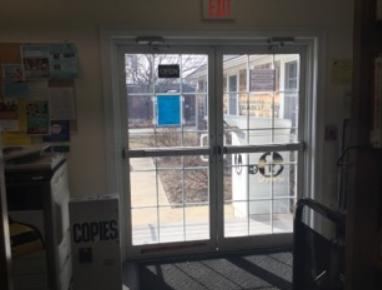
8	Secondary Exit Southeast Side, Near Children's Section	1		Emergency Exit	N/A

Tactile exit sign not provided Emergency exit not on an accessible route Directional sign to accessible emergency exit not provided Mat not securely attached	- - - -	Provide a directional sign indicating the location of the nearest emergency exit. Ensure tactile exit signs with raised characters and braille are provided at exit doors. Mount signs between 48"- 60" above finished floor located on the latch side of the door. Securely attach walk-off mat.	1	116	\$116
9	Emergency Exit Northeast Side, to Exterior Stairs	1		Emergency Exit	N/A

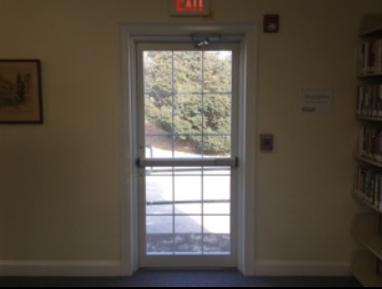
Directional sign to accessible emergency exit not provided Tactile exit sign not provided	- -	Provide a directional sign indicating the location of the nearest accessible emergency exit. Ensure tactile exit signs with raised characters and braille are provided at exit doors. Mount signs between 48"- 60" above finished floor located on the latch side of the door.	1	116	\$116

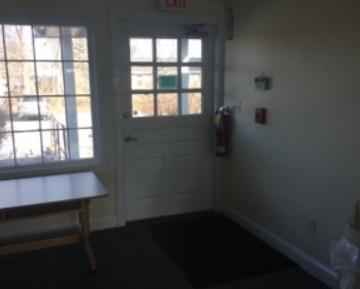
Mat not securely attached Tactile exit sign not provided Illuminated sign with ISA not provided.	- -	Securely attach mat. Ensure tactile exit signs with raised characters and braille are provided at exit doors. Mount signs between 48"- 60" above finished floor located on the latch side of the door. Provide an illuminated emergency egress sign with the International Symbol of Accessibility (ISA).	2	116	\$232
11	Accessible Main Entrance, North Side	1		Emergency Exit	N/A

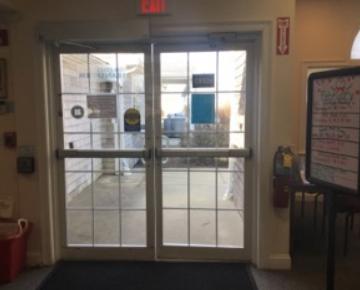
Mat not securely attached Tactile exit sign not provided Illuminated sign with ISA not provided.	- -	Securely attach mat. Ensure tactile exit signs with raised characters and braille are provided at exit doors. Mount signs between 48"- 60" above finished floor located on the latch side of the door. Provide an illuminated emergency egress sign with the International Symbol of Accessibility (ISA).	2	116	\$232

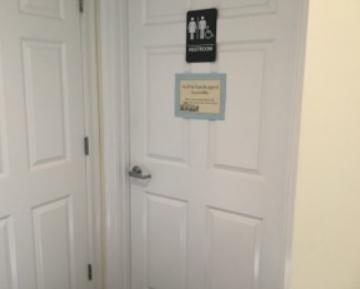
Access to Goods and Services												
Signage												
12	Staff and Accessible Toilet Room	1		Signage	Designation

Raised characters < 48" or > 60" above ground Sign not located on the latch side of the door	62.25" -	Mount signs so that the baseline of the lowest tactile character is 48" min. above finished floor and the baseline of the highest tactile character is 60" max. above finished floor. Locate sign at permanent rooms alongside the door on the latch side.	1	Labor	\$0
Operable Parts												
13	Book Return at Entrance on Southeast Side	Ext.		Operable Parts	Other

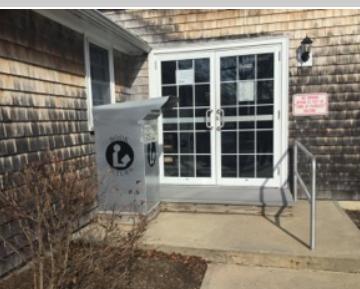
Element not on an accessible route	-	Ensure book return is located on an accessible route.	1	Labor	\$0
14	Main Library Area	1		Operable Parts	Other

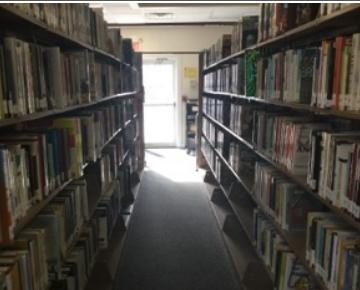
Reach < 15" or > 48"(forward/side approach)	67.5"	In order to provide program accessibility, assist library visitors if books or other library materials exceed their reach range.	1	Labor	\$0

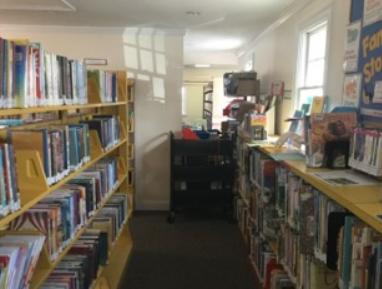
Reach < 15" or > 48"(forward/side approach)	55.5"	In order to provide program accessibility, assist library visitors if books or other library materials exceed their reach range.	1	Labor	\$0
16	Main Library Area	1		Operable Parts	Other

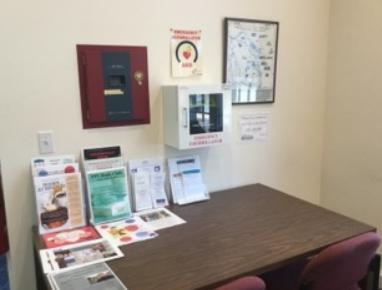
Side reach if obstruction > 24" deep is > 46" high	26"	Ensure that AED access is no higher than 46" above the finished floor. (Work surface is 26" deep.)	1	353	\$353
Dining or Work Surfaces												
17	Meeting Room	1		Dining or Work Surfaces	Work Surface

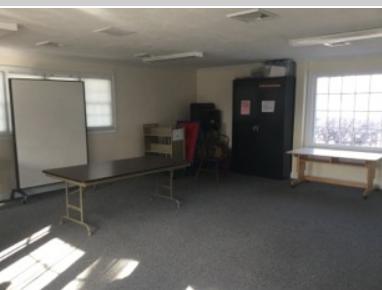
At least one or 5% accessible tables not provided Knee or toe clearance not provided	- 24.5"	Provide at least 1 work surface with 27" min. knee and toe clearance.	1	350	\$350
Toilet & Bathing Rooms												
Overall Access												
18	Men's Toilet Room	1		Overall Access	Toilet Room

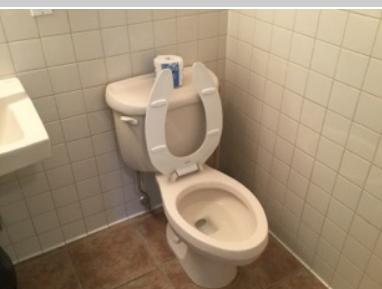
Accessible plumbing fixtures or stalls not provided Sign to accessible toilet not provided	- -	Provide a directional sign indicating the location of the nearest accessible toilet or bathing room.	1	116	\$116

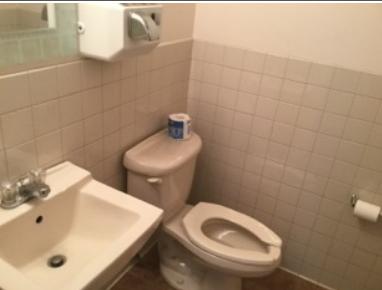
19	Women's Toilet Room	1		Overall Access	Toilet Room

Accessible plumbing fixtures or stalls not provided Sign to accessible toilet not provided	- -	Provide a directional sign indicating the location of the nearest accessible toilet or bathing room.	1	116	\$116

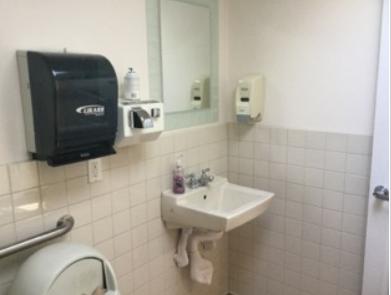
Mirror above lavatory w/reflective surface > 40"	51.75"	Lower mirror so that the bottom surface is at 40" max. above finished floor. In order to provide program accessibility, make this accessible single-user toilet room available to members of the public.	1	128	\$128
Additional Access												
Drinking Fountains												
21	Near Main Entrance on North Side	1		Drinking Fountains	Low

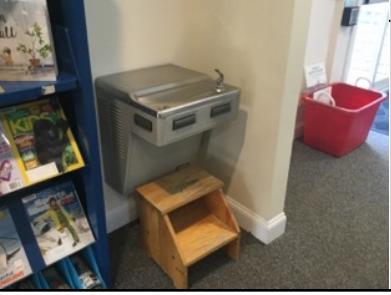
No drinking fountain provided for standing users	-	Provide an additional drinking fountain for standing users.	1	2014	\$2014

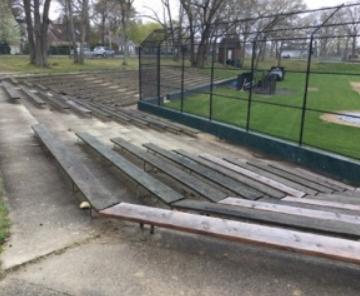
Exterior route < 36" wide	28"	Ensure that a clear width of 36" min. is maintained at the accessible route. (Cost based on expanding route an additional 8" wide to create a 36" wide 308' long concrete path.)	1	1643	\$1643
2	Route From Access Aisle to Bleachers	Ext.		Exterior Access Route	Exterior

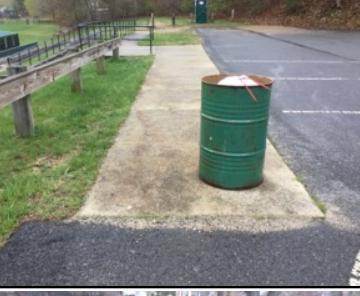
Obstructed by object		Relocate trash can to ensure there is a clear width of 36" for an accessible route.	1	Labor	\$0
3	Baseball Field	Ext.		Exterior Access Route	Walkway

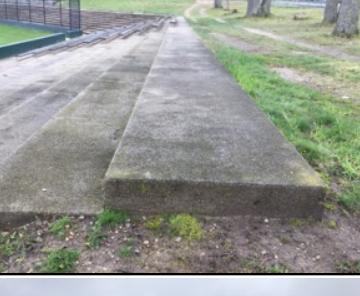
Level changes > 1/4"	4"	Alter change in level to be 1/4" high max. (Cost based on 3' x 3' concrete patch.)	1	103	\$103
4	Baseball Field Entrance From Ocean View Ave.	Ext.		Exterior Access Route	Sidewalk

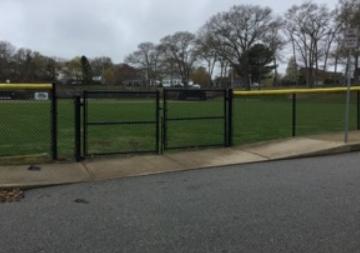
Running slope > 1:20 (5.00%)	9.9%	Reduce the running slope to be no steeper than 1:20 (5.00%). (Cost based on 48" wide min. 30' long of concrete to correct path running slope to 5.00% (1:20) max.)	1	600	\$600

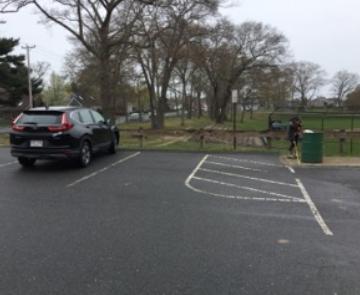
Off-Street Parking Lot or Garage												
5	Parking by Baseball Field	Ext.		Off-Street Parking Lot or Garage	N/A

Total # of parking Total # of designated accessible parking spaces Total # of designated van accessible spaces	20 0 0 -	Provide one van accessible parking space that is at least 132" wide adjacent to the access aisle. Provide a sign with the bottom of the sign 60" min. above the ground and the top 96" max. above the ground. Add the designation "Van Accessible" (Cost based on providing a sign at the van accessible space and re-painting at space.)	1	400	\$400

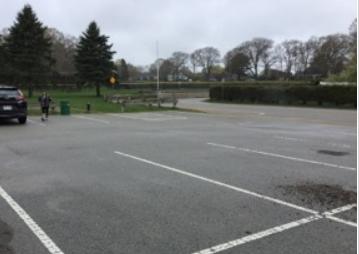
Total # of parking Total # of designated accessible parking spaces Total # of designated van accessible spaces	26 0 0	Provide one van accessible space that is 132" wide min. with an adjoining marked access aisle 60" wide min. Provide a sign with the bottom of the sign 60" min. above the ground and the top 96" max. above the ground. Add the designation "Van Accessible" to the sign located at the van accessible space.	1	400	\$400
7	Parking by Basketball Court and Play Area	Ext.		Off-Street Parking Lot or Garage	Visitor

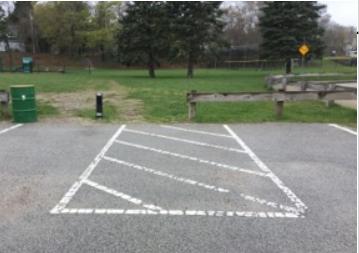
Access aisle does not adjoin an accessible route		Ensure the access aisle adjoins an accessible route. (Cost based on re-painting marked access aisle to be placed in front of accessible route.)	1	150	\$150

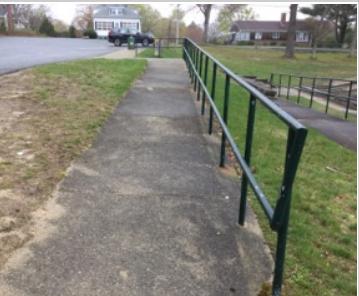
Access to Goods and Services												
Ramps												
8	Route From Access Aisle to Bleachers	Ext.		Ramps	Exterior

Handrails not continuous where required	66'	Provide continuous handrails for the length of ramp runs. (Cost based on 66' long metal handrail.)	1	2442	\$2442
9	Route From Access Aisle to Bleachers	Ext.		Ramps	Exterior

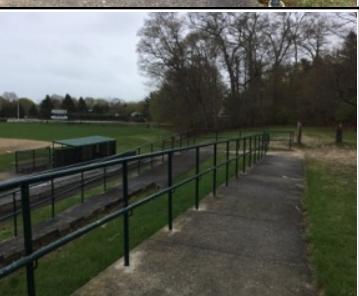
Handrails not provided on both sides	62'	Provide handrails with 1 1/4"- 2" circular cross sections or 4"- 6 1/4" non-circular cross sections that are 34"-38" high above the ramp surface. (Cost based on 62' long metal handrail.)	1	2294	\$2294
Picnic Tables												
10	Next to Play Area	Ext.		Picnic Tables	N/A

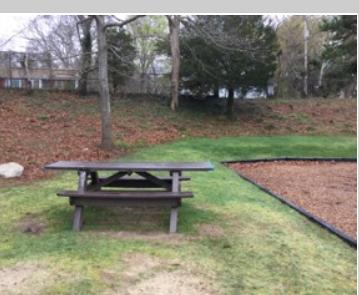
Number of seating spaces at picnic tables Number of accessible seating spaces Picnic table not on an accessible route	4 2 -	Locate picnic table on an accessible route. (Cost based on 36" wide min. 8' long stone dust path with running slope of 5.00% (1:20) max. and cross slope of 2.00% (1:50) max. and a 16' x 17' stone dust area around picnic table.)	1	1124	\$1124

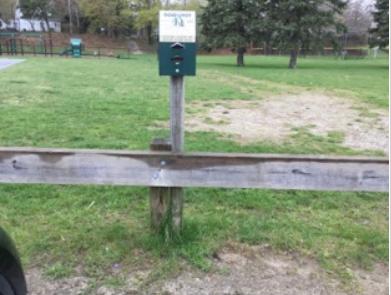
Dog waste bags container opening not within reach range Dog waste bags container not connected to an accessible route	53"	Ensure that operable parts are 48" max. above ground. Ensure dog waste bags container is located on an accessible route. (Cost based on 36" wide min. 4' long stone dust path with running slope of 5.00% (1:20) max. and cross slope of 2.00% (1:50) max.)	1	45	\$45
Toilet & Bathing Rooms												
12	Near Parking Lot by Baseball Field	Ext.		Portable Toilet	N/A

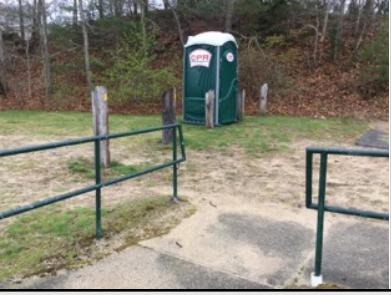
Not located on an accessible route Accessible portable toilets not provided		Locate portable toilet on an accessible route. Ensure that at least 5% of portable toilets is accessible.	1	2300	\$2300

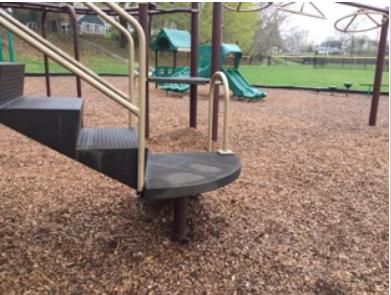
Play and Sport Areas												
13	Play Area	Ext.		Play Areas	N/A

No compliant transfer system	22.5"	Alter height of transfer system to 18" max. aff.	1	Labor	\$0
14	Play Area	Ext.		Play Areas	N/A

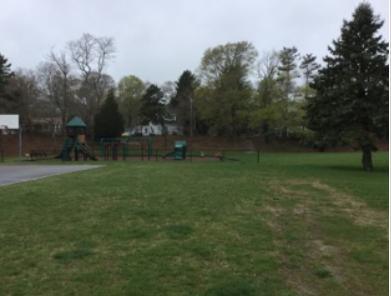
Accessible route not provided to ground level play components	141'	Ensure an accessible route is provided to one of each type of ground level play components. (Cost based on 36" wide min. 141' long stone dust path with running slope of 5.00% (1:20) max. and a cross slope of 2.00% (1:50) max.)	1	1606	\$1606

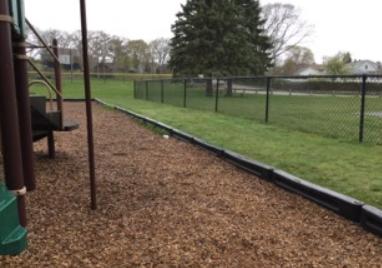
ID	Location	Floor	Room	Element	Type	Photo	Issues	Current Measure	Recommendations	Quantity	Price	Cost Estimation
15	Play Area	Ext.		Play Areas	N/A

Accessible route not provided to ground level play components	25'	Ensure an accessible route is provided to the play area. (Cost based on 36" wide min. 25' long stone dust path with running slope of 5.00% (1:20) max. and cross slope of 2.00% (1:50) max.)	1	285	\$285
16	Play Area	Ext.		Play Areas	N/A

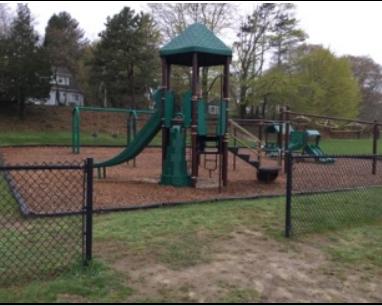
Surface not stable, firm, and slip-resistant	-	Provide an accessible impact-attenuating surface around the play components. (Cost based on 1,688 square feet of poured in place rubber.)	1	23632	\$23632
Field												
17	Baseball Field - Dugout	Ext.		Field	Baseball

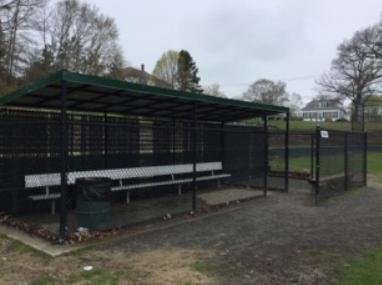
Accessible spaces are not provided at team seating Not connected to an accessible-route		Provide a 36" x 48" clear floor space at team seating. Ensure team seating is connected to an accessible route. (Cost based on 36" x 48" stone dust patch.)	2	52	\$104

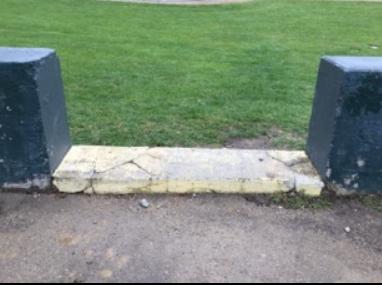
18	Baseball Field	Ext.		Field	Baseball

Not connected to an accessible-route		Remove step onto baseball field and ensure baseball field is connected to an accessible route. (Cost based on 36" wide min. 3' long concrete path with running slope of 5.00% (1:20) max. and cross slope of 2.00% (1:50) max.)	1	45	\$45
19	Baseball Field	Ext.		Field	Baseball

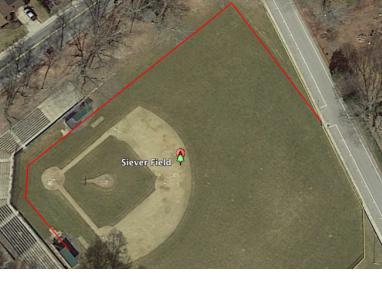
Not connected to an accessible-route		Ensure baseball field and team seating is connected to an accessible route. Proposed route is shown in red in the adjacent image. (Cost based on 36" wide min. 615' long stone dust path with running slope of 5.00% (1:20) max. and cross slope of 2.00% (1:50) max.)	1	7005	\$7005

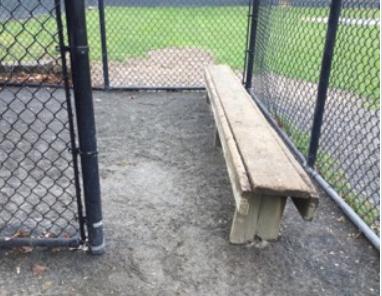
ID	Location	Floor	Room	Element	Type	Photo	Issues	Current Measure	Recommendations	Quantity	Price	Cost Estimation
20	Baseball Field - Dugout Entrance	Ext.		Field	Baseball

Practice areas are not on an accessible route	25"	Remove bench to create an accessible route to practice area.	1	Labor	\$0
Court												
21	Basketball Court	Ext.		Court	Basketball

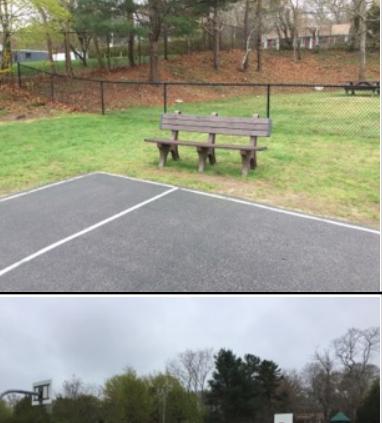
Accessible spaces are not provided at sidelines seating Not connected to accessible route		Provide a 36" x 48" clear floor space at sidelines seating. Ensure bench is connected to an accessible route. (Cost based on 36" x 48" stone dust patch and 36" wide min. 4' long stone dust path with running slope of 5.00% (1:20) max. and a cross slope of 2.00% (1:50) max.)	1	45	\$45
22	Basketball Court	Ext.		Court	Basketball

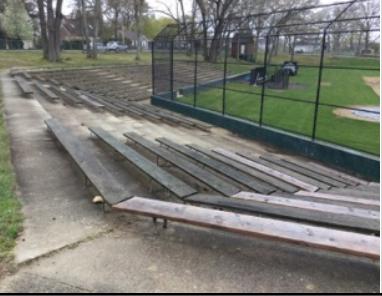
Bleachers												
23	Baseball Field	Ext.		Bleachers	N/A

Min. # of designated wheelchair spaces not provided Seating spaces < 36" x 48" (single space)		Provide the required number of accessible wheelchair spaces. Provide a 36" by 48" clear floor space behind the circulation path. Provide companion seating adjacent to the wheelchair spaces. (Cost based on 36" x 48" concrete patch.)	2	92	\$184
Best Practice

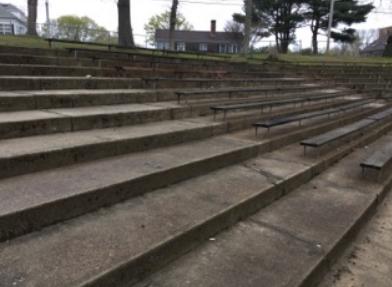
Handrails not provided		Consider providing a handrail on one side of each aisle.	4	0	\$0

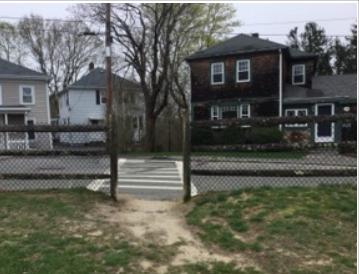
ID	Location	Floor	Room	Element	Type	Photo	Issues	Current Measure	Recommendations	Quantity	Price	Cost Estimation
Approach and Entrance												
Exterior Access Route												
1	Entrance by Basketball Court	Ext		Exterior Access Route	Exterior

Cross slope > 1:50 (2.00%) (MAAB) Surface not stable, firm, and slip-resistant Does not prevent accumulation of water Running slope > 1:20 (5.00%)	4.1% - - 6.3%	See Record 4 for cost to provide an accessible route between this entrance and the basketball court.	1	0	\$0
2	Crosswalk Closest to Playground	Ext		Exterior Access Route	Walkway

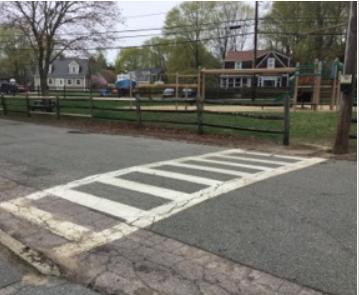
Level changes > 1/4" Does not prevent accumulation of water	3.75" -	Alter change in level to be 1/4" high max. Repair surface.	1	36	\$36
3	Entrance by Playground	Ext		Exterior Access Route	Exterior

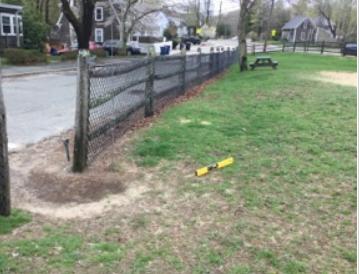
Does not prevent accumulation of water	-	See Record 10 for cost to provide an accessible route from this entrance to the playground.	1	0	\$0

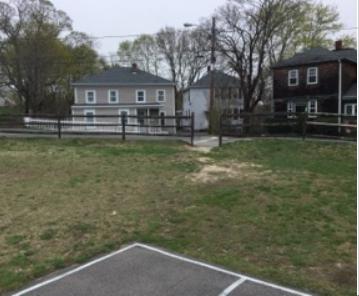
4	Route From Entrance to Basketball Court	Ext		Exterior Access Route	Exterior

Accessible route not provided	40'	Ensure an accessible route is provided between the entrance and the basketball court. (Cost estimate for a 40' asphalt route.)	1	520	\$520
5	Route Between Memorial and Basketball Court	Ext		Exterior Access Route	Exterior

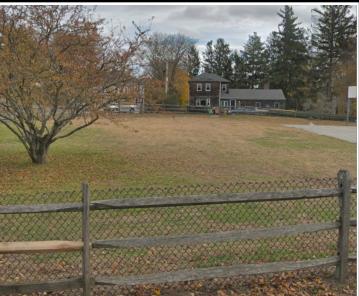
Accessible route not provided		Ensure an accessible route is provided between the memorial and basketball court. (Cost estimate for an 84' long asphalt route.)	1	1092	\$1092

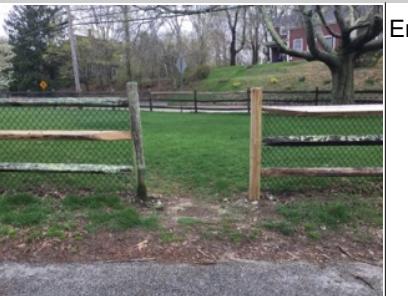
Entrance not on an accessible route	15.7%	Provide a directional sign indicating the location of the nearest accessible entrance.	1	173	\$173
Access to Goods and Services												
Picnic Tables												
8	Playground	Ext		Picnic Tables	N/A

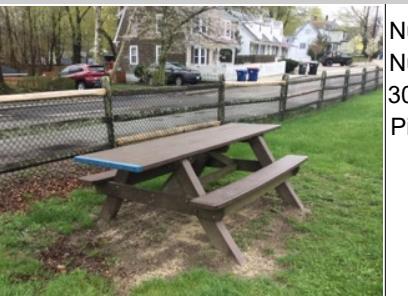
Number of seating spaces at picnic tables Number of accessible seating spaces 30" clear width not provided Picnic table not on an accessible route	4 2 28" -	Provide at least one accessible picnic table that is 30" wide. Locate picnic table on an accessible route.	1	828	\$828

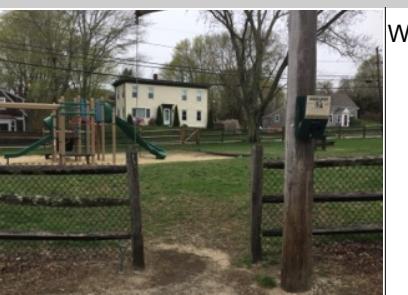
Dog Parks												
9	Entrance by Playground	Ext		Dog Parks	N/A

Waste and bag dispenser/receptacle not within reach range	62"	Locate bag dispenser 48" max. above the ground.	1	128	\$128
Play and Sport Areas

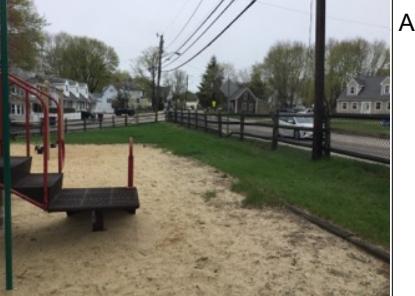
Accessible route not provided	25'	Ensure an accessible route is provided to the playground. (Cost estimate for a 25' long asphalt route.)	1	325	\$325
Court												
12	Route Between Basketball Court and Playground	Ext		Court	Basketball

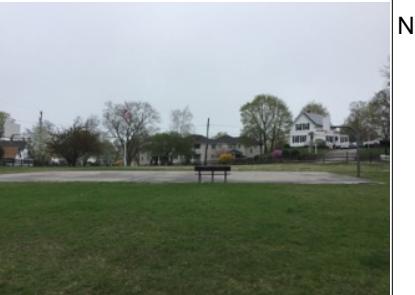
Not connected to accessible route	148'	Provide an accessible route between playground and basketball court. (Cost estimate for a 148' long asphalt surface.)	1	1,924	\$1924
Best Practice												
13	Basketball Court	Ext

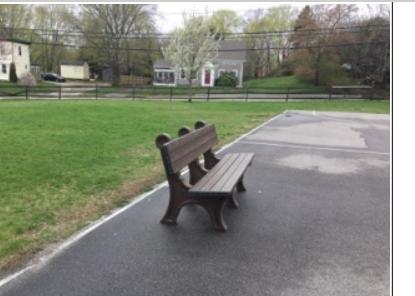
As best practice provide more benches and ensure they are on an accessible route.	1		\$0

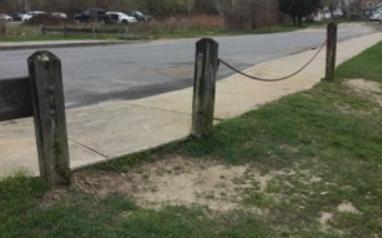
Level changes > 1/4"	3"	Alter change in level to be 1/4" high max. (Cost based on 3' x 3' concrete patch.)	1	103	\$103
3	Concession Stand	Ext		Exterior Access Route	Exterior

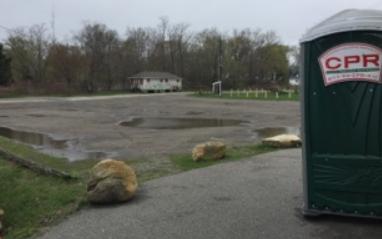
Surface not stable, firm, and slip-resistant Does not prevent accumulation of water Not maintained in an operable working condition Accessible route not provided	- - 3'	Ensure the parking lot surface is maintained in operable working condition. Ensure an accessible route is provided from parking lot to concession area. (Cost based on 36" wide min. 3' long stone dust path with running slope of 5.00% (1:20) max. and cross slope of 2.00% (1:50) max.)	1	34	\$34

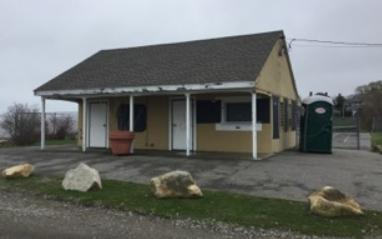
4	Concession Stand	Ext		Exterior Access Route	Exterior

Accessible route not provided	6'	Ensure an accessible route is provided. NB: The existing building is not owned by the Town of Plymouth and is being replaced. (Cost based on 36" wide min. 6' long stone dust path with running slope of 5.00% (1:20) max. and cross slope of 2.00% (1:50) max.)	1	68	\$68
5	Pond by Play Area	Ext		Exterior Access Route	Exterior

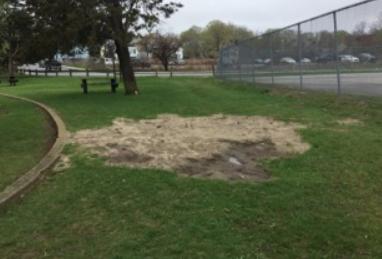
Accessible route not provided	117'	Ensure an accessible route is provided. (Cost based on 36" wide min. 117' long stone dust path with running slope of 5.00% (1:20) max. and cross slope of 2.00% (1:50) max.)	1	1333	\$1333

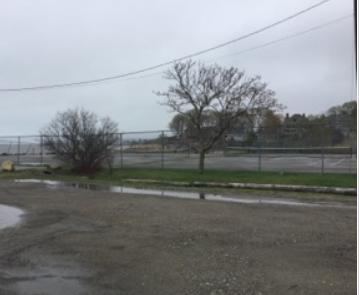
ID	Location	Floor	Room	Element	Type	Photo	Issues	Current Measure	Recommendations	Quantity	Price	Cost Estimation
Off-Street Parking Lot or Garage												
6	Parking Between Tennis Courts and Baseball Field	Ext		Off-Street Parking Lot or Garage	Visitor

Total # of parking Total # of designated accessible parking spaces Total # of designated van accessible spaces	25 0 0	Provide one (1) van accessible space that is at least 132" wide with a marked access aisle that is at least 60" wide. Provide a sign with the bottom of the sign 60" min. above the ground and the top 96" max. above the ground. Add the designation "Van Accessible" to the sign located at the van accessible space.	1	925	\$925
7	Parking by Basketball Court	Ext		Off-Street Parking Lot or Garage	N/A

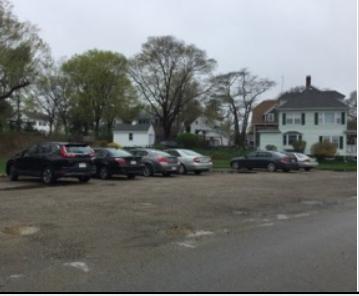
Total # of parking Total # of designated accessible parking spaces Total # of designated van accessible spaces	15 0 0	Provide one (1) van accessible space that is at least 132" wide with a marked access aisle that is at least 60" wide. Provide a sign with the bottom of the sign 60" min. above the ground and the top 96" max. above the ground. Add the designation "Van Accessible" to the sign located at the van accessible space.	1	925	\$925

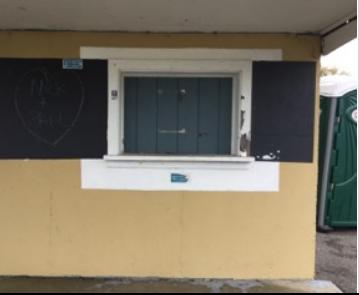
Access to Goods and Services												
Service Counter												
8	Concession Stand	Ext		Service Counter	N/A

Counter > 36" high	46"	Provide a counter that is 36" max. above the ground. NB: The existing building is not owned by the Town of Plymouth and is being replaced.	1	440	\$440
Picnic Tables												
9	Pond by Play Area	Ext		Picnic Tables	N/A

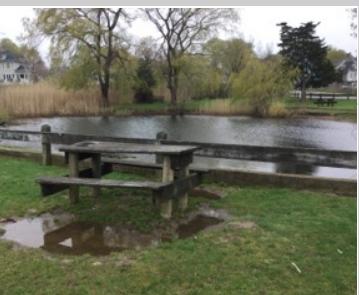
Number of seating spaces at picnic tables Number of accessible seating spaces Toe or knee clearance at table not provided Picnic table not on an accessible route	4 0 - -	Provide at least one accessible picnic table with top between 28"- 34" above the ground and 27" clear height underneath. Locate picnic table on an accessible route. (Cost based on 36" wide min. 11' long stone dust path with running slope of 5.00% (1:20) max. and cross slope of 2.00% (1:50) max. and one (1) accessible picnic table.)	1	825	\$825

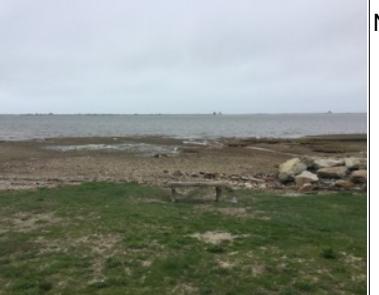
ID	Location	Floor	Room	Element	Type	Photo	Issues	Current Measure	Recommendations	Quantity	Price	Cost Estimation
Benches												
10	By Concession Stand	Ext		Benches	N/A

No accessible route to 20% of benches		Provide an accessible route to 20% of benches in this area. (Cost based on 36" wide min. 24' long stone dust path with running slope of 5.00% (1:20) max. and cross slope of 2.00% (1:50) max.)	1	273	\$273
Trash / Recycling												
11	Baseball Field	Ext		Trash / Recycling	N/A

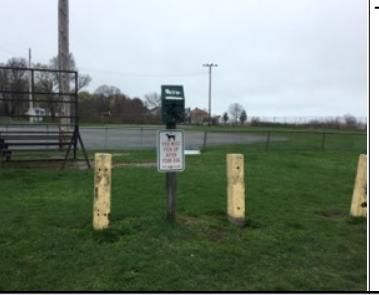
Trash container not connected to an accessible route	10'	Ensure trash container is located on an accessible route. (Cost based on 36" wide min. 10' long stone dust path with running slope of 5.00% (1:20) max. and cross slope of 2.00% (1:50) max.)	1	114	\$114
Toilet & Bathing Rooms												
Portable Toilet												
12	Concession Stand	Ext		Portable Toilet	N/A

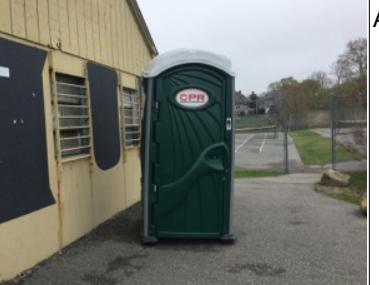
Accessible portable toilets not provided		Ensure that at least 5% of portable toilets is accessible. (Cost based on one accessible portable toilet.)	1	2300	\$2300

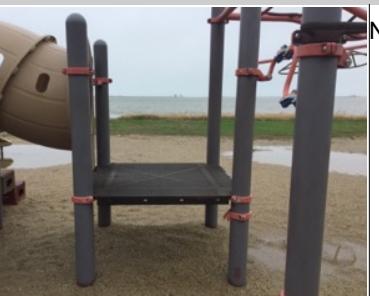
Play and Sport Areas												
Play Areas												
13	Play Area	Ext		Play Areas	N/A

No compliant transfer system	26.25"	Alter height of transfer system to 18" max. aff.	1	Labor	\$0

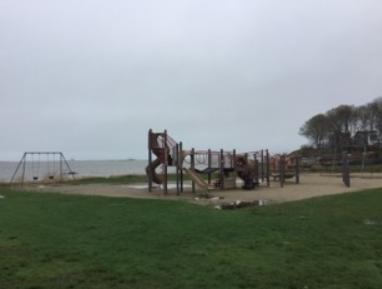
ID	Location	Floor	Room	Element	Type	Photo	Issues	Current Measure	Recommendations	Quantity	Price	Cost Estimation
14	Play Area	Ext		Play Areas	N/A

Accessible route not provided.	50'	Ensure play area is connected to an accessible route. (Cost based on 36" wide min. 50' long stone dust path with running slope of 5.00% (1:20) max. and cross slope of 2.00% (1:50) max.)	1	570	\$570
15	Play Area	Ext		Play Areas	N/A

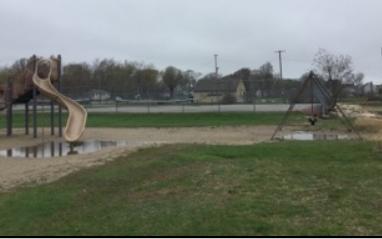
Surface not stable, firm, and slip-resistant		Provide an accessible impact-attenuating surface around the play components. (Cost base on 645 square feet of poured in place rubber.)	1	9030	\$9030
Field												
16	Baseball Field	Ext		Field	Baseball

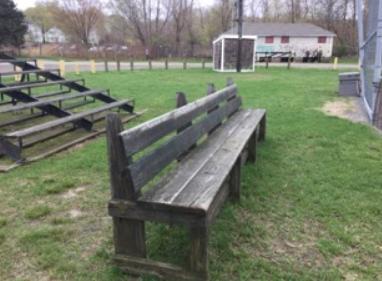
Accessible spaces are not provided at team seating		Provide a 36" x 48" clear floor space at team seating. (Cost based on 36" x 48" stone dust patch.)	2	45	\$90
17	Baseball Field	Ext		Field	Baseball

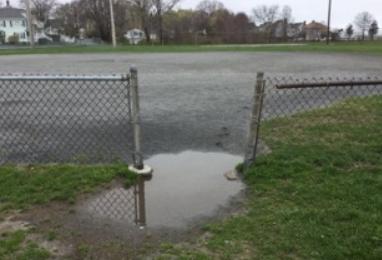
Clear width at door < 32" Does not prevent accumulation of water	30"	Widen the door so that there is 32" min. clear width. Repair surface.	1	128	\$128

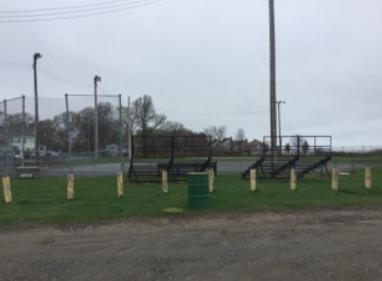
18	Parking Between Tennis Courts and Baseball Field	Ext		Field	Baseball

Not connected to an accessible-route	50'	Ensure baseball field is connected to an accessible route. (Cost based on 36" wide min. 50' long stone dust path with running slope of 5.00% (1:20) max. and cross slope of 2.00% (1:50) max.)	1	570	\$570

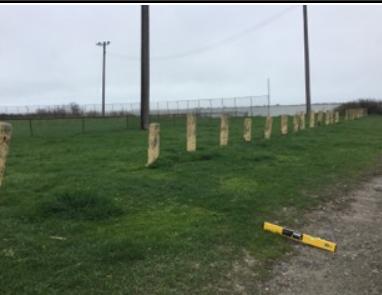
Running slope > 1:20 (5.00%)	17.9	Reduce the running slope to be no steeper than 1:20 (5.00%). See ID number 18 for cost.	1		\$0
Court												
20	Route to Basketball Court	Ext		Court	Basketball

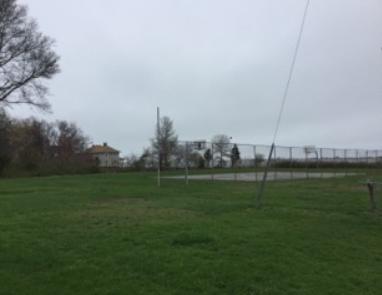
Not connected to accessible route	215'	Ensure basketball court is connected to an accessible route. (Cost based on 36" wide min. 215' long stone dust path with running slope of 5.00% (1:20) max. and cross slope of 2.00% (1:50) max.)	1	2449	\$2449
21	Route From Parking to Tennis Courts	Ext		Court	Tennis

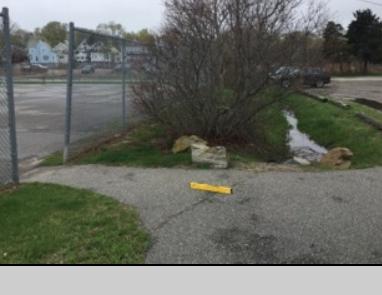
Running slope > 1:20 (5.00%)	6.6%	Reduce the running slope to be no steeper than 1:20 (5.00%).	1	120	\$120
Bleachers												
22	Baseball Field	Ext		Bleachers	N/A

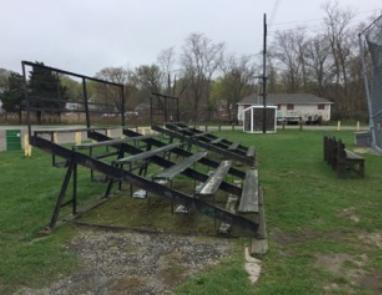
Min. # of designated wheelchair spaces not provided Seats not connected by accessible route	-	Provide the required number of accessible wheelchair spaces. Provide an accessible route to the seating area. (Cost based on 36" wide min. 208' long stone dust path with running slope of 5.00% (1:20) max. and cross slope of 2.00% (1:50) max.)	1	2369	\$2369

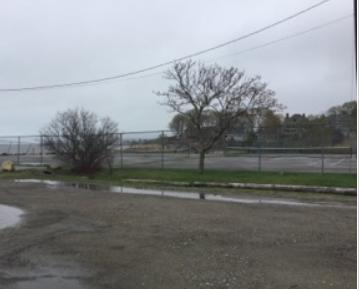
Total # of parking Total # of designated accessible parking spaces Total # of designated van accessible spaces	25 0 0	Provide one (1) van accessible space that is at least 132" wide with a marked access aisle that is at least 60" wide. Provide a sign with the bottom of the sign 60" min. above the ground and the top 96" max. above the ground. Add the designation "Van Accessible" to the sign located at the van accessible space.	1	925	\$925
7	Parking by Basketball Court	Ext		Off-Street Parking Lot or Garage	N/A

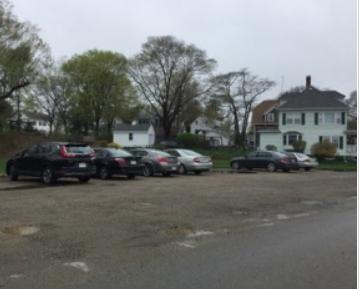
Total # of parking Total # of designated accessible parking spaces Total # of designated van accessible spaces	15 0 0	Provide one (1) van accessible space that is at least 132" wide with a marked access aisle that is at least 60" wide. Provide a sign with the bottom of the sign 60" min. above the ground and the top 96" max. above the ground. Add the designation "Van Accessible" to the sign located at the van accessible space.	1	925	\$925

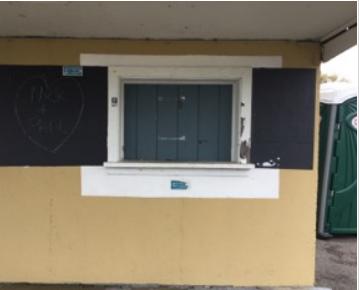
Access to Goods and Services												
Service Counter												
8	Concession Stand	Ext		Service Counter	N/A

Counter > 36" high	46"	Provide a counter that is 36" max. above the ground. NB: The existing building is not owned by the Town of Plymouth and is being replaced.	1	440	\$440
Picnic Tables												
9	Pond by Play Area	Ext		Picnic Tables	N/A
