Town of Plymouth

Part A – Executive Summary

October 2019

Prepared by the
**Institute for
Human
Centered
Design**

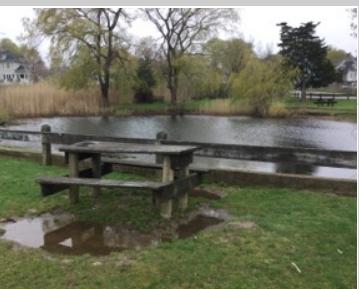
Number of seating spaces at picnic tables Number of accessible seating spaces Toe or knee clearance at table not provided Picnic table not on an accessible route	4 0 - -	Provide at least one accessible picnic table with top between 28"- 34" above the ground and 27" clear height underneath. Locate picnic table on an accessible route. (Cost based on 36" wide min. 11' long stone dust path with running slope of 5.00% (1:20) max. and cross slope of 2.00% (1:50) max. and one (1) accessible picnic table.)	1	825	\$825

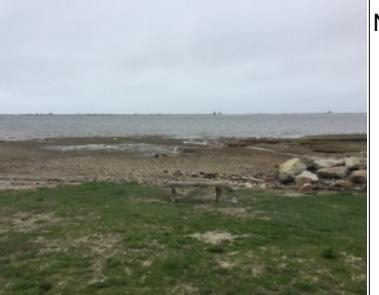
No accessible route to 20% of benches		Provide an accessible route to 20% of benches in this area. (Cost based on 36" wide min. 24' long stone dust path with running slope of 5.00% (1:20) max. and cross slope of 2.00% (1:50) max.)	1	273	\$273
Trash / Recycling												
11	Baseball Field	Ext		Trash / Recycling	N/A

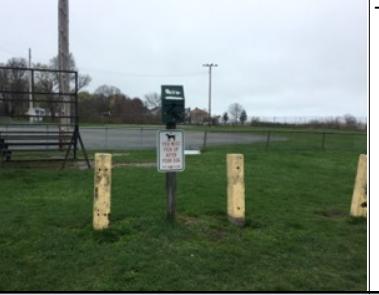
Trash container not connected to an accessible route	10'	Ensure trash container is located on an accessible route. (Cost based on 36" wide min. 10' long stone dust path with running slope of 5.00% (1:20) max. and cross slope of 2.00% (1:50) max.)	1	114	\$114
Toilet & Bathing Rooms												
Portable Toilet												
12	Concession Stand	Ext		Portable Toilet	N/A

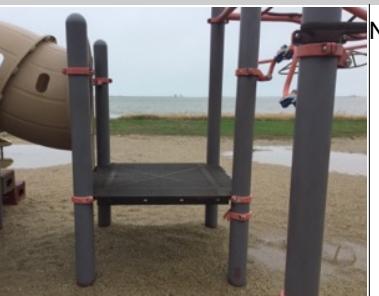
Play and Sport Areas												
Play Areas												
13	Play Area	Ext		Play Areas	N/A

No compliant transfer system	26.25"	Alter height of transfer system to 18" max. aff.	1	Labor	\$0

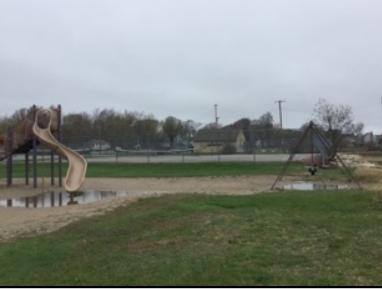
Surface not stable, firm, and slip-resistant		Provide an accessible impact-attenuating surface around the play components. (Cost base on 645 square feet of poured in place rubber.)	1	9030	\$9030
Field												
16	Baseball Field	Ext		Field	Baseball

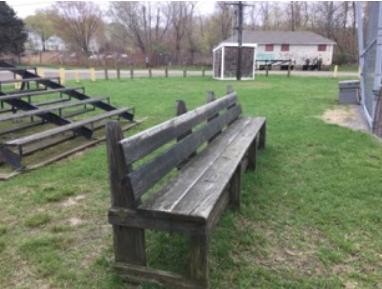
Accessible spaces are not provided at team seating		Provide a 36" x 48" clear floor space at team seating. (Cost based on 36" x 48" stone dust patch.)	2	45	\$90
17	Baseball Field	Ext		Field	Baseball

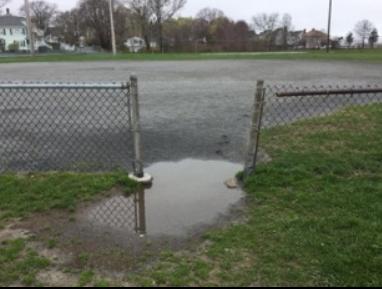
Clear width at door < 32" Does not prevent accumulation of water	30"	Widen the door so that there is 32" min. clear width. Repair surface.	1	128	\$128

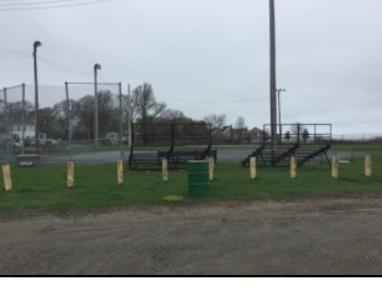
18	Parking Between Tennis Courts and Baseball Field	Ext		Field	Baseball

Not connected to an accessible-route	50'	Ensure baseball field is connected to an accessible route. (Cost based on 36" wide min. 50' long stone dust path with running slope of 5.00% (1:20) max. and cross slope of 2.00% (1:50) max.)	1	570	\$570

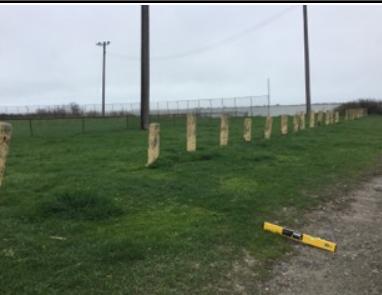
Running slope > 1:20 (5.00%)	17.9	Reduce the running slope to be no steeper than 1:20 (5.00%). See ID #18 for cost.	1		\$0
Court												
20	Route to Basketball Court	Ext		Court	Basketball

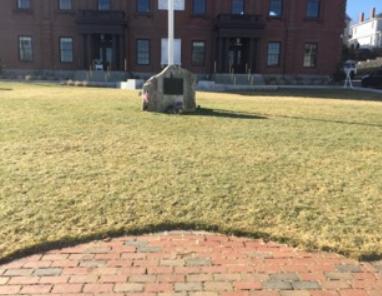
Accessible route not provided	30'	Ensure an accessible route is provided to the monument. Running slope should be 1:20 (5.00%) max., and cross slope should be 1:50 (2.00%) max. (Cost based on 30'x3' new brick path to monument.)	1	1170	\$1170
Off-Street Parking Lot or Garage												
2	Parking by Main Accessible Entrance	Ext.		Off-Street Parking Lot or Garage	N/A

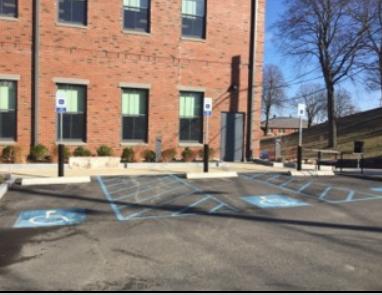
Total # of parking Total # of designated accessible parking spaces Total # of designated van accessible spaces Running or cross slope at access aisle > 1:50 (2.00%)	12 5 2 3.2%	Reduce slope in access aisle to be no steeper than 1:50 (2.00%). (Cost based on 8' of asphalt to reduce slope.)	1	288	\$288

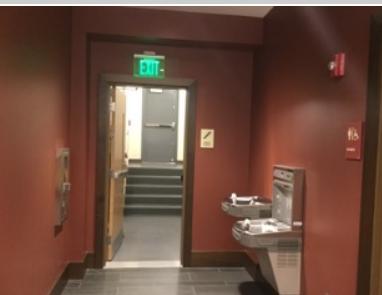
Emergency Exit												
3	East Egress	1		Emergency Exit	N/A

Directional sign to accessible emergency exit not provided	-	Provide a directional sign indicating the location of the nearest accessible emergency exit.	1	116	\$116
Access to Goods and Services												
Means of Egress												
4	Lobby	1		Means of Egress	N/A

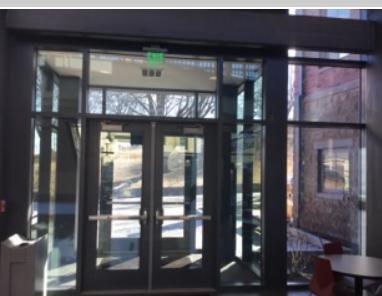
Tactile exit sign not provided	-	Ensure tactile exit signs with raised characters and braille are provided at exit doors. Mount signs between 48"- 60" above finish floor located on the latch side of the door.	4	116	\$464

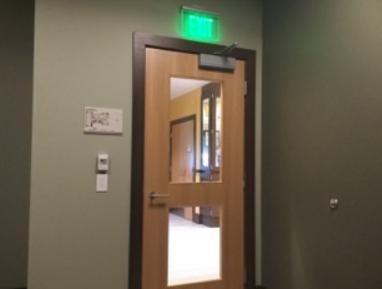
Tactile exit sign not provided	-	Ensure tactile exit signs with raised characters and braille are provided at exit doors. Mount signs between 48"- 60" above finish floor located on the latch side of the door.	1	116	\$116
6	Hallway Near Town Clerk	1		Means of Egress	N/A

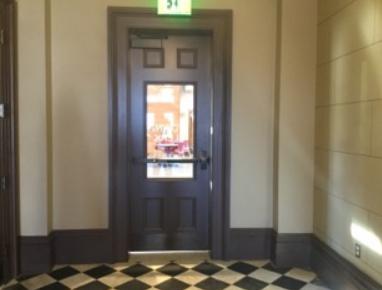
Tactile exit sign not provided	-	Ensure tactile exit signs with raised characters and braille are provided at exit doors. Mount signs between 48"- 60" above finish floor located on the latch side of the door.	1	116	\$116
7	Great Hall	2		Means of Egress	N/A

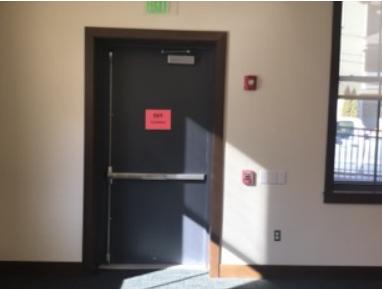
Tactile exit sign not provided	-	Ensure tactile exit signs with raised characters and braille are provided at exit doors. Mount signs between 48"- 60" above finish floor located on the latch side of the door.	1	116	\$116

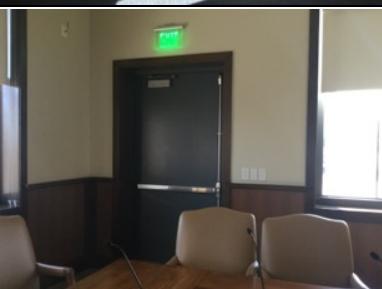
8	Great Hall	2		Means of Egress	N/A

Tactile exit sign not provided	-	Ensure tactile exit signs with raised characters and braille are provided at exit doors. Mount signs between 48"- 60" above finish floor located on the latch side of the door.	1	116	\$116
9	Great Hall	2		Means of Egress	N/A

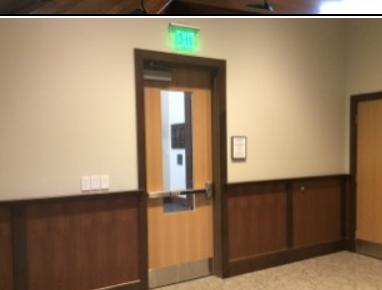
Tactile exit sign not provided	-	Ensure tactile exit signs with raised characters and braille are provided at exit doors. Mount signs between 48"- 60" above finish floor located on the latch side of the door.	1	116	\$116

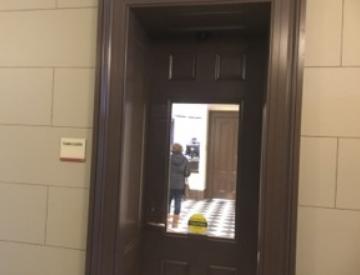
Maneuvering clearance not provided at recess > 8"	24"	Repair power door. (IHCD team was told a power door is installed, but it was not working on the day of the survey.)	1	Labor	\$0
11	Rope Walk Meeting Room	2		Doors, Doorways, & Gates	Meeting Room

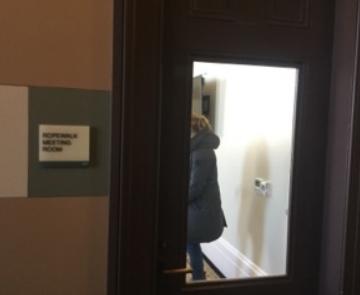
Door requires > 5 lbs. of force to open	12 lbs.	Adjust closers so doors do not require more than 5 pounds of force to open.	1	Labor	\$0
Toilet & Bathing Rooms												
Toilet Compartment												
12	Women's and Men's Multi-User Toilet Room Accessible Compartment	1, 2, 3, 4		Toilet Compartment	Accessible Compartment

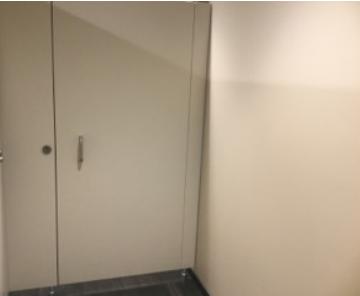
Toe clearance < 9"	-	Adjust partition to provide toe clearance.	8	Labor	\$0
Additional Access												
Drinking Fountains

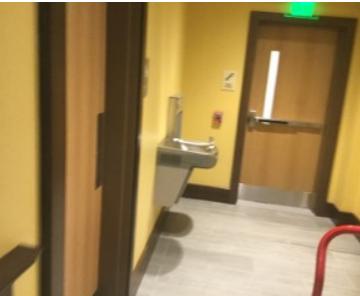
13	Hallway with High Fountain in Circulation Path	1, 2, 3, 4		Drinking Fountains	High

Standing height fountain does not have cane protection	32"	Provide a cane detectable barrier skirt under the high unit. (One of the two high fountains on each floor is in the circulation path and needs cane protection.)	4	445	\$1780
Best Practice

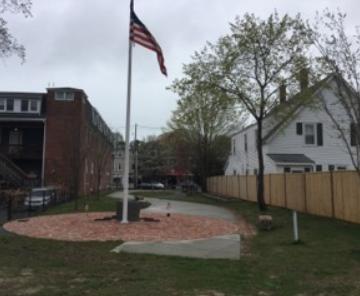
Not provided from all site arrival points		Ensure an accessible route is provided from all points of arrival. (See ID #2 for cost)	1		\$0
2	Standish Ave.	Ext		Exterior Access Route	Sidewalk

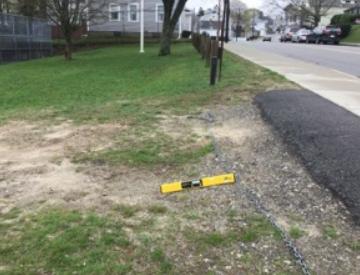
Surface not stable, firm, and slip-resistant Running slope > 1:20 (5.00%) Accessible route not provided	- 19.2% 375'	Repair surface. Reduce the running slope to be no steeper than 1:20 (5.00%). Ensure an accessible route is provided. (Cost based on 36" wide min. 375' long stone dust path with running slope of 5.00% (1:20) max. and a cross slope of 2.00% (1:50) max. that runs the length of the park and connects to	1	4271	\$4271
3	Pathway to Benches Near Court St.	Ext		Exterior Access Route	Walkway

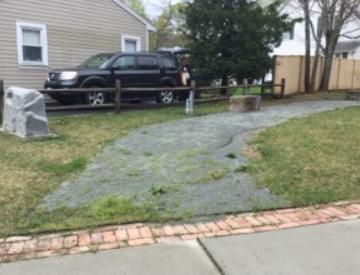
Not maintained in an operable working condition	87'	Ensure the accessible route is maintained in operable working condition. (Cost based on 36" wide min. 87' long stone dust path with running slope of 5.00% (1:20) max. and cross slope of 2.00% (1:50) max.)	1	991	\$991

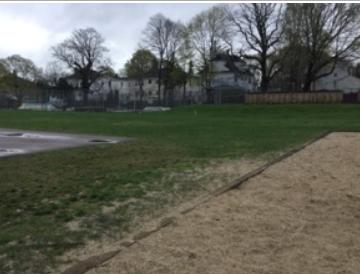
4	Between Play Area and Basketball Court	Ext		Exterior Access Route	Exterior

Accessible route not provided	35'	Ensure an accessible route is provided. (Cost based on 36" wide min. 35' long stone dust path with running slope of 5.00% (1:20) max. and cross slope of 2.00% (1:50) max.)	1	398	\$398
Access to Goods and Services

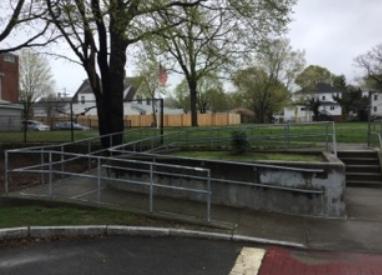
Cross slope > 1:50 (2.00%) (MAAB) Edge protection < 4" high	4% -	Reduce cross slope to be no steeper than 1:50 (2.00%). Provide edge protection that prevents the passage of a 4" diameter sphere, where any portion of the sphere is within 4" of the finish floor or ground surface. (Cost based on 60' edge protection and repaving 35' of concrete ramp to a shallower slope.)	1	4314	\$4314
6	School Parking Lot	Ext		Ramps	Exterior

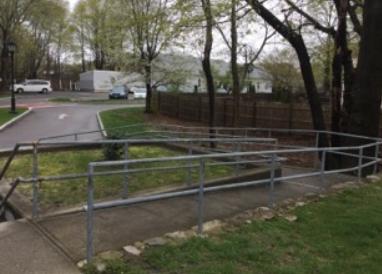
Handrails < 34" or > 38" above ramp surface	33.5"	Alter so the handrails are 34"- 38" high above the ramp surface.	1	Labor	\$0
7	School Parking Lot	Ext		Ramps	Exterior

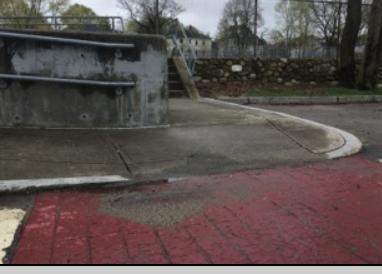
Landing has a slope > 1:50 (2.00%) (MAAB)	3.0%	Alter so that the slope in all directions is no greater than 1:50 (2.00%).	1	125	\$125

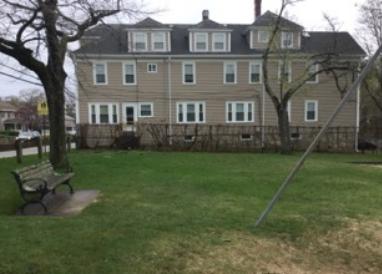
Benches												
8	Play Area	Ext		Benches	N/A

No accessible route to 20% of benches 20% of benches have clear space < 36" x 48"	- -	Relocate 20% of benches on an accessible route. Ensure that 20% of benches have a clear floor space of 36" wide min. by 48" deep min. (Cost is for a level asphalt patch alongside bench and relocated bench.)	1	180	\$180
9	Memorial Near Court St.	Ext		Benches	N/A

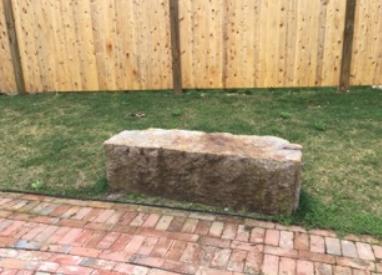
20% of benches have clear space < 36" x 48" Shoulder alignment not provided at bench - (12") back	- -	Ensure that 20% of benches have a clear floor space of 36" wide min. by 48" deep min. Provide shoulder alignment with the adjacent wheelchair space. The shoulder alignment of the wheelchair space shall be measured 36" from the front of the wheelchair space. (Cost is for a level stone dust patch alongside bench.)	1	44	\$44
Play and Sport Areas

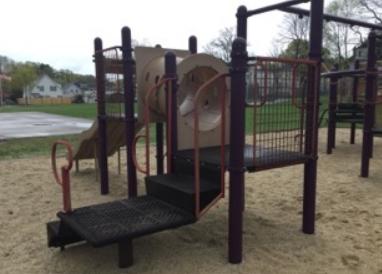
ID	Location	Floor	Room	Element	Type	Photo	Issues	Current Measure	Recommendations	Quantity	Price	Cost Estimation
Play Areas												
10	Play Area	Ext		Play Areas	N/A

No compliant transfer system Surface not stable, firm, and slip-resistant	20" 920'	Alter height of transfer system to 18" max. aff. Provide an accessible impact-attenuating surface around the play components. (Cost estimate based on a 920 sq. ft. poured-in place rubber surface.)	1	12880	\$12880
11	Play Area	Ext		Play Areas	N/A

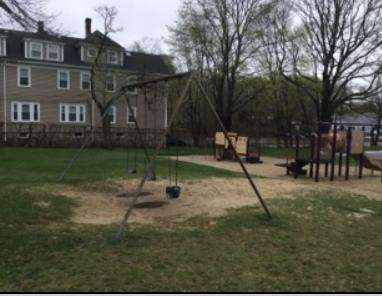
Accessible route not provided.	13'	Ensure an accessible route is provided. (Cost based on 36" wide min. 13' long stone dust path with running slope of 5.00% (1:20) max. and cross slope of 2.00% (1:50) max.)	1	148	\$148
Court												
12	Basketball Court	Ext		Court	Basketball

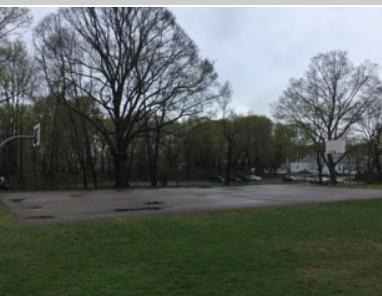
Not connected to accessible route	30'	Ensure basketball court is connected to an accessible route. (Cost based on 36" wide min. 30' long stone dust path with running slope of 5.00% (1:20) max. and cross slope of 2.00% (1:50) max.)	1	341	\$341

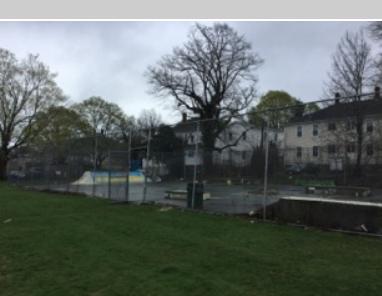
Rink												
13	Skateboard Area	Ext		Rink	Skate Rink

Not connected to an accessible route	90'	Ensure skate park is connected to an accessible route. (Cost based on 36" wide min. 90' long stone dust path with running slope of 5.00% (1:20) max. and cross slope of 2.00% (1:50) max.)	1	1025	\$1025
14	Street Hockey Rink	Ext		Rink	Skate Rink

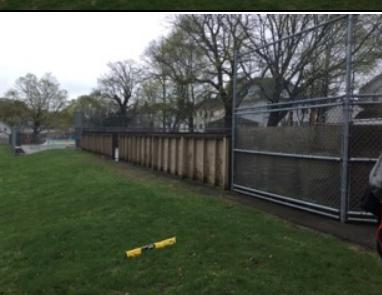
Running slope > 1:20 (5.00%) Accessible route not provided	14.5% 60'	Reduce the running slope to be no steeper than 1:20 (5.00%). Ensure street hockey rink is connected to an accessible route. (Cost based on 36" wide min. 60' long stone dust path with running slope of 5.00% (1:20) max. and cross slope of 2.00% (1:50) max.)	1	684	\$684

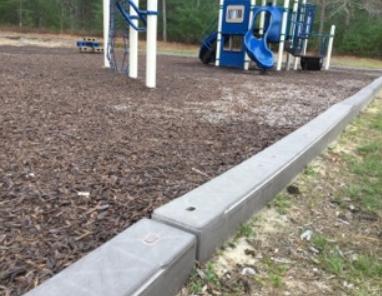
ID	Location	Floor	Room	Element	Type	Photo	Issues	Current Measure	Recommendations	Quantity	Price	Cost Estimation
Approach and Entrance												
Exterior Access Route												
1	Playground	Ext		Exterior Access Route	Exterior

Level changes > 1/4" Accessible route not provided	4" 10'	Alter change in level to be 1/4" high max. Ensure an accessible route is provided. (Cost based on 36" wide min. 10' long asphalt path with running slope of 5.00% (1:20) max. and cross slope of 2.00% (1:50) max. and 1/4" max. change in level at entry to playground.)	1	130	\$130
2	Near Parking Lot	Ext		Exterior Access Route	Exterior

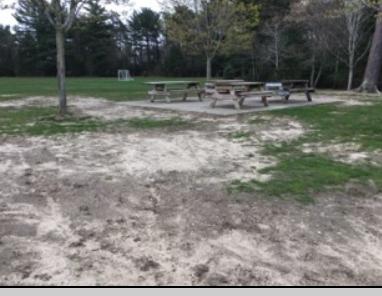
Surface not stable, firm, and slip-resistant Does not prevent accumulation of water Accessible route not provided	- - -	Repair surface. Ensure an accessible route is provided. (Cost based on 36" wide min. 30' long asphalt path with running slope of 5.00% (1:20) max. and cross slope of 2.00% (1:50) max.)	1	360	\$360

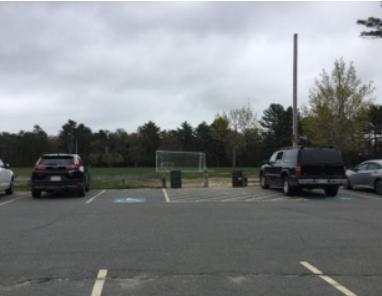
Off-Street Parking Lot or Garage												
3	Parking Lot	Ext		Off-Street Parking Lot or Garage	Visitor

Total # of parking Total # of designated accessible parking spaces Total # of designated van accessible spaces Sign not provided	75 2 0 -	Provide a van accessible space and access aisle. Provide signs with the bottom of the sign 60" min. above the ground and the top 96" max. above the ground. Add the words "Van Accessible" to the sign at the van accessible space. (Cost based on one additional van accessible space and two signs.)	1	1425	\$1425
Toilet & Bathing Rooms												
Portable Toilet												
4	Near Parking Lot	Ext		Portable Toilet	N/A

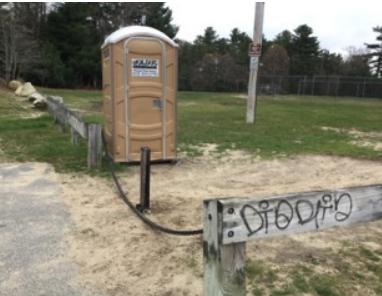
Accessible portable toilets not provided		Ensure that at least 5% of portable toilets is accessible. (Cost for one accessible portable toilet.)	1	2300	\$2300
Play and Sport Areas

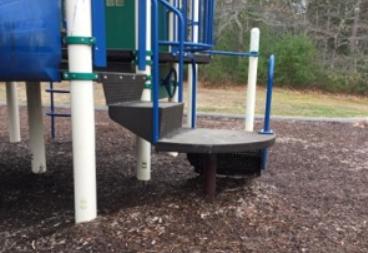
ID	Location	Floor	Room	Element	Type	Photo	Issues	Current Measure	Recommendations	Quantity	Price	Cost Estimation
Play Areas												
5	Playground	Ext		Play Areas	N/A

No compliant transfer system	20"	Alter height of transfer system to 18" max. aff.	1	Labor	\$0
6	Playground	Ext		Play Areas	N/A

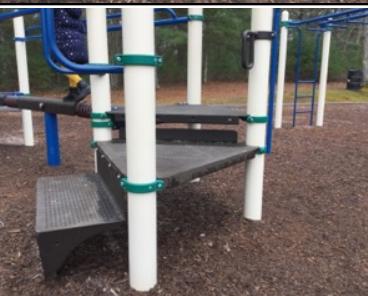
No compliant transfer system	23"	Alter height of transfer system to 18" max. aff.	1	Labor	\$0
7	Playground	Ext		Play Areas

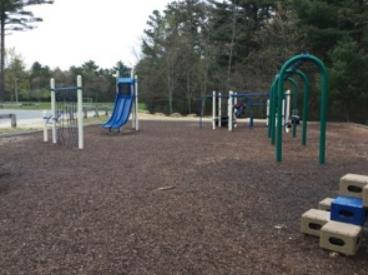
Accessible route not provided to ground level play components Surface not stable, firm, and slip-resistant		Provide an accessible impact-attenuating surface around and under play components. Repair surface. (Cost based on 1,655 square feet of poured in place rubber.)	1	23170	\$23170
Field												
8	Baseball Field	Ext		Field	Baseball

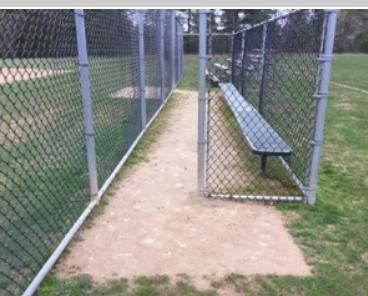
Accessible spaces are not provided at team seating	-	Provide a 36" x 48" clear floor space at team seating. (Cost based on two (2) 3'x4' asphalt patches, one at the end of each team seating bench, and the cost for relocating the fence at one end of each team seating bench to allow room for the asphalt patch.)	2	180	\$360

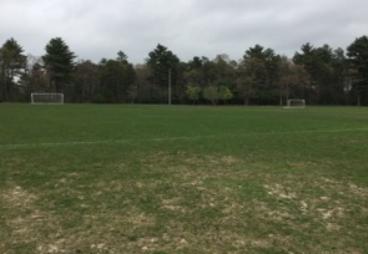
9	Soccer Field	Ext		Field	Soccer

Not connected to an accessible-route	350'	Ensure soccer field is connected to an accessible route. (Cost based on 36" wide min. 350' long asphalt path with running slope of 5.00% (1:20) max. and cross slope of 2.00% (1:50) max.)	1	4550	\$4550

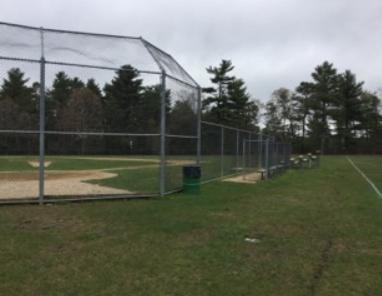
ID	Location	Floor	Room	Element	Type	Photo	Issues	Current Measure	Recommendations	Quantity	Price	Cost Estimation
10	Baseball Field	Ext		Field	Baseball

Not connected to an accessible-route	250'	Ensure baseball field is connected to an accessible route. (Cost based on 36" wide min. 250' long asphalt path with running slope of 5.00% (1:20) max. and cross slope of 2.00% (1:50) max.)	1	3250	\$3250
Bleachers												
11	Baseball Field	Ext		Bleachers	N/A

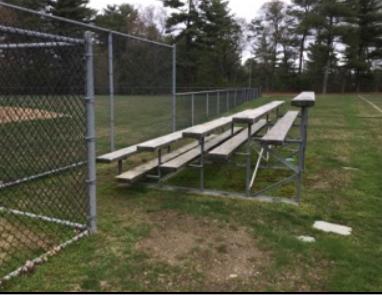
Total number of seats in the facility Min. # of designated wheelchair spaces not provided Seating spaces < 33" x 48" (2 spaces) Seats not connected by accessible route	50 0 - -	Provide a 33" by 48" clear floor space adjacent to bleachers. Provide an accessible route to the seating area. (Cost based on a 3'x4' asphalt patch.)	2	54	\$108
