TOWN OF PLYMOUTH COMMUNITY PRESERVATION COMMITTEE

SPIRE CENTER FOR THE PERFORMING ARTS

CONDITIONS ASSESSMENT & CONCEPTUAL DESIGN

THE SPIRE CENTER FOR THE PERFORMING ARTS

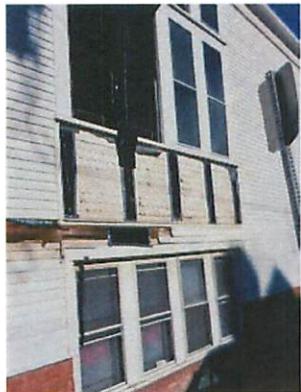
Left: Fishscale shingles revealed under vinyl siding.

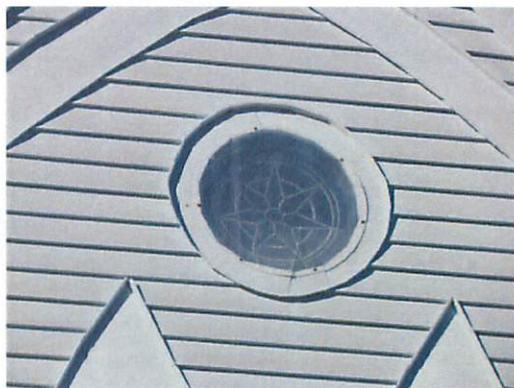
With the exception of the southeast tower, all elevations at the Spire Center are covered with aluminum siding that obscures the original wood cladding and trim elements. Assessment of the conditions of the clapboards, decorative shingles and trim underneath cannot be made until the siding has been removed.

Character defining siding and molded trim features are hidden behind flat aluminum elements.

- Remove aluminum siding and sheet aluminum over trim.
- Replace damaged clapboards and decorative shingles and trim with new parts milled to match the historic size.
- Strip, prep and repaint wood elements.
- Replicate missing carved ornaments in panels between the windows at the gable ends. These are seen in historic photographs.
- Replace missing trim, moldings, corbels and brackets.

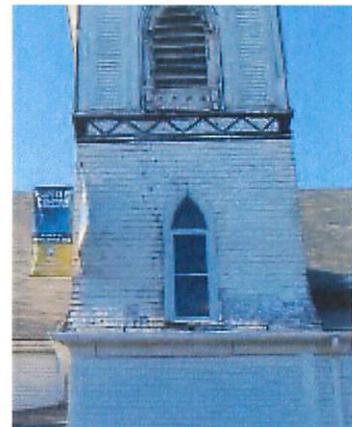
Wall surfaces and trim elements covered by aluminum siding.

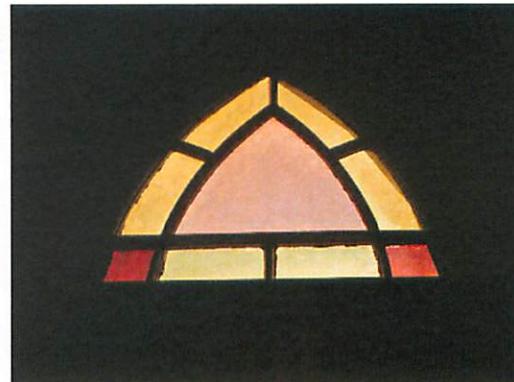
Ongoing investigative removal of the aluminum siding and storm windows reveals that the original wood windows are in fair condition, with widespread paint failure and areas of rot.

Arched window at east transept seen from the interior.

- Fully strip, repair, reglaze, prep and paint window sash.
- Fully strip, repair, prep and paint doors.

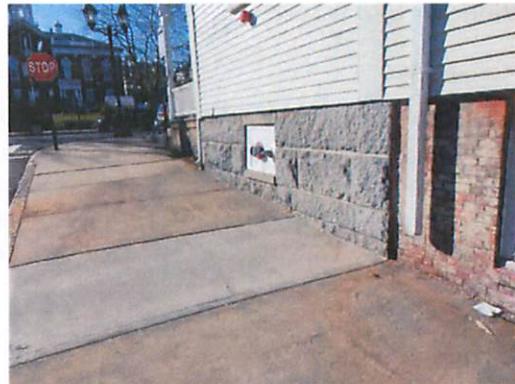
The building has a brick foundation. At the facade and southeast tower it is faced with dressed granite. The granite is in good condition. The brick is in fair condition with areas of failed mortar and poorly matched mortar; the brick surface has vestiges of a paint coating.

Dressed granite-faced brick foundation at southeast tower.

- Repoint the brick selectively with correct mortar.
- Repoint granite facing stones.

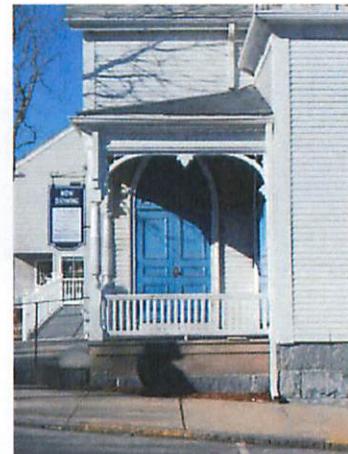
The front entry is a concrete slab that is spalled, chipped and cracked at the southeast corner. It is approached by a granite step.

Concrete slab porch at southeast corner.

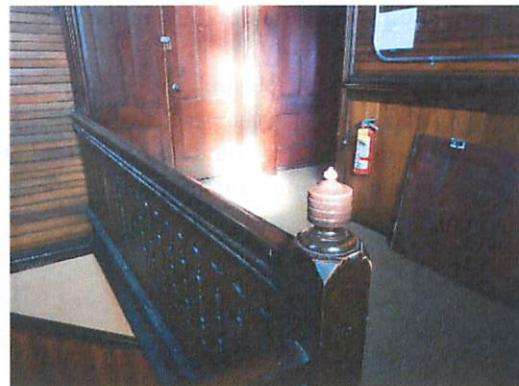
Third floor stair landing.

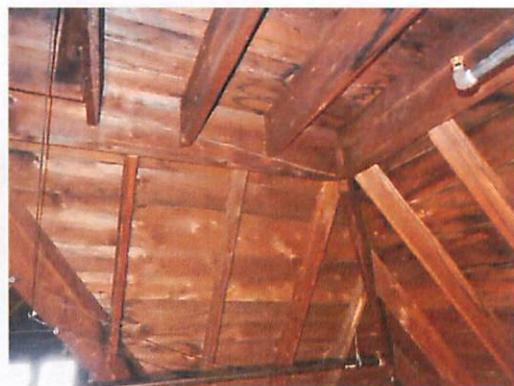
Wood framing at hip roof.

- Removed old knob and tube wiring and re-wire with code compliant wiring.
- Critical framing repairs:
 - Reinforce existing collar beams with new steel beams supported on new tube steel posts that are in turn supported on new transfer beams in the attic floor.
 - Introduce new tension tie elements and connections to join the two halves of the corbel trusses. (See the structural report that follows for detailed recommendations on framing repairs.)

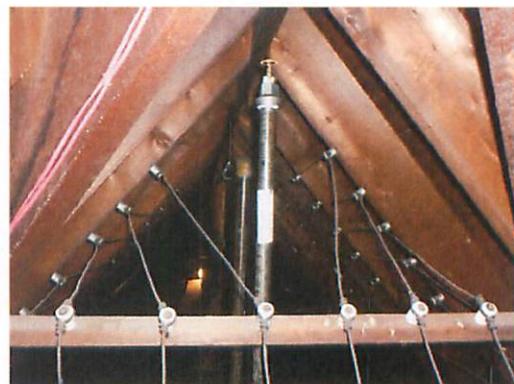
Original knob and tube wiring.

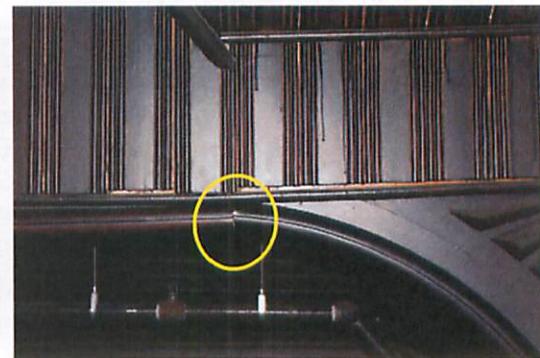
Trim elements at corbel truss have separated due to uneven load.

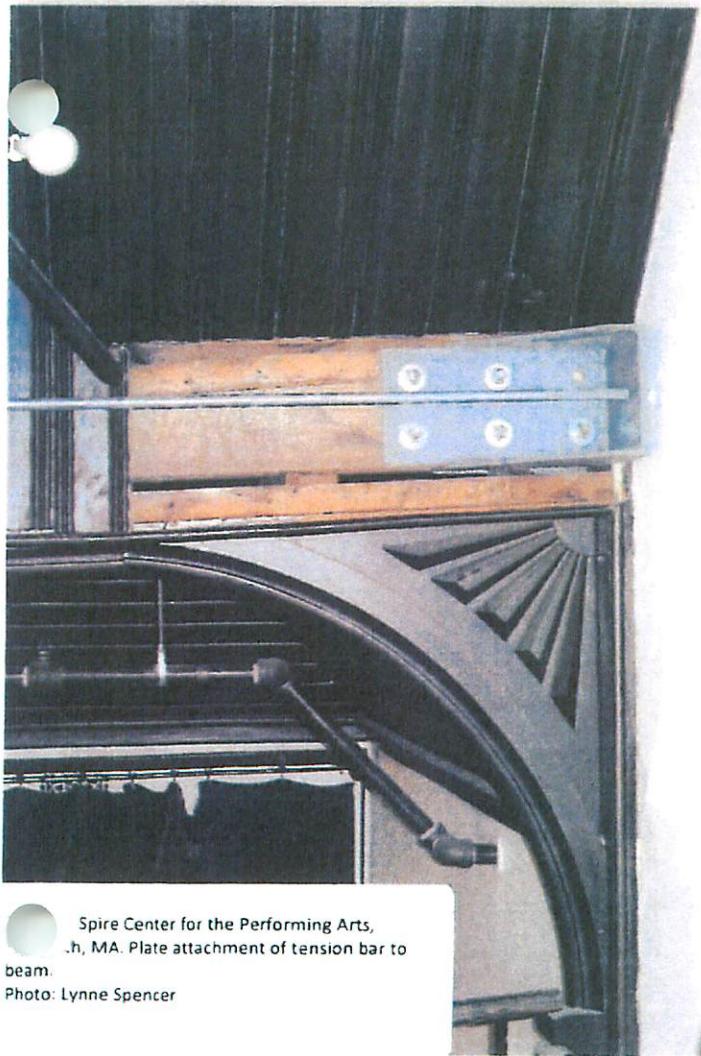
Spire Center for the Performing Arts, Plymouth, MA. Plate attachment of tension bar to beam.

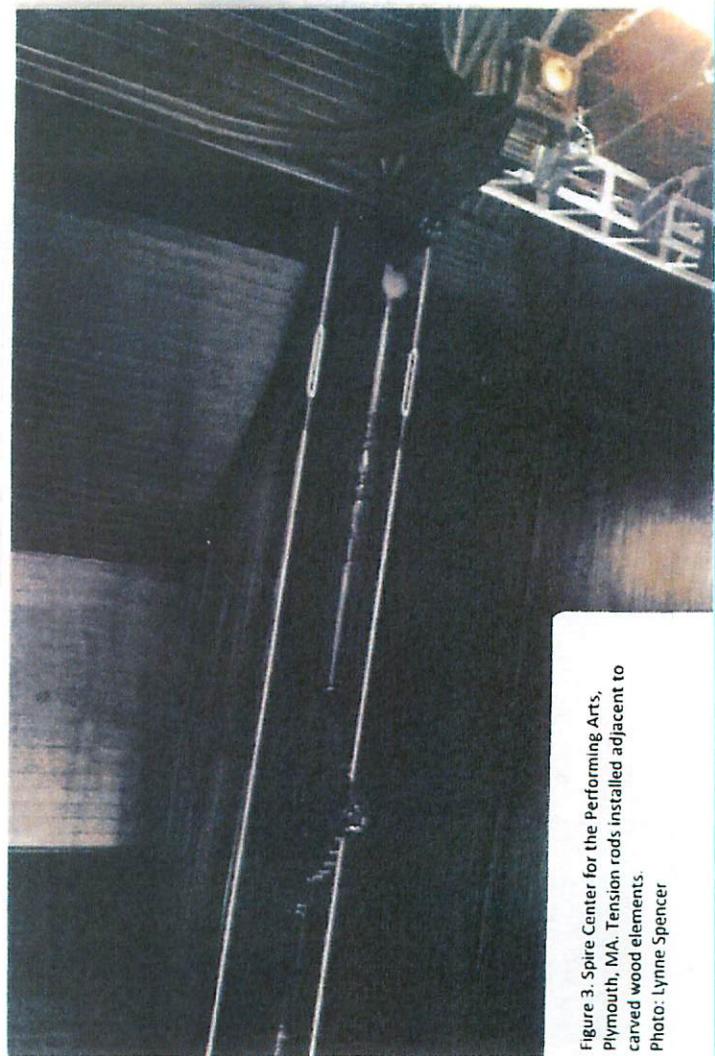
Figure 3. Spire Center for the Performing Arts, Plymouth, MA. Tension rods installed adjacent to carved wood elements.

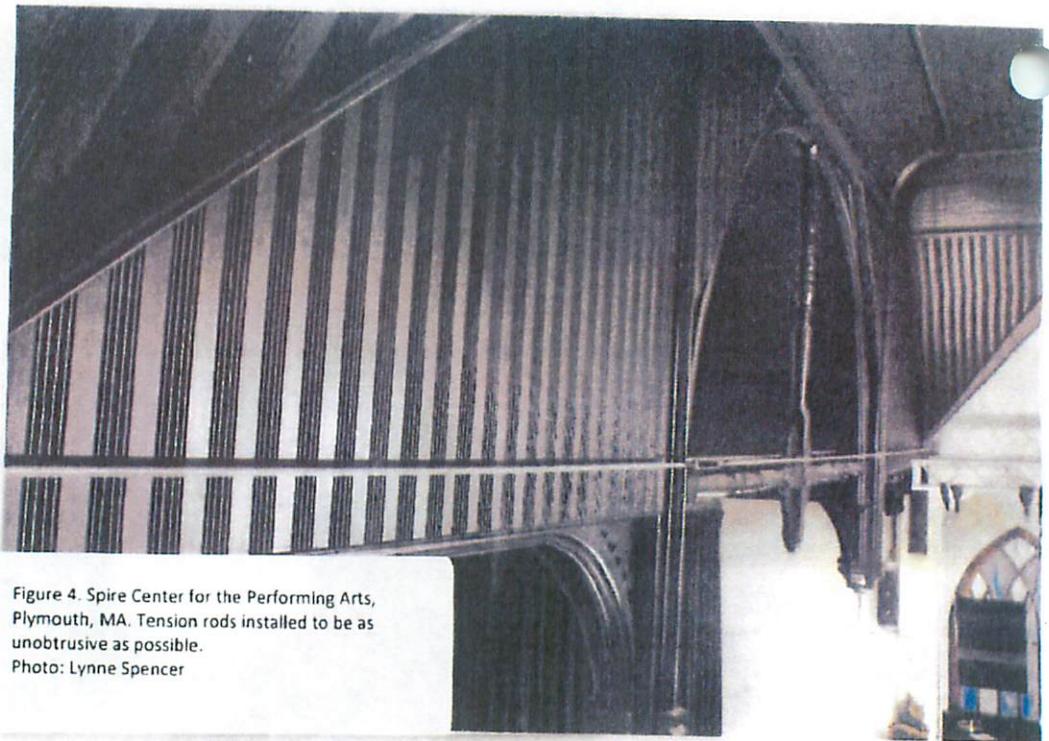
Figure 4. Spire Center for the Performing Arts, Plymouth, MA. Tension rods installed to be as unobtrusive as possible.

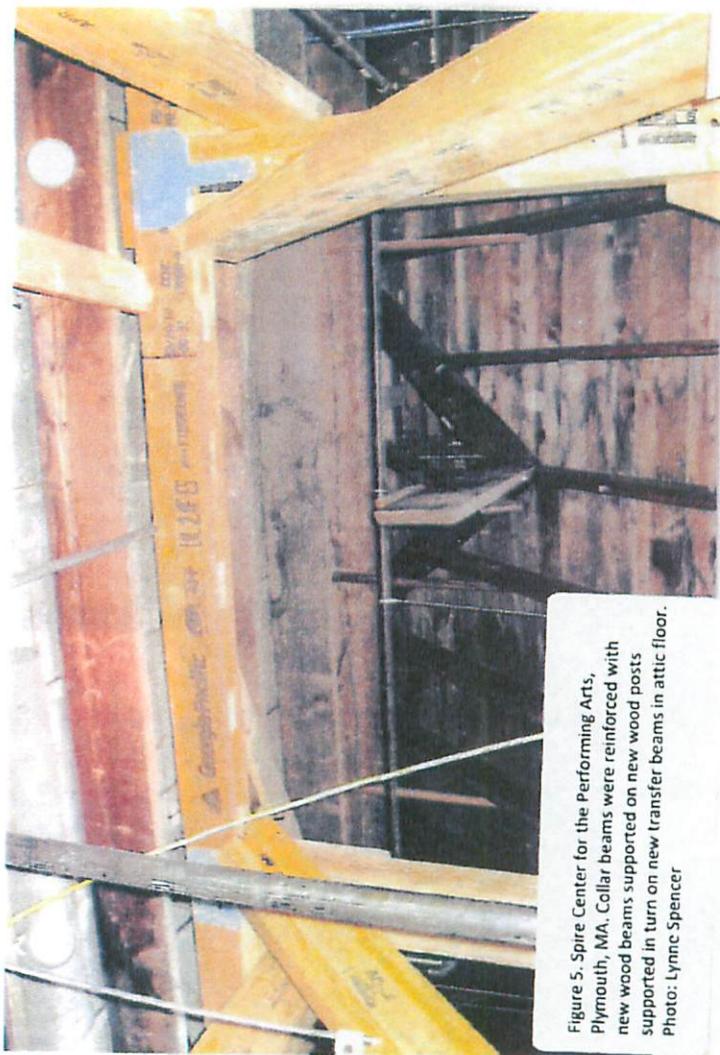
Figure 5. Spire Center for the Performing Arts, Plymouth, MA. Collar beams were reinforced with new wood beams supported on new wood posts supported in turn on new transfer beams in attic floor.

Coastal Engineering had prepared schematic design plans for the structural augmentation and retrofit of the areas of failure described above. The existing collar beams were reinforced with new wood beams supported on new wood posts that are in turn supported on new transfer beams in the attic floor (Figures 5, 5g, 5h).

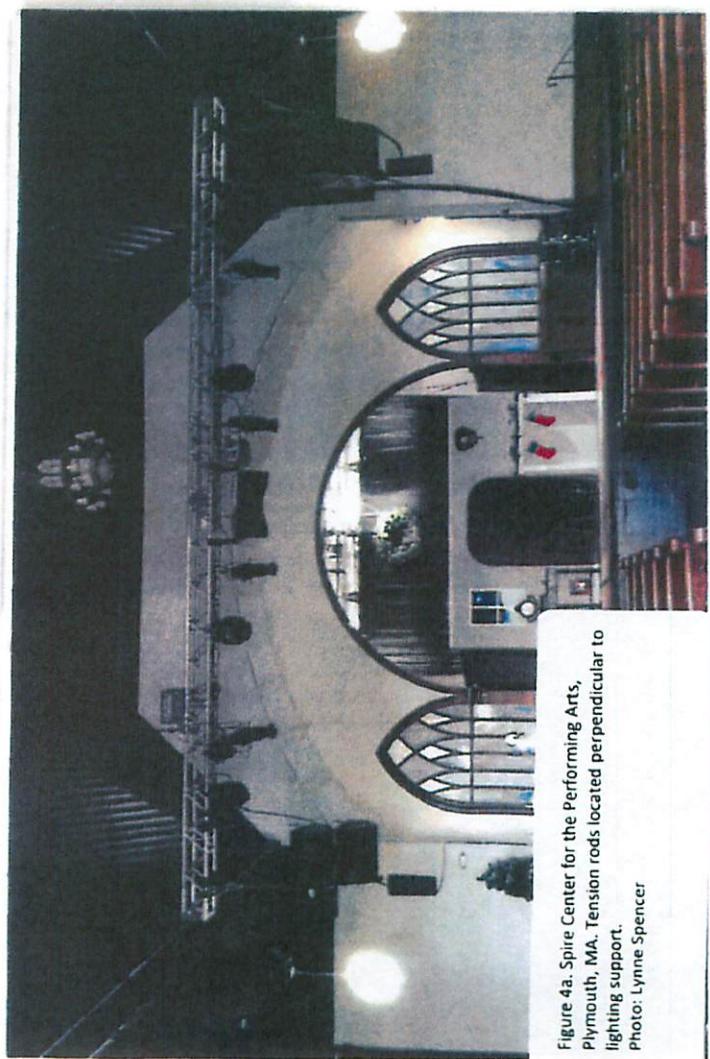
Figure 4a. Spire Center for the Performing Arts, Plymouth, MA. Tension rods located perpendicular to lighting support.
Photo: Lynne Spencer

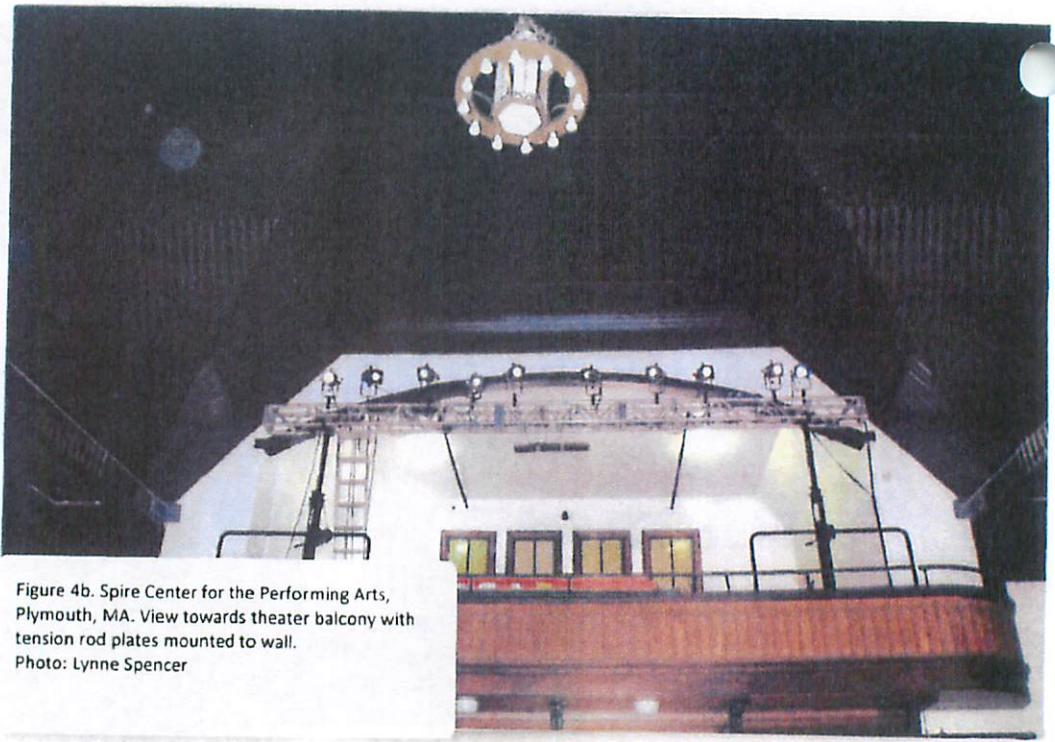
Figure 4b. Spire Center for the Performing Arts, Plymouth, MA. View towards theater balcony with tension rod plates mounted to wall.
Photo: Lynne Spencer

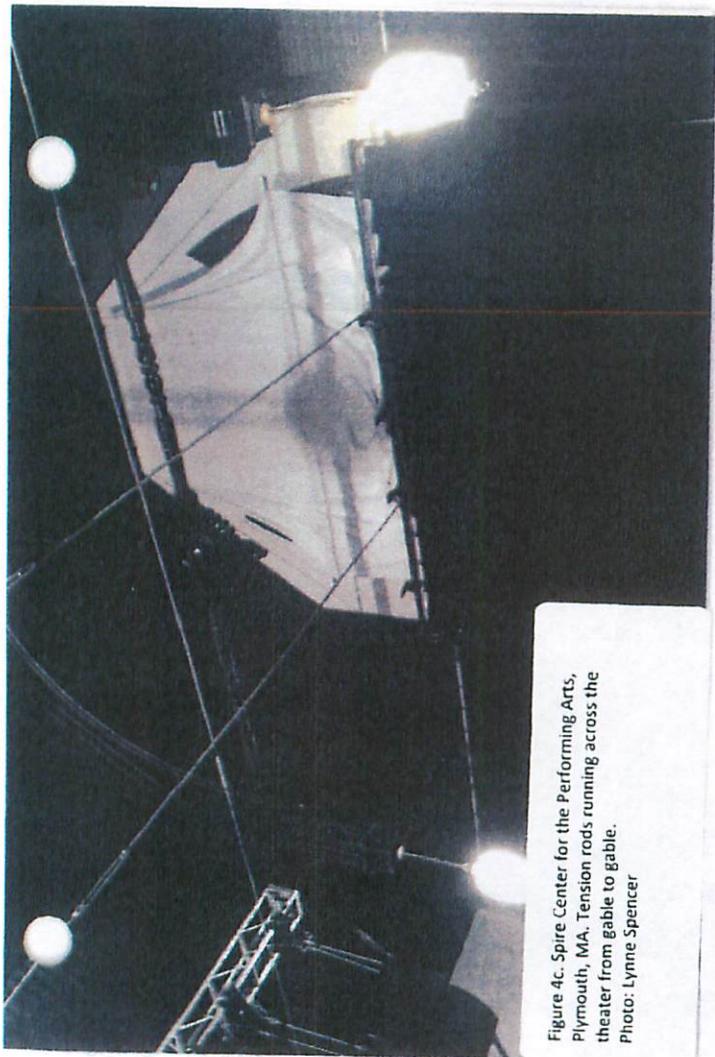
Figure 4c. Spire Center for the Performing Arts, Plymouth, MA. Tension rods running across the theater from gable to gable.
Photo: Lynne Spencer

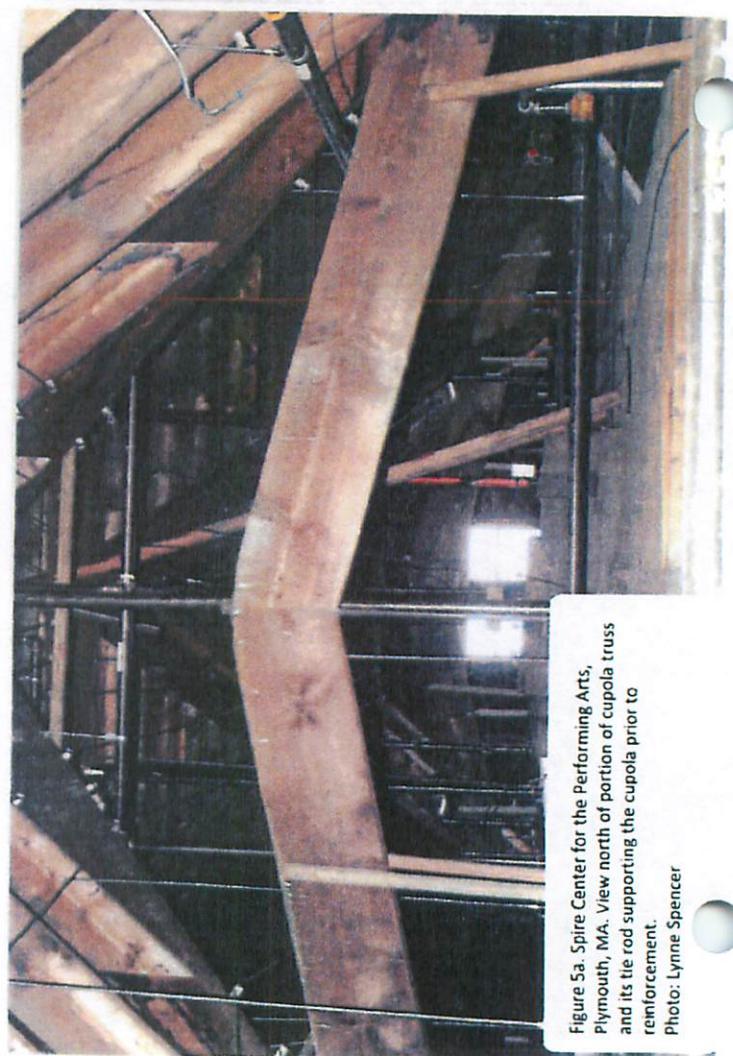
Figure 5a. Spire Center for the Performing Arts, Plymouth, MA. View north of portion of cupola truss and its tie rod supporting the cupola prior to reinforcement.
Photo: Lynne Spencer

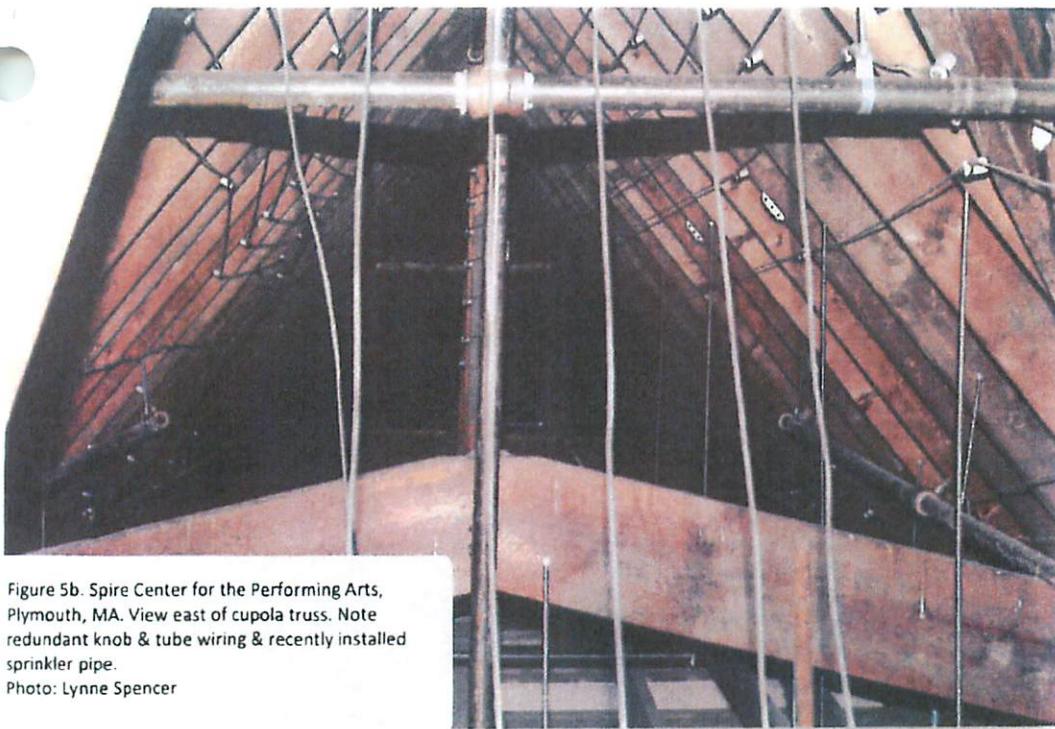
Figure 5b. Spire Center for the Performing Arts, Plymouth, MA. View east of cupola truss. Note redundant knob & tube wiring & recently installed sprinkler pipe.

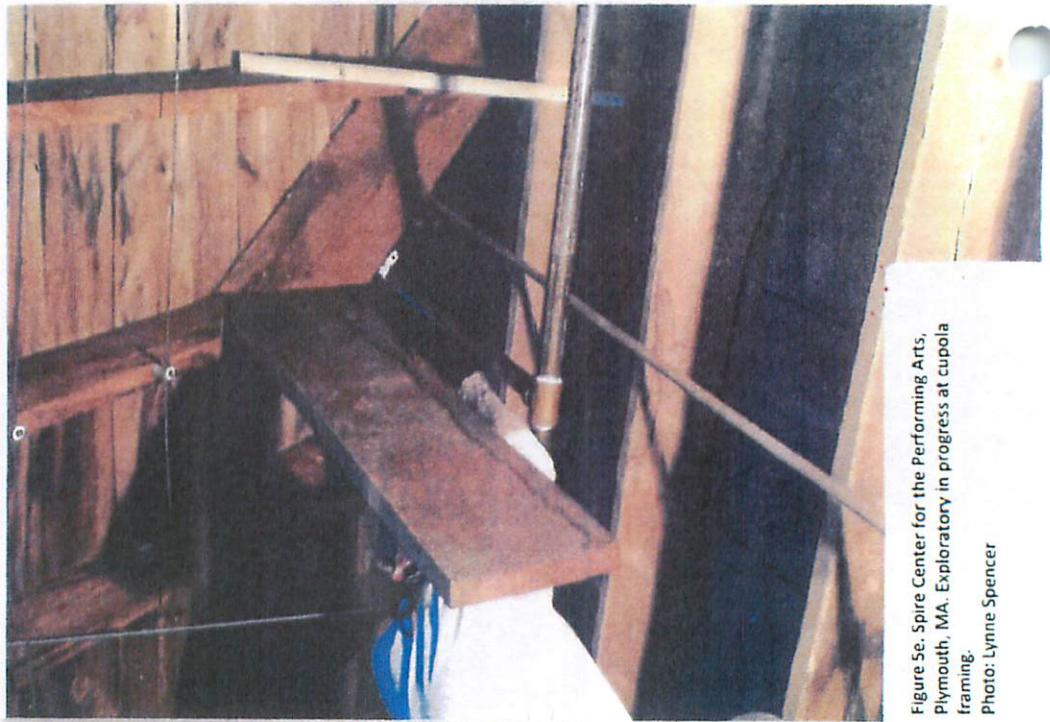
Figure 5e. Spire Center for the Performing Arts, Plymouth, MA. Exploratory in progress at cupola framing.
Photo: Lynne Spencer

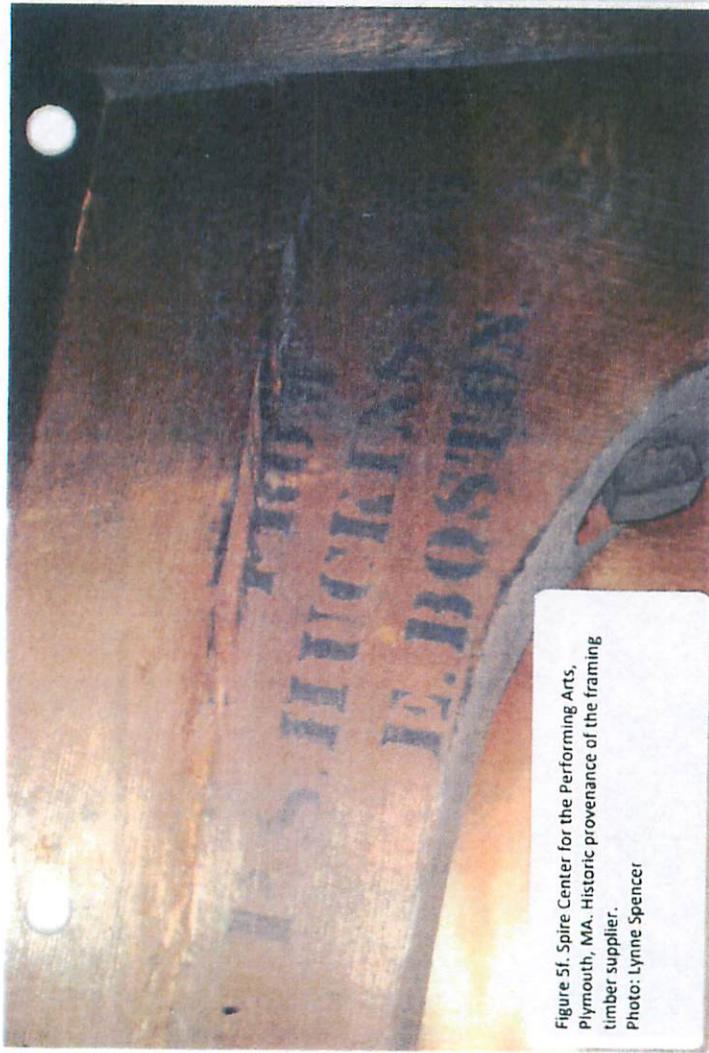
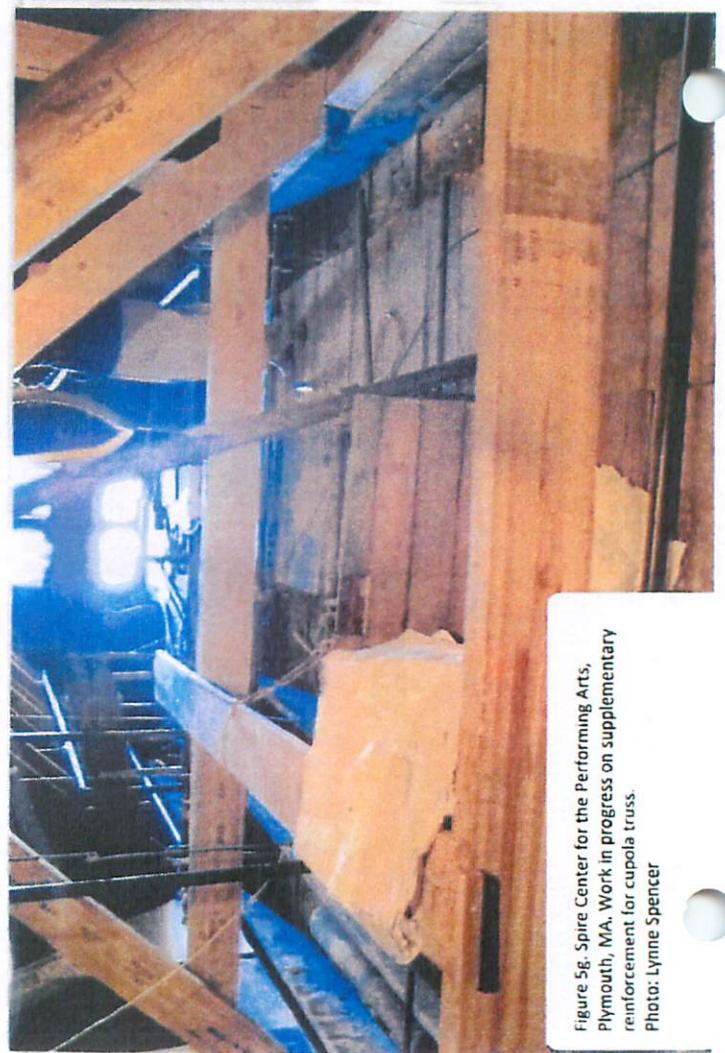
Figure 5g. Spire Center for the Performing Arts, Plymouth, MA. Work in progress on supplementary reinforcement for cupola truss.
Photo: Lynne Spencer

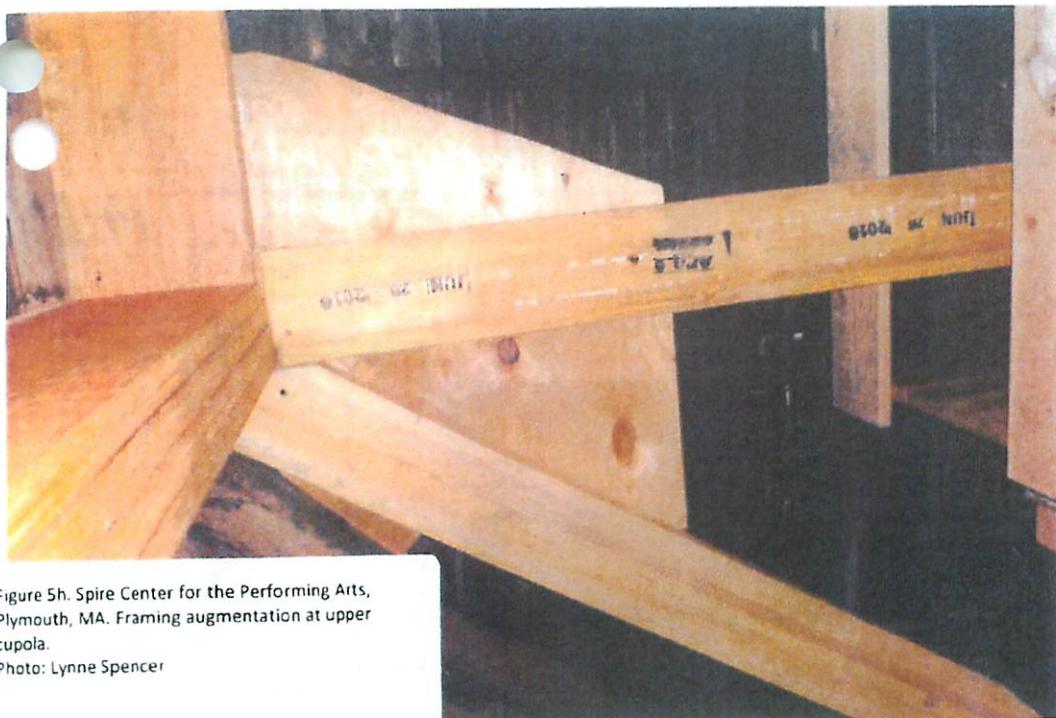
Figure 5h. Spire Center for the Performing Arts, Plymouth, MA. Framing augmentation at upper cupola.

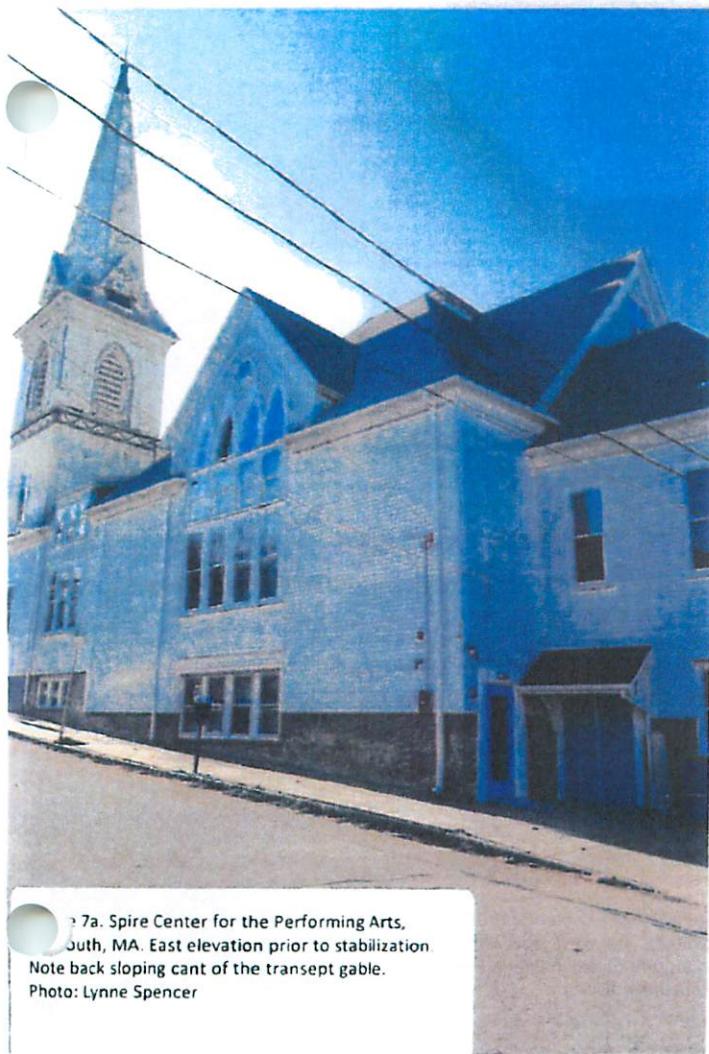
Additional work included adding temporary beams inside and outside the outer walls of the east and west transepts, bolted together at 18" intervals. Remedial work at the transept initially was designed to address the backway leaning seen in the gable walls above the roof edge (Figures 7a, 7b). Exploratory work involving removal of siding revealed that the entire wall was inadequately framed (Figure 7c). A permanent retrofit was designed but proved to be too expensive for the funding available. Instead, temporary reinforcing beams were installed to stabilize the walls until funding is identified for the permanent reinforcement of the east and west transepts (Figures 7d, 7e).

Figure 7a. Spire Center for the Performing Arts, Plymouth, MA. East elevation prior to stabilization.

Note back sloping cant of the transept gable.

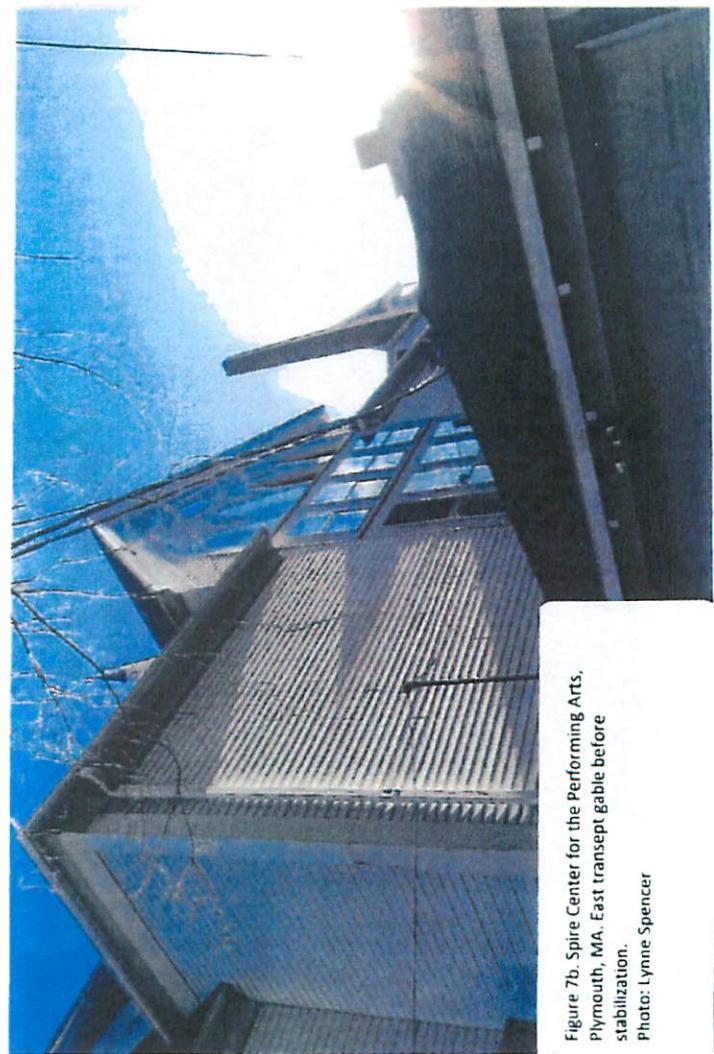
Figure 7b. Spire Center for the Performing Arts, Plymouth, MA. East transept gable before stabilization.

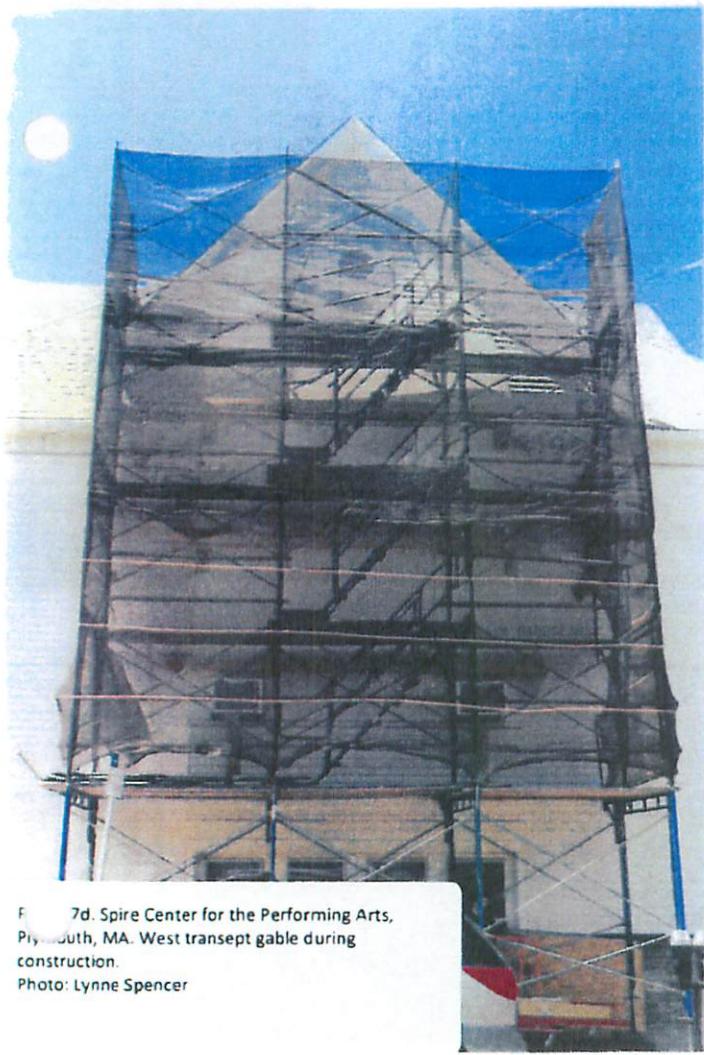
Figure 7d. Spire Center for the Performing Arts, Plymouth, MA. West transept gable during construction.
Photo: Lynne Spencer

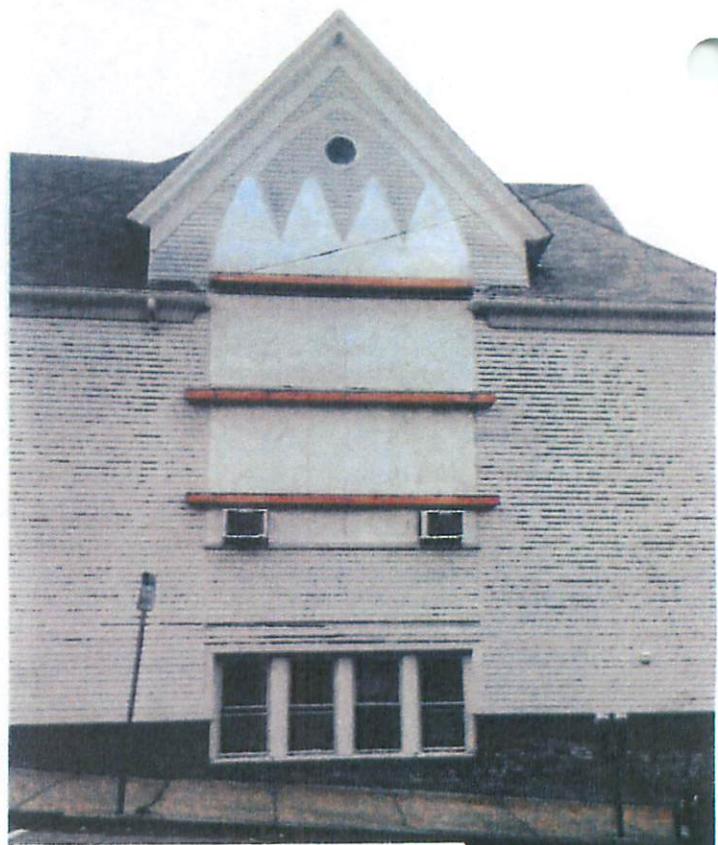
Figure 7e. Spire Center for the Performing Arts, Plymouth, MA. West gable with temporary restraining beams thru-bolted to interior restraints.
Photo: Ross Dekle
